ARLINGTON NATIONAL CEMETERY

MS4 Permit Year 2016/2017

Annual Report and Program Plan Update

Reporting Period
July 1, 2016 through June 30, 2017
(Due: October 1, 2017)

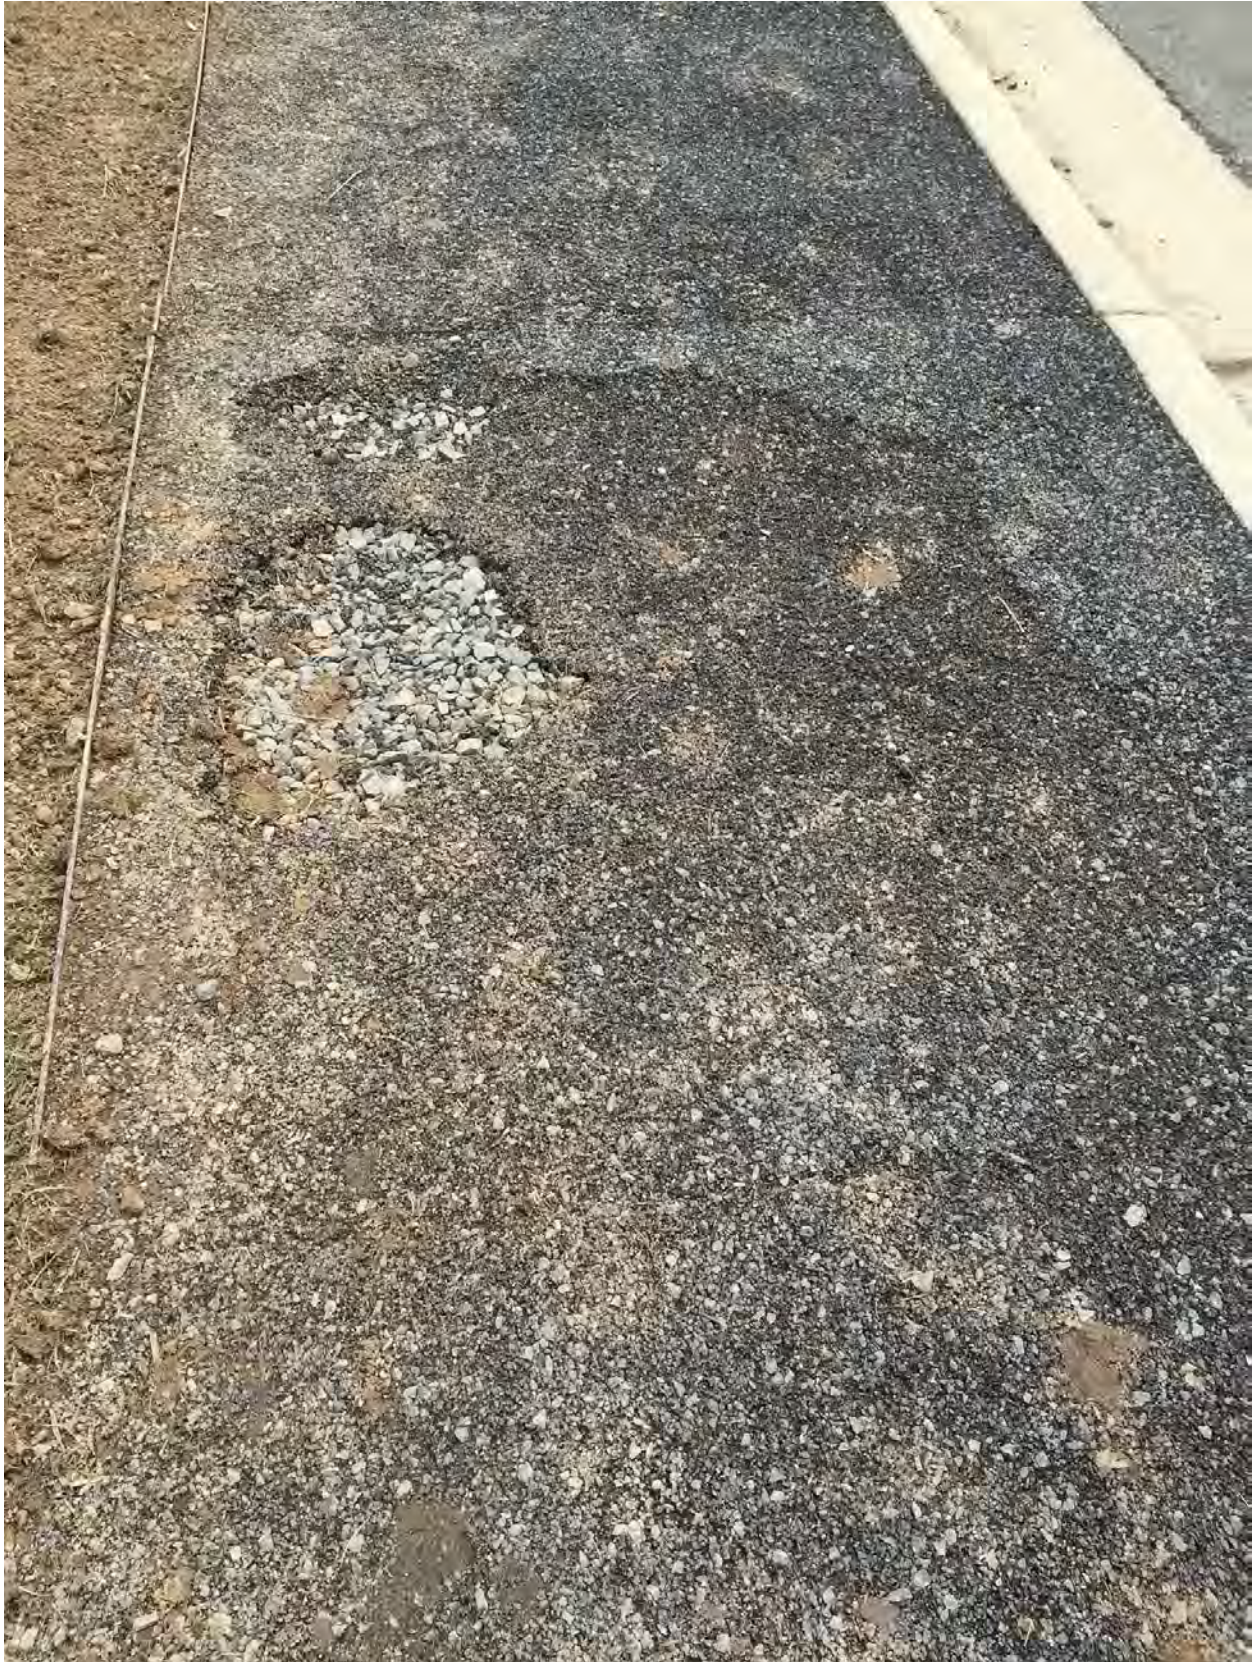
Eisenhower Permeable Pavement
May 2017

Structural Integrity	There is evidence of surface deterioration, such as slumping, cracking, spalling or broken pavers.	Y	Y	Y	Repair or replace affected areas, as necessary.	Professional	Missing pavement. Notified leadership of required repair.
Observation Wells	Is each observation well still capped?	N/A			Repair, as necessary.	Professional	
Outlet	Outlets are obstructed or erosion and soil exposure is evident below the outlet.	N/A			Remove obstructions and stabilize eroded or exposed areas.	Owner or Professional

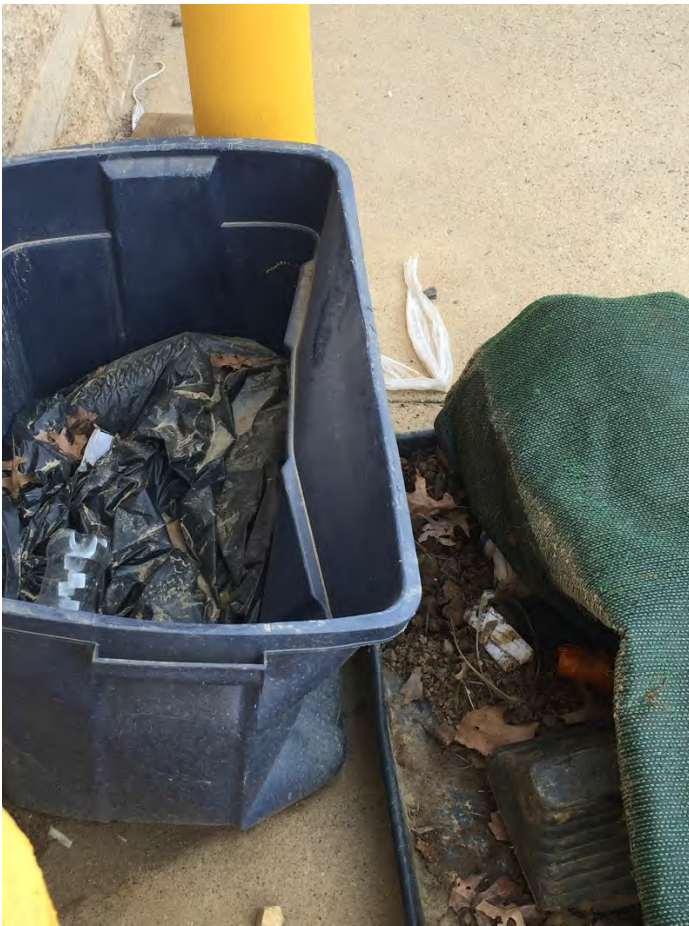
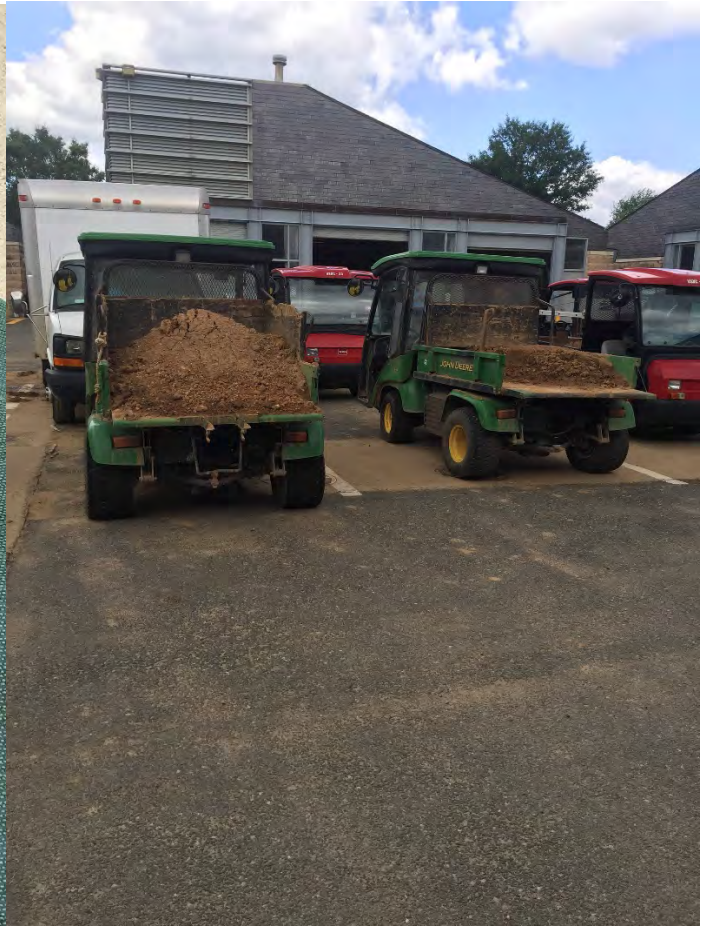
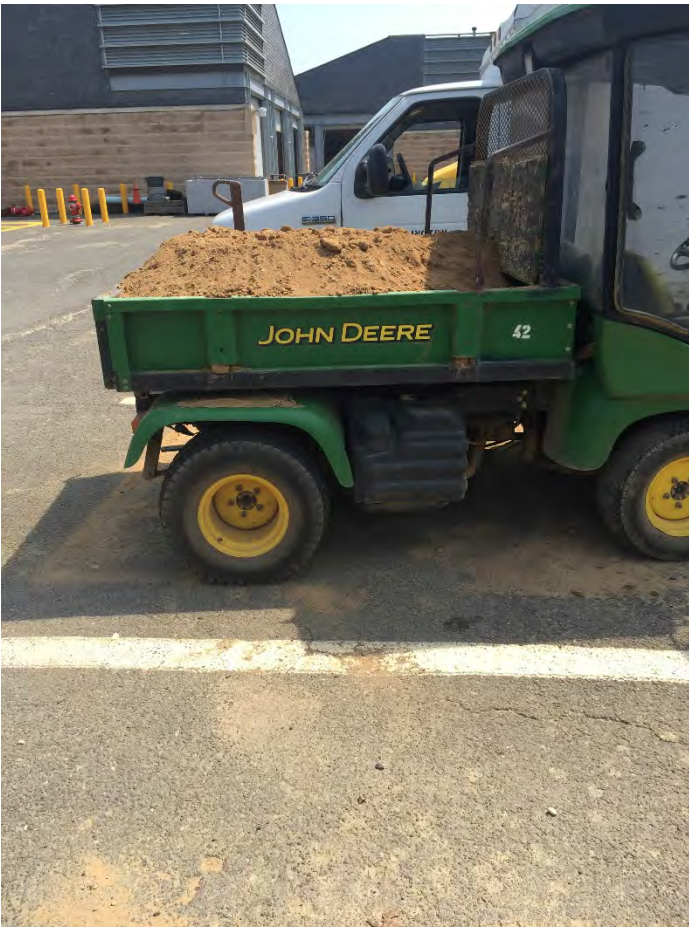
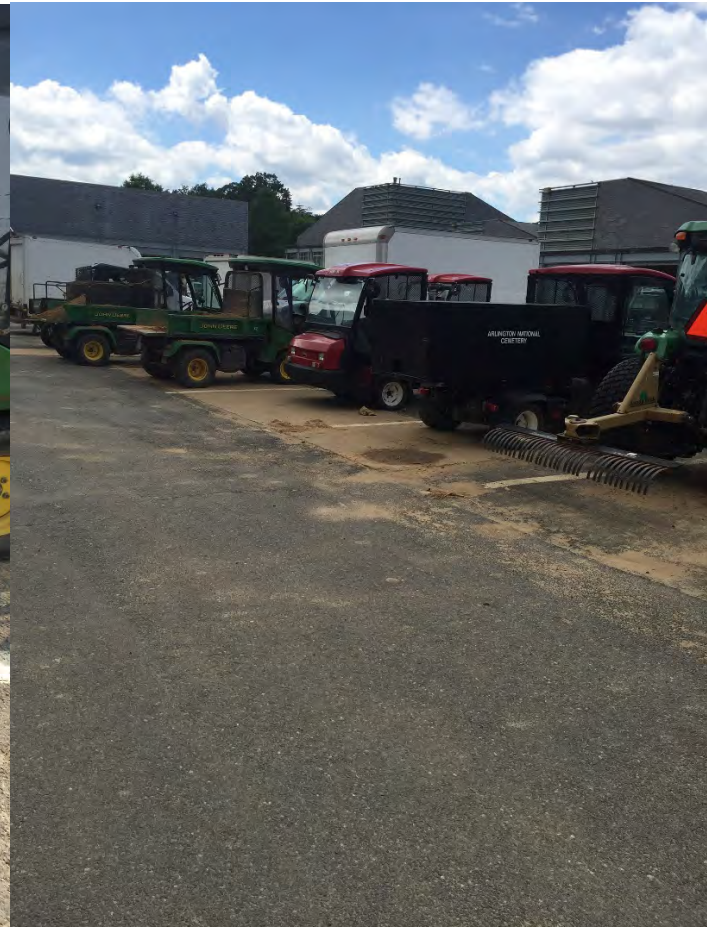
Discussed concerns and findings with Cemetery Operations Leadership, Mr.Brion Moore, and provided recommendations.

07/10/17: Operations has replaced trash cans.
