## **ANNUAL REPORT UPDATE**

**Reporting Period**  
**July 1, 2018 to June 30, 2019 (Due October 1, 2019)**

### **Arlington National Cemetery**

**VPDES Permit Number: VAR040139**  
**Permit Effective Date: November 1, 2018**  
**Permit Expiration Date: October 31, 2023**

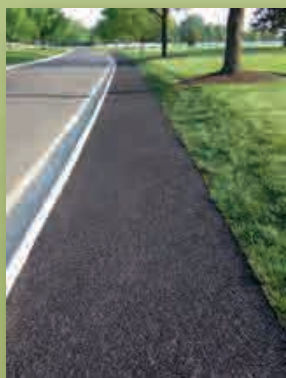
Permeable pavement is installed at the Millennium Site and used for sidewalks near the new Chapel Gate and along Eisenhower Avenue.

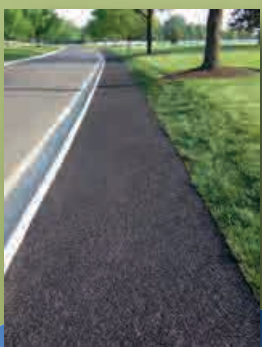
El pavimento permeable reduce las escorrentías contaminadas al permitir que las aguas de escorrentía pluvial se infiltren a través de la superficie, lo cual filtra los contaminantes.

El pavimento permeable se instala en el Sitio del Milenio ("Millennium Site") y se utiliza para las aceras cerca al Portón de la Capilla ("Chapel Gate") y cerca de la Avenida Eisenhower ("Eisenhower Avenue").

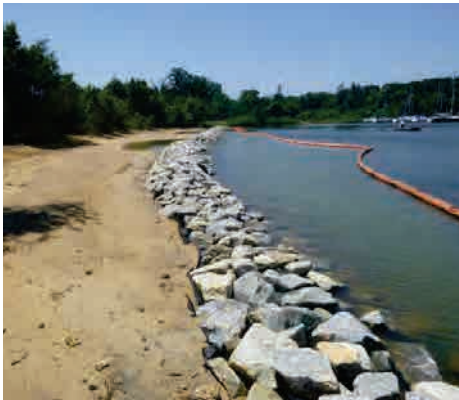
As an important component of a larger effort totaling 28,000 linear feet of shoreline restoration at the North Severn Complex, this project included the repair and restoration of 1,517 linear feet of shoreline that was severely damaged by erosion for decades. The project protects both nearby infrastructure and the North Severn Complex and reduces TN, TP, and TSS loads.

**Challenges Overcome:** The project included five reaches subject to high wave action and storm energy, which led to extensive erosion. The shoreline along Mill Creek was also dominated by *Phragmites australis*, a non-native invasive species. Rather than repairing the existing bulkhead, stone revetment, which has a 50-year useful life, was recommended. To minimize the impact to tidal water, the existing stone at the toe of the slope in front of the bulkhead was retained. In areas where native tidal wetlands grew behind the bulkhead, the design was modified by adding stone to the top and front of the bulkhead, allowing tidal water to flood the area.

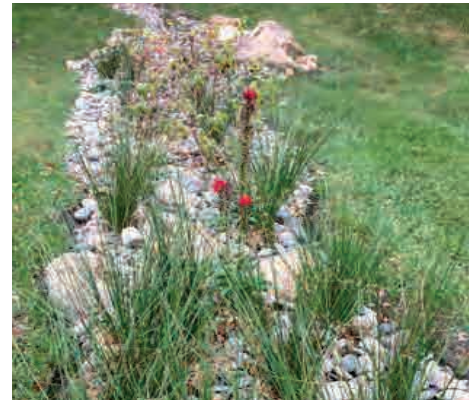
**Challenges Overcome:** Rain gardens create beautiful landscape features in the parking lots, but the grass channel leading to the underground device did not meet beautification standards. Keeping with the standards expected of ANC, the facility installed boulders and rocks to create a curving channel to slow stormwater flow and beautify the small area.

To honor the aesthetic character of ANC, plants were carefully selected. Species tolerant of wet conditions were selected to soak up water, provide food for local wildlife, and create a serene view and sitting area for visitors.

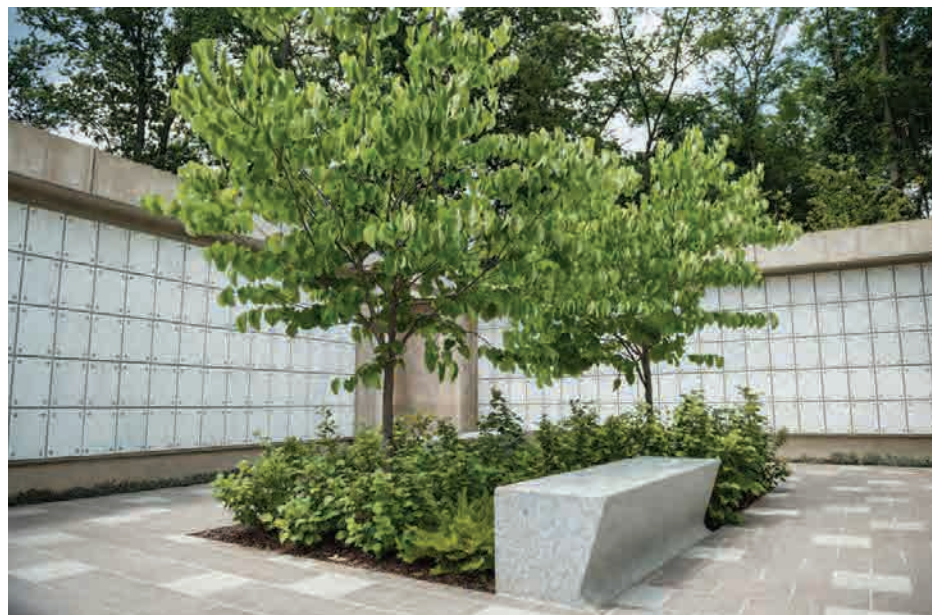
An Urban Bioretention garden located within Columbarium Court 11 of the newest area of Arlington National Cemetery, the Millennium Project, Arlington, Virginia, July 20, 2018. They contain *Fothergilla* and *Cephalotaxus*, low-growing shrubs, in between stone benches. (U.S. Army photo by Elizabeth Fraser)

- **Micro-Bioretenention gardens** adjacent to Shelter 1 are small depressed gardens treating runoff from small area developments.
- **Bioretenention basins** adjacent to Columbaria are depressed gardens treating runoff from large impervious and pervious areas.
- **Urban Bioretenention gardens** located within the Columbaria are expanded tree pits and planting beds.

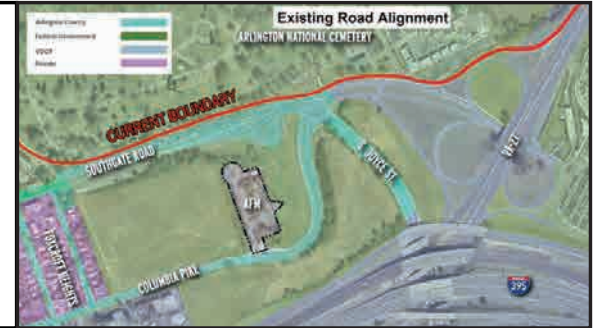
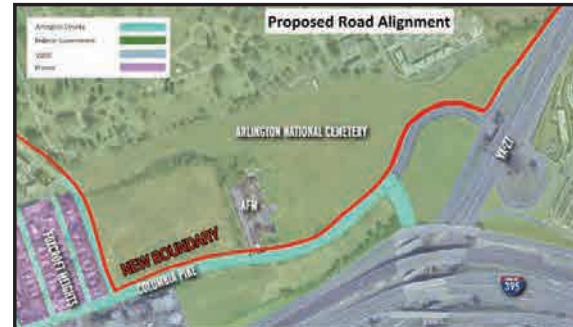
### MAP 2: DAR PROJECT AFTER

Arlington National Cemetery will have more burial space within its new boundary, especially with the field operations' footprint being located in the space south of Columbia Pike.

Three steps must take place:

1. Acquire the land shown on the left.
2. Realign the roads.
3. Move the utilities.

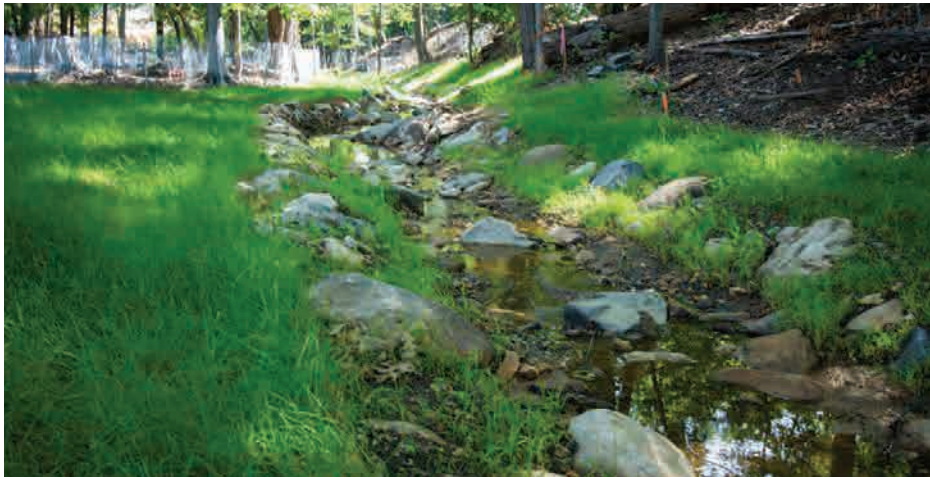
One BMP includes a restored stream and vegetated buffer in the Millennium section. ANC chose to improve the condition of the stream running through the project site because of stream bank erosion.

While streams are complex and natural systems, predicting their response to an engineered design is not easy. Ultimately, ANC chose a stream channel design to meet required water quality reductions and improve stream conditions. This design included adjusting stream elevation, adding step pools and a border pool, stream bank stabilization, and restoring the adjacent buffer area.

Stream located near Columbarium Courts 12 and 13 of Arlington National Cemetery, Arlington, Virginia, Aug. 20, 2014. (U.S. Army Core of Engineers photo)

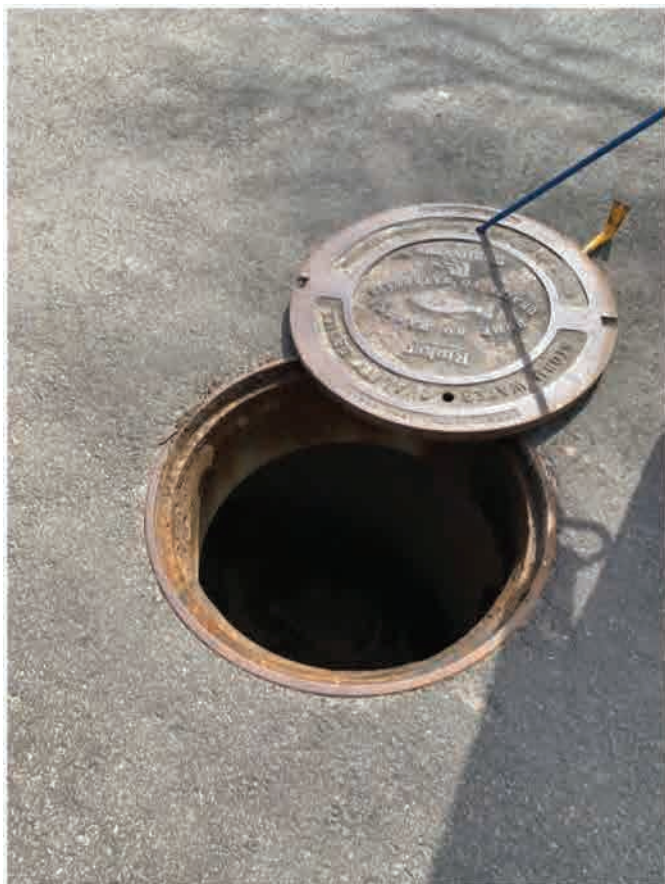
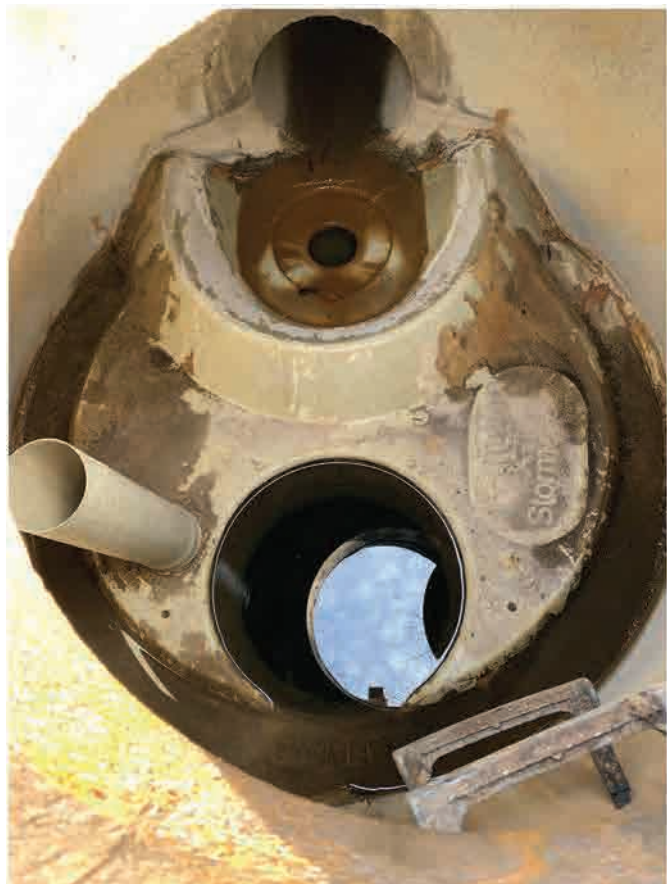
## STORMCEPTOR

Inspector Name: Renee Lavinsky		Date: 2/26/19		Date of last inspection:	
Weather/site conditions: Sun, 48F		Time since last rainfall: > 24 hours			
BMP INFORMATION					
BMP Installation Date: 2002-2003		Model:            900            1200            ✓ 1800            2400			
BMP #: STC-2	Location: Columbarium 8	As-Built Plans available: <input checked="" type="checkbox"/> Yes <input type="checkbox"/> No			
ROUTINE MAINTENANCE ACTIVITIES					
Activity		Frequency		Completed	
None		NA		NA	
FIELD INSPECTION CHECKLIST					
Criteria	Maintenance Required?	ANC or Professional fix	Comments		Date Repaired
Inlet/Outlet/Access					
Pipe blockages	<input type="checkbox"/> Yes <input checked="" type="checkbox"/> No				
Pipe or joint breaks or cracks	<input type="checkbox"/> Yes <input checked="" type="checkbox"/> No				
Access portals cracked, damaged, or unable to open	<input type="checkbox"/> Yes <input checked="" type="checkbox"/> No

Sediment Levels					
Sediment depth of the following values (sampling procedures provided below):		<input type="checkbox"/> Yes <input checked="" type="checkbox"/> No	No sediment observed		
<i>Model #</i>	<i>Depth (in.)</i>				
900	6				
1200	7				
1800	12				
2400	12				
Oil Levels					
Oil greater than 1" (sampling procedures provided below):	<input type="checkbox"/> Yes <input checked="" type="checkbox"/> No				
Upstream and Drainage Area					
Oil, fuel, or chemical spills	<input type="checkbox"/> Yes <input checked="" type="checkbox"/> No <input type="checkbox"/> N/A				
Sediment on pavement	<input type="checkbox"/> Yes <input checked="" type="checkbox"/> No <input type="checkbox"/> N/A				
Trash, debris, bare soil, and/or erosion	<input type="checkbox"/> Yes <input checked="" type="checkbox"/> No <input type="checkbox"/> N/A				
Additional Observations or Comments:					
ANNUAL REPORTING					
Are significant maintenance activities required for the stormwater management facility to perform as designed? (does not activities such as grass mowing or trash collection)					<input type="checkbox"/> Yes <input checked="" type="checkbox"/> No

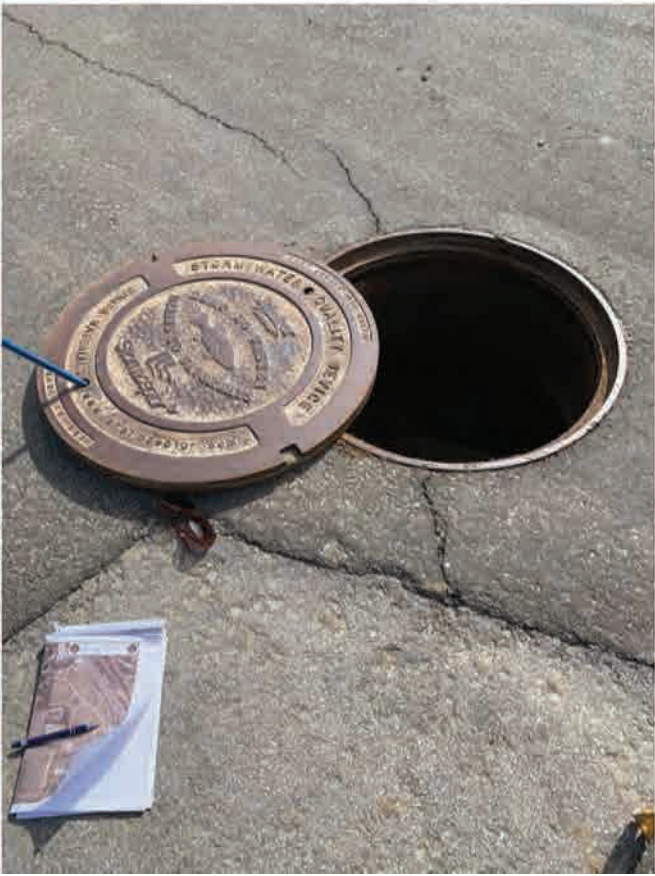
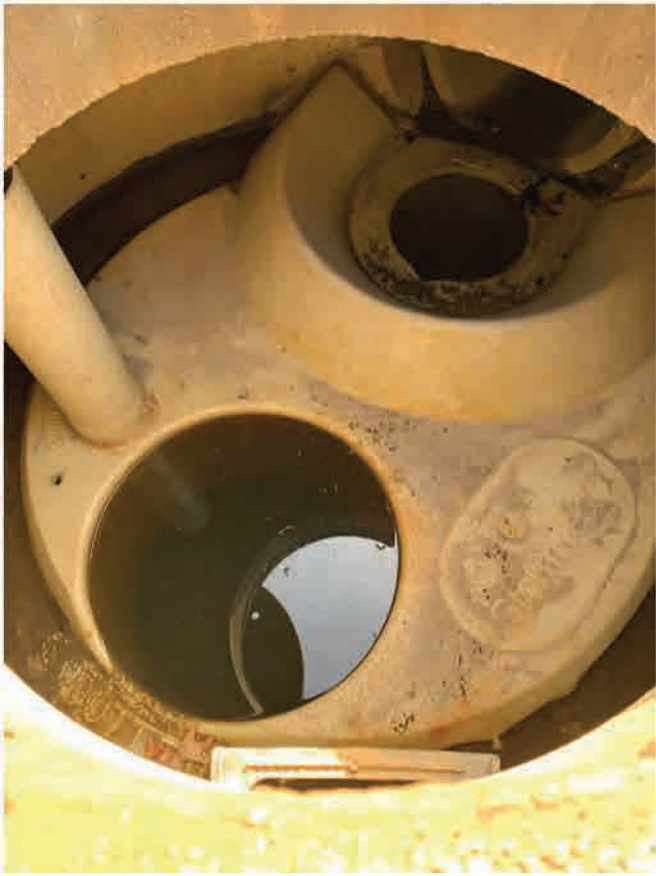
Arlington National Cemetery Post-Construction Inspection Checklist					STORMCEPTOR
Inspector Name: Renee Lavinsky			Date: 2/26/19	Date of last inspection:	
Weather/site conditions: Sun, 48F			Time since last rainfall: > 24 hours		
BMP INFORMATION					
BMP Installation Date: 2013			Model:	<input checked="" type="checkbox"/> 900	<input type="checkbox"/> 1200 <input type="checkbox"/> 1800 <input type="checkbox"/> 2400
BMP #: STC-3	Location: Columbarium 9 North		As-Built Plans available: <input checked="" type="checkbox"/> Yes <input type="checkbox"/> No		
ROUTINE MAINTENANCE ACTIVITIES					
Activity			Frequency		Completed
None			NA		NA
FIELD INSPECTION CHECKLIST					
Criteria	Maintenance Required?	ANC or Professional fix	Comments		Date Repaired
<b>Inlet/Outlet/Access</b>					
Pipe blockages	<input type="checkbox"/> Yes <input checked="" type="checkbox"/> No				
Pipe or joint breaks or cracks	<input type="checkbox"/> Yes <input checked="" type="checkbox"/> No

Access portals cracked, damaged, or unable to open	<input type="checkbox"/> Yes <input checked="" type="checkbox"/> No				
<b>Sediment Levels</b>					
Sediment depth of the following values (sampling procedures provided below):		<input type="checkbox"/> Yes <input checked="" type="checkbox"/> No	No sediment observed		
<i>Model #</i>	<i>Depth (in.)</i>				
900	6				
1200	7				
1800	12				
2400	12				
<b>Oil Levels</b>					
Oil greater than 1" (sampling procedures provided below):	<input type="checkbox"/> Yes <input checked="" type="checkbox"/> No				
<b>Upstream and Drainage Area</b>					
Oil, fuel, or chemical spills	<input type="checkbox"/> Yes <input checked="" type="checkbox"/> No <input type="checkbox"/> N/A				
Sediment on pavement	<input type="checkbox"/> Yes <input checked="" type="checkbox"/> No <input type="checkbox"/> N/A				
Trash, debris, bare soil, and/or erosion	<input type="checkbox"/> Yes <input checked="" type="checkbox"/> No <input type="checkbox"/> N/A

<b>Additional Observations or Comments:</b>					
ANNUAL REPORTING					
Are significant maintenance activities required for the stormwater management facility to perform as designed? (does not activities such as grass mowing or trash collection)					<input type="checkbox"/> Yes <input checked="" type="checkbox"/> No

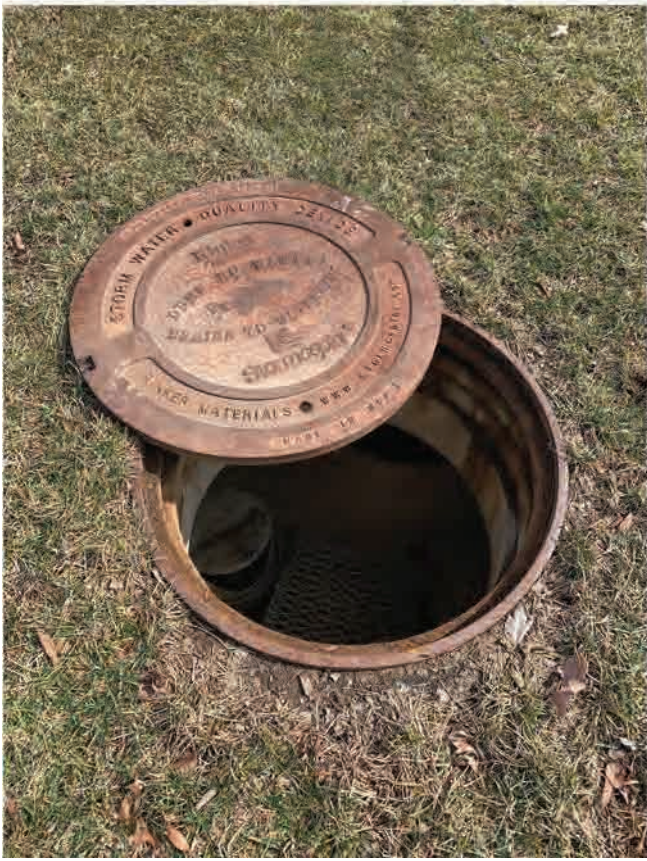
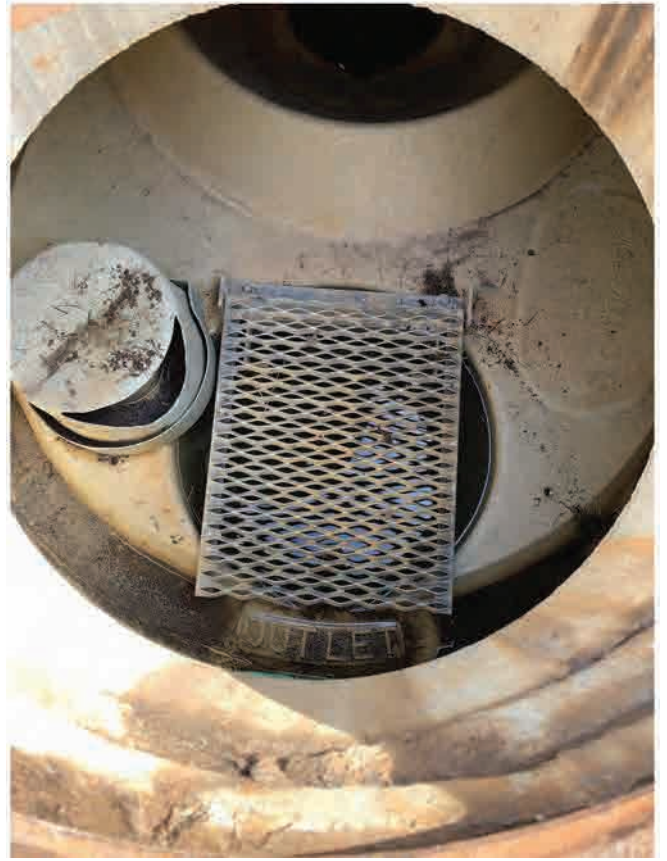
Arlington National Cemetery Post-Construction Inspection Checklist					STORMCEPTOR
Inspector Name: Renee Lavinsky			Date: 2/26/19	Date of last inspection:	
Weather/site conditions: Sun, 48F			Time since last rainfall: > 24 hours		
BMP INFORMATION					
BMP Installation Date: 2013			Model:	<input checked="" type="checkbox"/> 900	<input type="checkbox"/> 1200 <input type="checkbox"/> 1800 <input type="checkbox"/> 2400
BMP #: STC-4	Location: Columbarium 9 South		As-Built Plans available: <input checked="" type="checkbox"/> Yes <input type="checkbox"/> No		
ROUTINE MAINTENANCE ACTIVITIES					
Activity			Frequency		Completed
None			NA		NA
FIELD INSPECTION CHECKLIST					
Criteria	Maintenance Required?	ANC or Professional fix	Comments		Date Repaired
<b>Inlet/Outlet/Access</b>					
Pipe blockages	<input type="checkbox"/> Yes <input checked="" type="checkbox"/> No				
Pipe or joint breaks or cracks	<input type="checkbox"/> Yes <input checked="" type="checkbox"/> No

Access portals cracked, damaged, or unable to open	<input type="checkbox"/> Yes <input checked="" type="checkbox"/> No				
<b>Sediment Levels</b>					
Sediment depth of the following values (sampling procedures provided below):		<input type="checkbox"/> Yes <input checked="" type="checkbox"/> No	No sediment observed		
<i>Model #</i>	<i>Depth (in.)</i>				
900	6				
1200	7				
1800	12				
2400	12				
<b>Oil Levels</b>					
Oil greater than 1" (sampling procedures provided below):	<input type="checkbox"/> Yes <input checked="" type="checkbox"/> No				
<b>Upstream and Drainage Area</b>					
Oil, fuel, or chemical spills	<input type="checkbox"/> Yes <input checked="" type="checkbox"/> No <input type="checkbox"/> N/A				
Sediment on pavement	<input type="checkbox"/> Yes <input checked="" type="checkbox"/> No <input type="checkbox"/> N/A				
Trash, debris, bare soil, and/or erosion	<input type="checkbox"/> Yes <input checked="" type="checkbox"/> No <input type="checkbox"/> N/A

<b>Additional Observations or Comments:</b>					
ANNUAL REPORTING					
Are significant maintenance activities required for the stormwater management facility to perform as designed? (does not activities such as grass mowing or trash collection)					<input type="checkbox"/> Yes <input checked="" type="checkbox"/> No

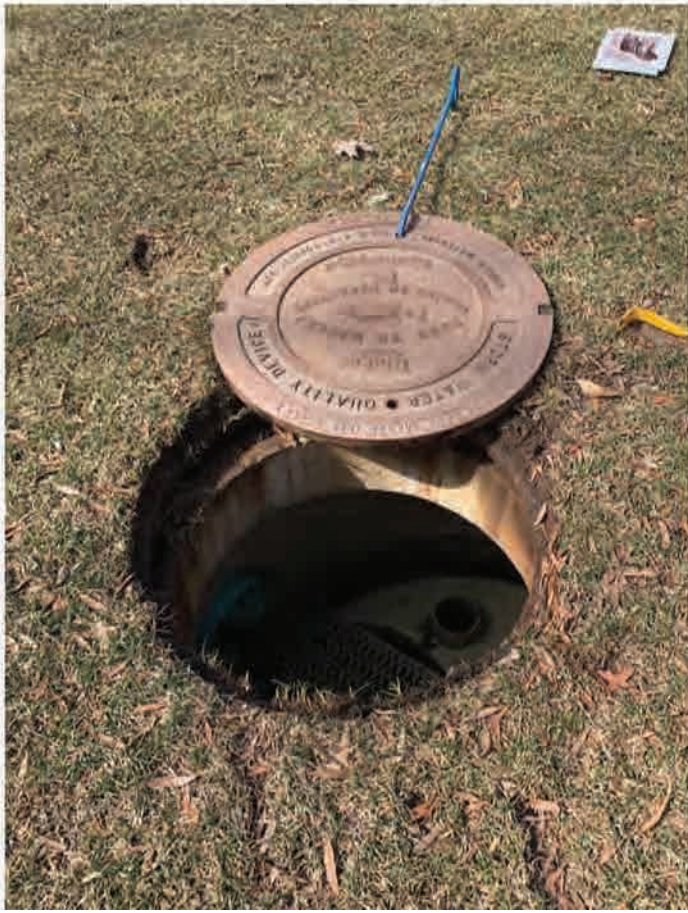
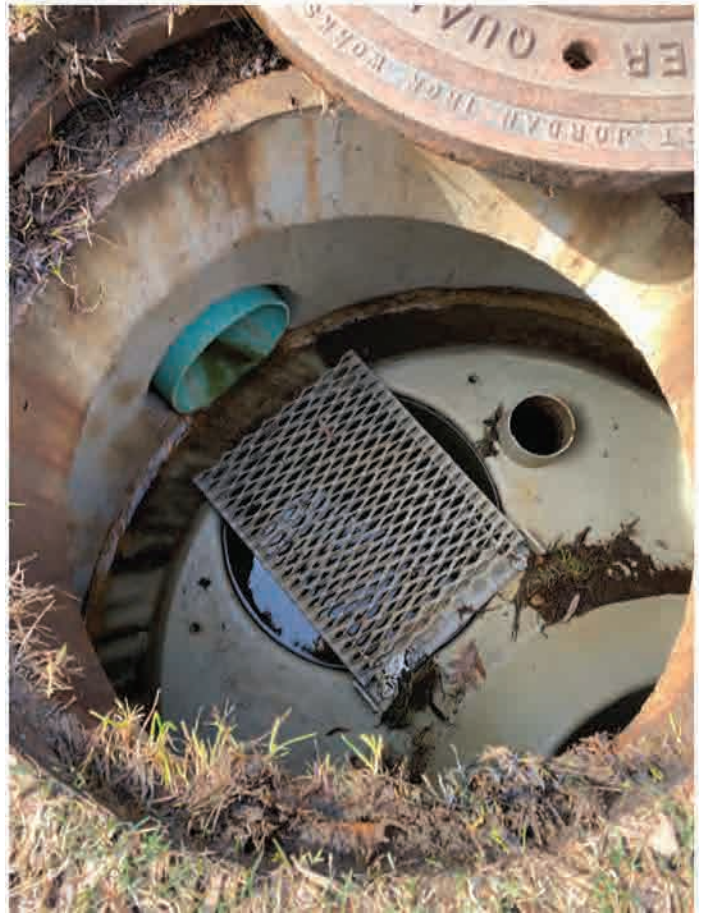
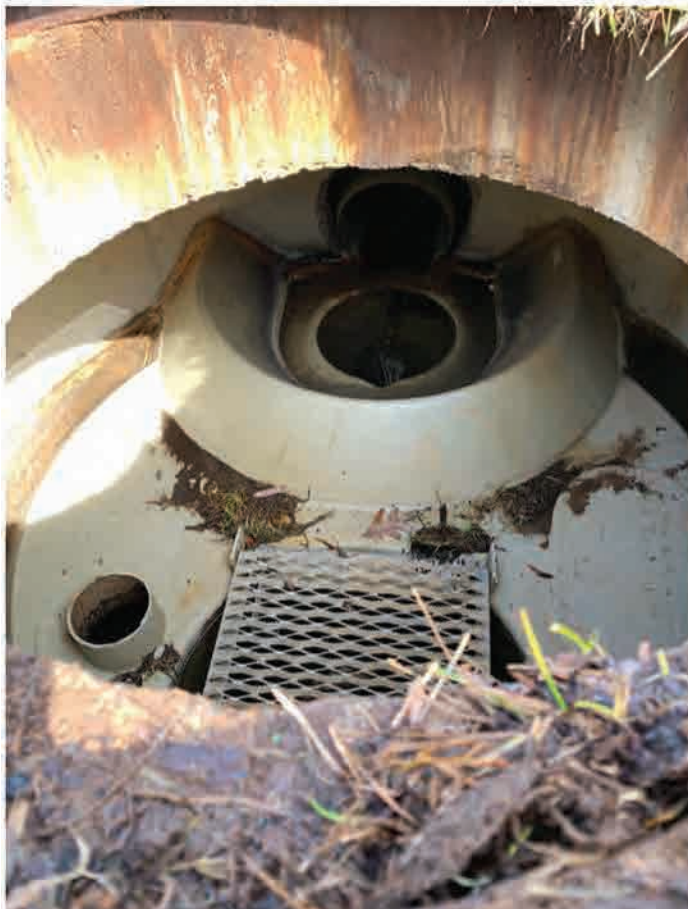
Arlington National Cemetery Post-Construction Inspection Checklist				STORMCEPTOR	
Inspector Name: Renee Lavinsky			Date: 2/26/19		Date of last inspection:
Weather/site conditions: Sun, 48F			Time since last rainfall: > 24 hours		
BMP INFORMATION					
BMP Installation Date: 2006			Model:      900      1200      1800      ✓ 2400		
BMP #: STC-5	Location: Section 76		As-Built Plans available: <input checked="" type="checkbox"/> Yes <input type="checkbox"/> No		
ROUTINE MAINTENANCE ACTIVITIES					
Activity			Frequency		Completed
None			NA		NA
FIELD INSPECTION CHECKLIST					
Criteria	Maintenance Required?	ANC or Professional fix	Comments		Date Repaired
<b>Inlet/Outlet/Access</b>					
Pipe blockages	<input checked="" type="checkbox"/> Yes <input type="checkbox"/> No	Professional	Water overflow from weir (see below)		
Pipe or joint breaks or cracks	<input type="checkbox"/> Yes <input checked="" type="checkbox"/> No

Access portals cracked, damaged, or unable to open	<input type="checkbox"/> Yes <input checked="" type="checkbox"/> No				
<b>Sediment Levels</b>					
Sediment depth of the following values (sampling procedures provided below):		<input type="checkbox"/> Yes <input checked="" type="checkbox"/> No	No sediment observed		
<i>Model #</i>	<i>Depth (in.)</i>				
900	6				
1200	7				
1800	12				
2400	12				
<b>Oil Levels</b>					
Oil greater than 1" (sampling procedures provided below):	<input type="checkbox"/> Yes <input checked="" type="checkbox"/> No				
<b>Upstream and Drainage Area</b>					
Oil, fuel, or chemical spills	<input type="checkbox"/> Yes <input checked="" type="checkbox"/> No <input type="checkbox"/> N/A				
Sediment on pavement	<input type="checkbox"/> Yes <input checked="" type="checkbox"/> No <input type="checkbox"/> N/A				
Trash, debris, bare soil, and/or erosion	<input type="checkbox"/> Yes <input checked="" type="checkbox"/> No <input type="checkbox"/> N/A

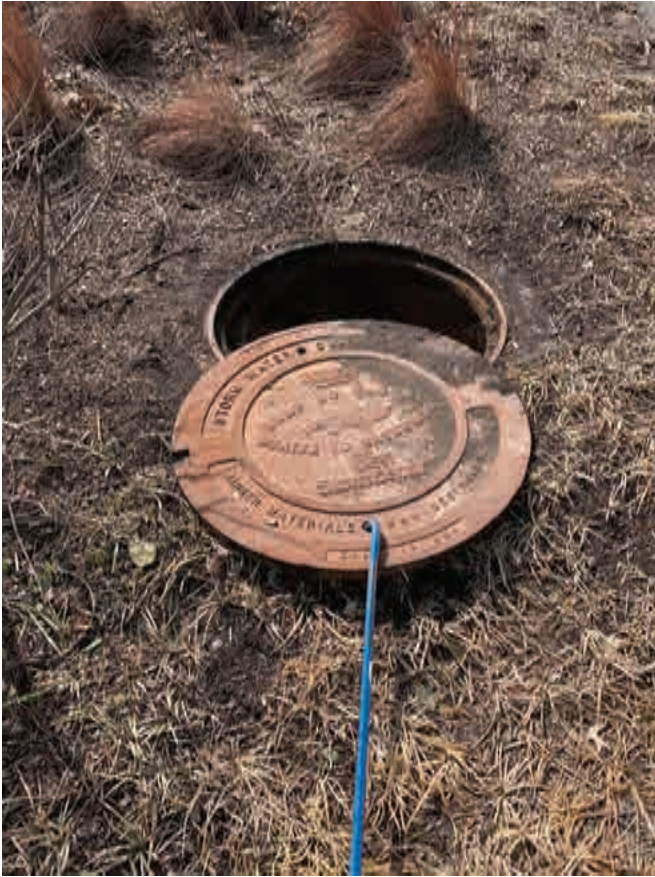
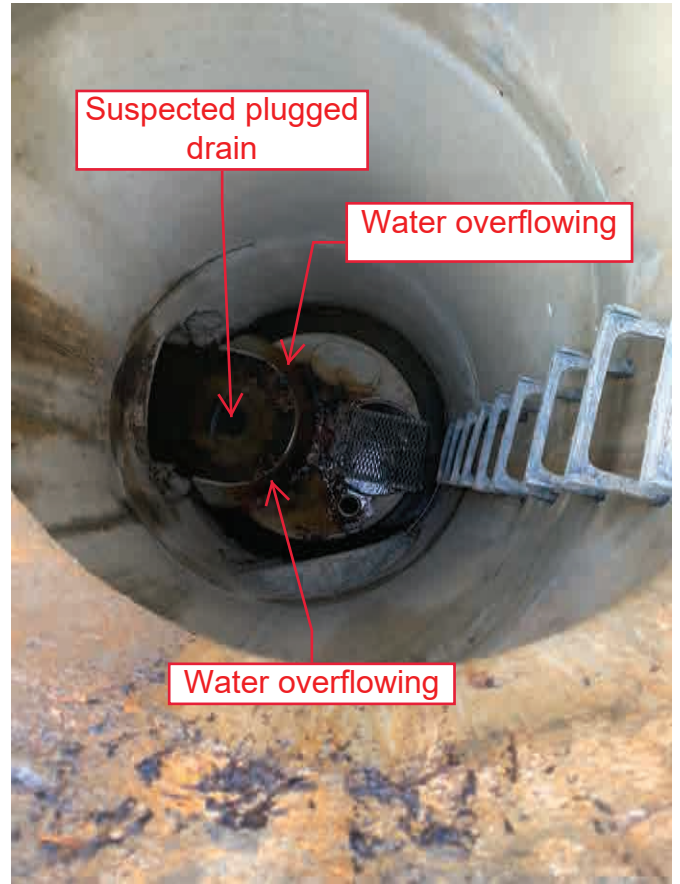
<b>Additional Observations or Comments:</b>					
Sediment was not visible in STC-5; however, water was overflowing the weir, indicating that the drain into the stormceptor may be blocked.					
ANNUAL REPORTING					
Are significant maintenance activities required for the stormwater management facility to perform as designed? (does not activities such as grass mowing or trash collection)					<input type="checkbox"/> Yes <input checked="" type="checkbox"/> No

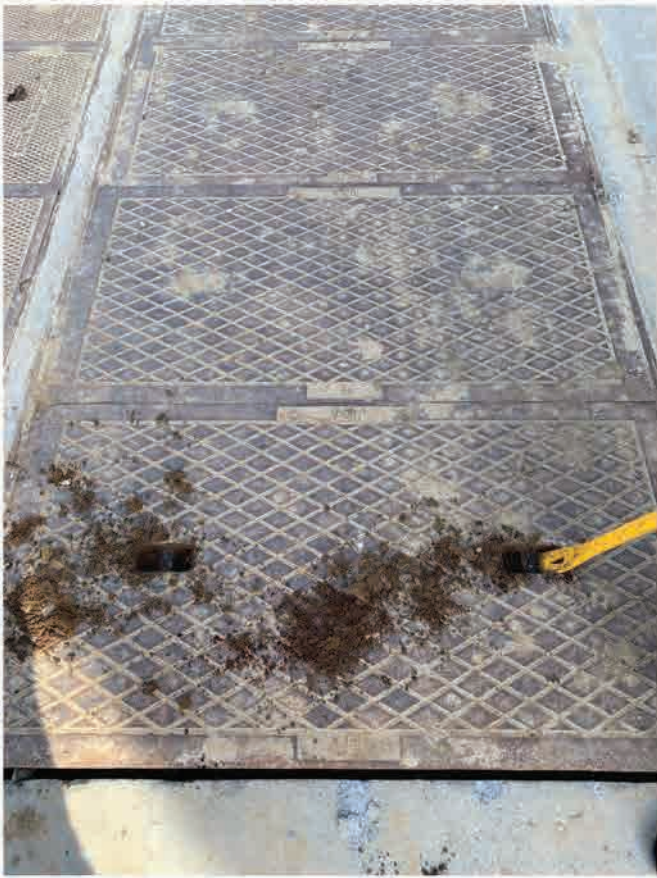
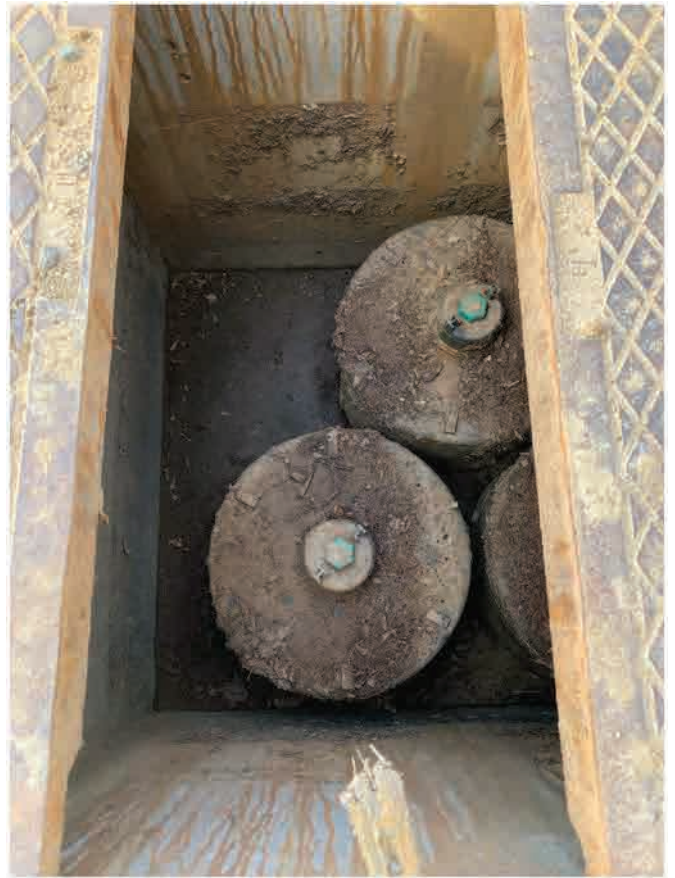
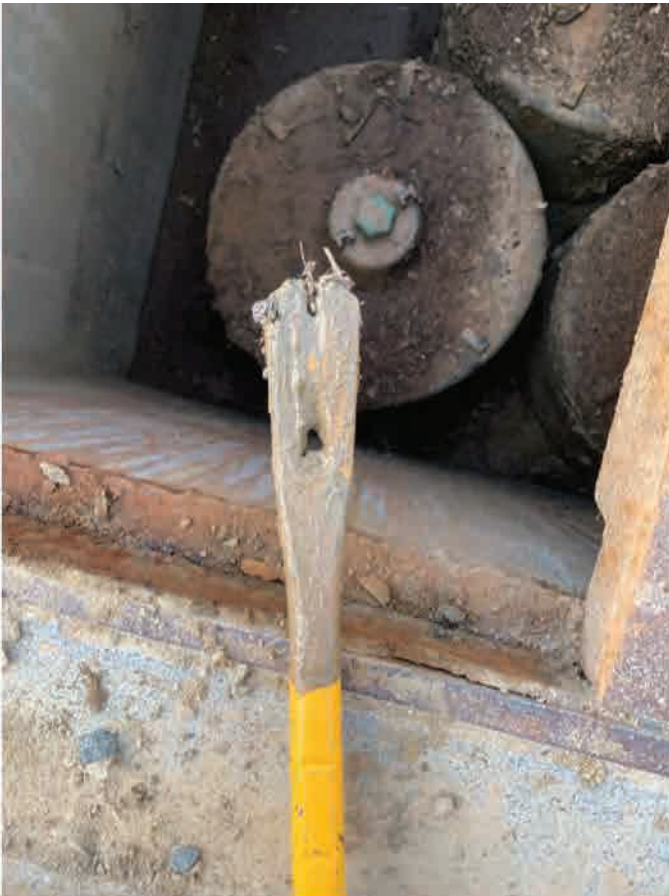
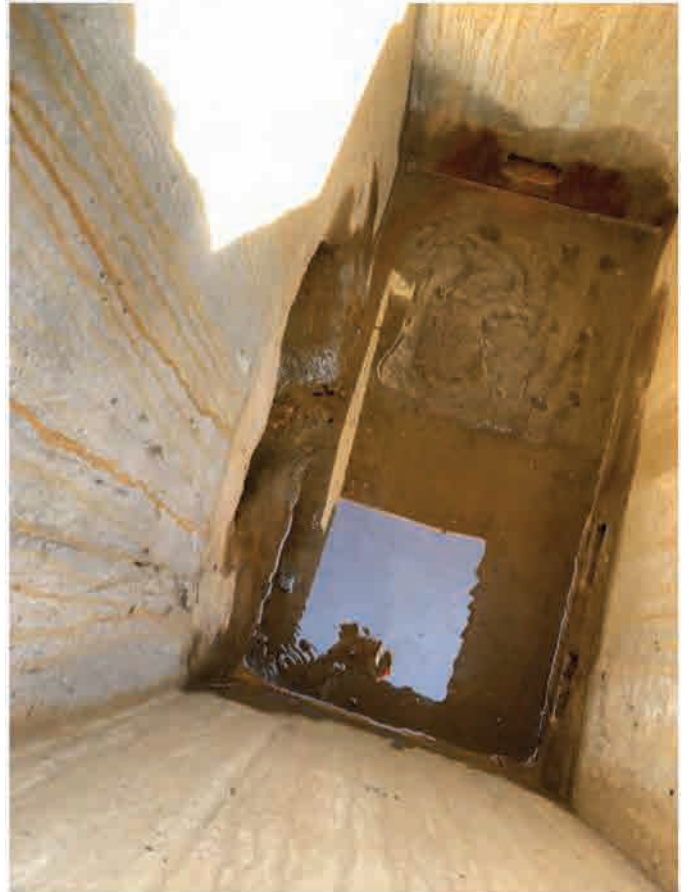
Access cover missing, cracked, damaged, or unable to open	<input type="checkbox"/> Yes <input checked="" type="checkbox"/> No			
<b>Sediment Level</b>				
Sediment accumulation in forebay	<input checked="" type="checkbox"/> Yes <input type="checkbox"/> No <input type="checkbox"/> N/A	Professional	Approximately 6 inches of sediment in concrete vault	
Sediment depth on vault floor greater than 15% of diameter or interior depth of vault	<input type="checkbox"/> Yes <input checked="" type="checkbox"/> No			
Standing water inside chamber for more than 24 hours after storm	<input type="checkbox"/> Yes <input checked="" type="checkbox"/> No			
Scum line present	<input type="checkbox"/> Yes <input checked="" type="checkbox"/> No			
Chamber cracked (cracks wider than ½ inch), collapsed, or bent out of shape	<input checked="" type="checkbox"/> Yes <input type="checkbox"/> No	Professional	Water entering from crack in southwest corner of vault

<b>Upstream and Drainage Area</b>				
Oil, fuel, or chemical spills	<input type="checkbox"/> Yes <input checked="" type="checkbox"/> No <input type="checkbox"/> N/A			
Sediment on pavement	<input checked="" type="checkbox"/> Yes <input type="checkbox"/> No <input type="checkbox"/> N/A	Professional	Sediment tracked throughout service area.	
Trash, debris, bare soil, and/or erosion	<input type="checkbox"/> Yes <input checked="" type="checkbox"/> No <input type="checkbox"/> N/A			
<b>Additional Observations or Comments:</b> The concrete vault in which the filters are located has sediment 6-12 inches deep. South end near outlet has minimal sediment and north end has most.				
ANNUAL REPORTING				
Are significant maintenance activities required for the stormwater management facility to perform as designed? (does not activities such as grass mowing or trash collection)				<input type="checkbox"/> Yes <input type="checkbox"/> No

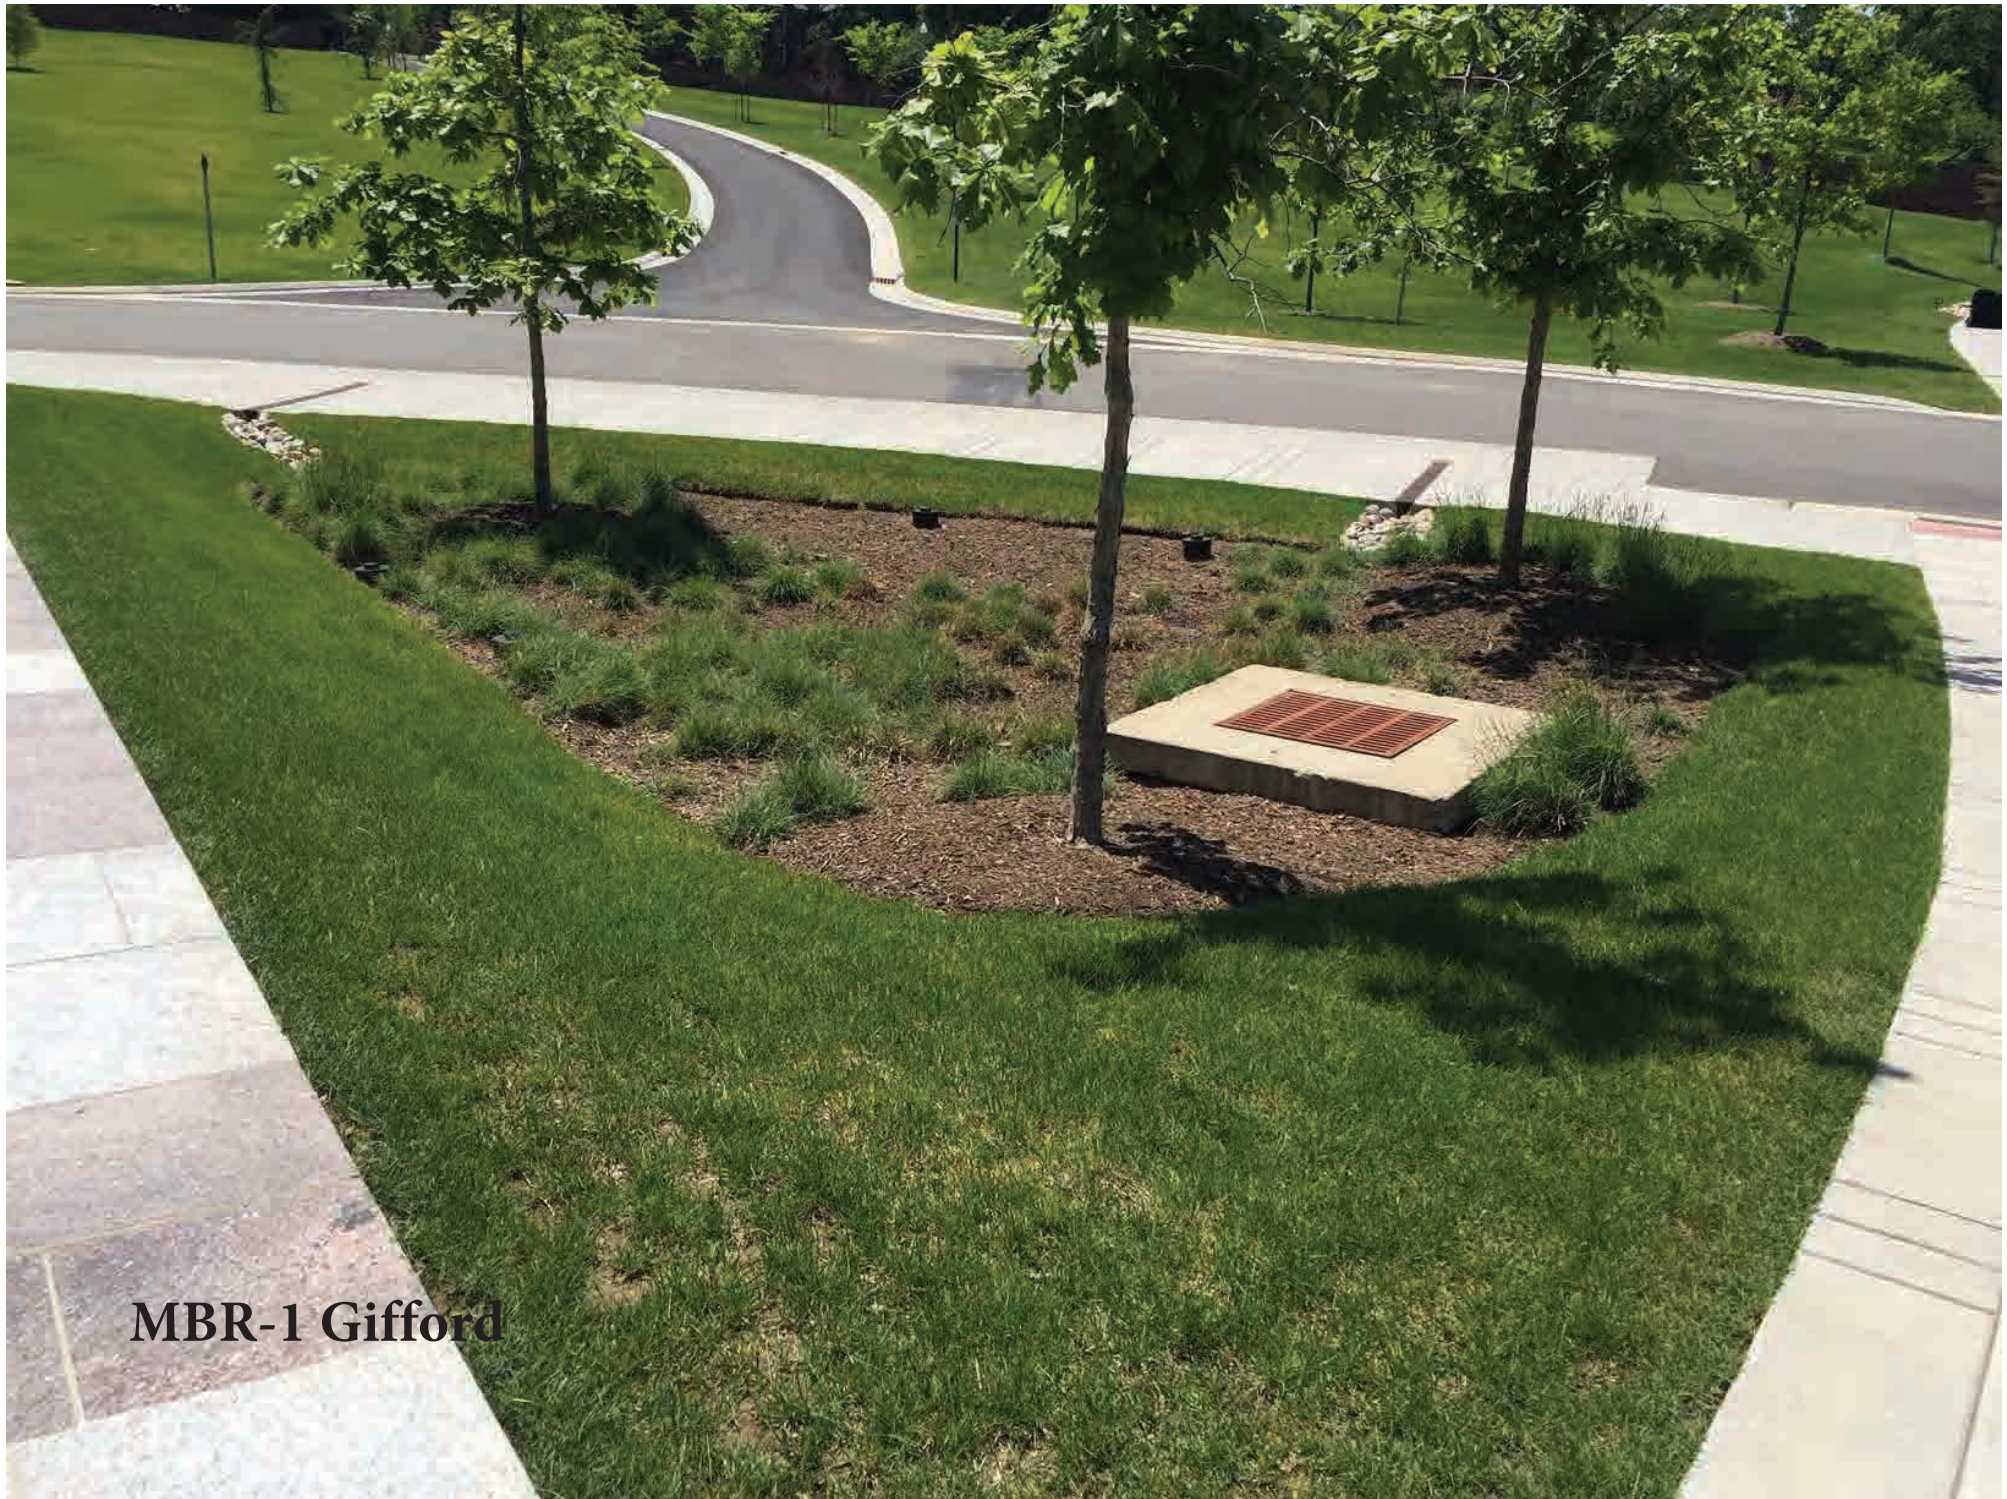
**MBR-1 Gifford**

Observation well caps present	<input checked="" type="checkbox"/> Yes <input type="checkbox"/> No <input type="checkbox"/> N/A			
<b>Inlets</b>				
Sediment build-up, trash, debris, or erosion at curb cuts, pavement edges, and/or bypassing	<input checked="" type="checkbox"/> Yes <input type="checkbox"/> No	ANC	Sheet flow bypassing curb cuts.	ongoing
Inflow hindered by vegetation	<input checked="" type="checkbox"/> Yes <input type="checkbox"/> No	ANC	Installed turf too high.	ongoing
<b>Drainage and Adjacent Upstream Areas</b>				
Adequate vegetation	<input checked="" type="checkbox"/> Yes <input type="checkbox"/> No			
Trash, debris, bare soil, signs of scour, oil, grease, and/or erosion	<input type="checkbox"/> Yes <input checked="" type="checkbox"/> No			
<b>Additional Observations or Comments:</b> <p>With small curb cuts and flat gutter pan, stormwater bypasses curb cuts and enters inlets connected to RG-5. Without sufficient stormwater flow, the vegetation is failing to thrive.</p> <p>ANC has begun steps to replace curb cuts, lower turf, and replace vegetation.</p>

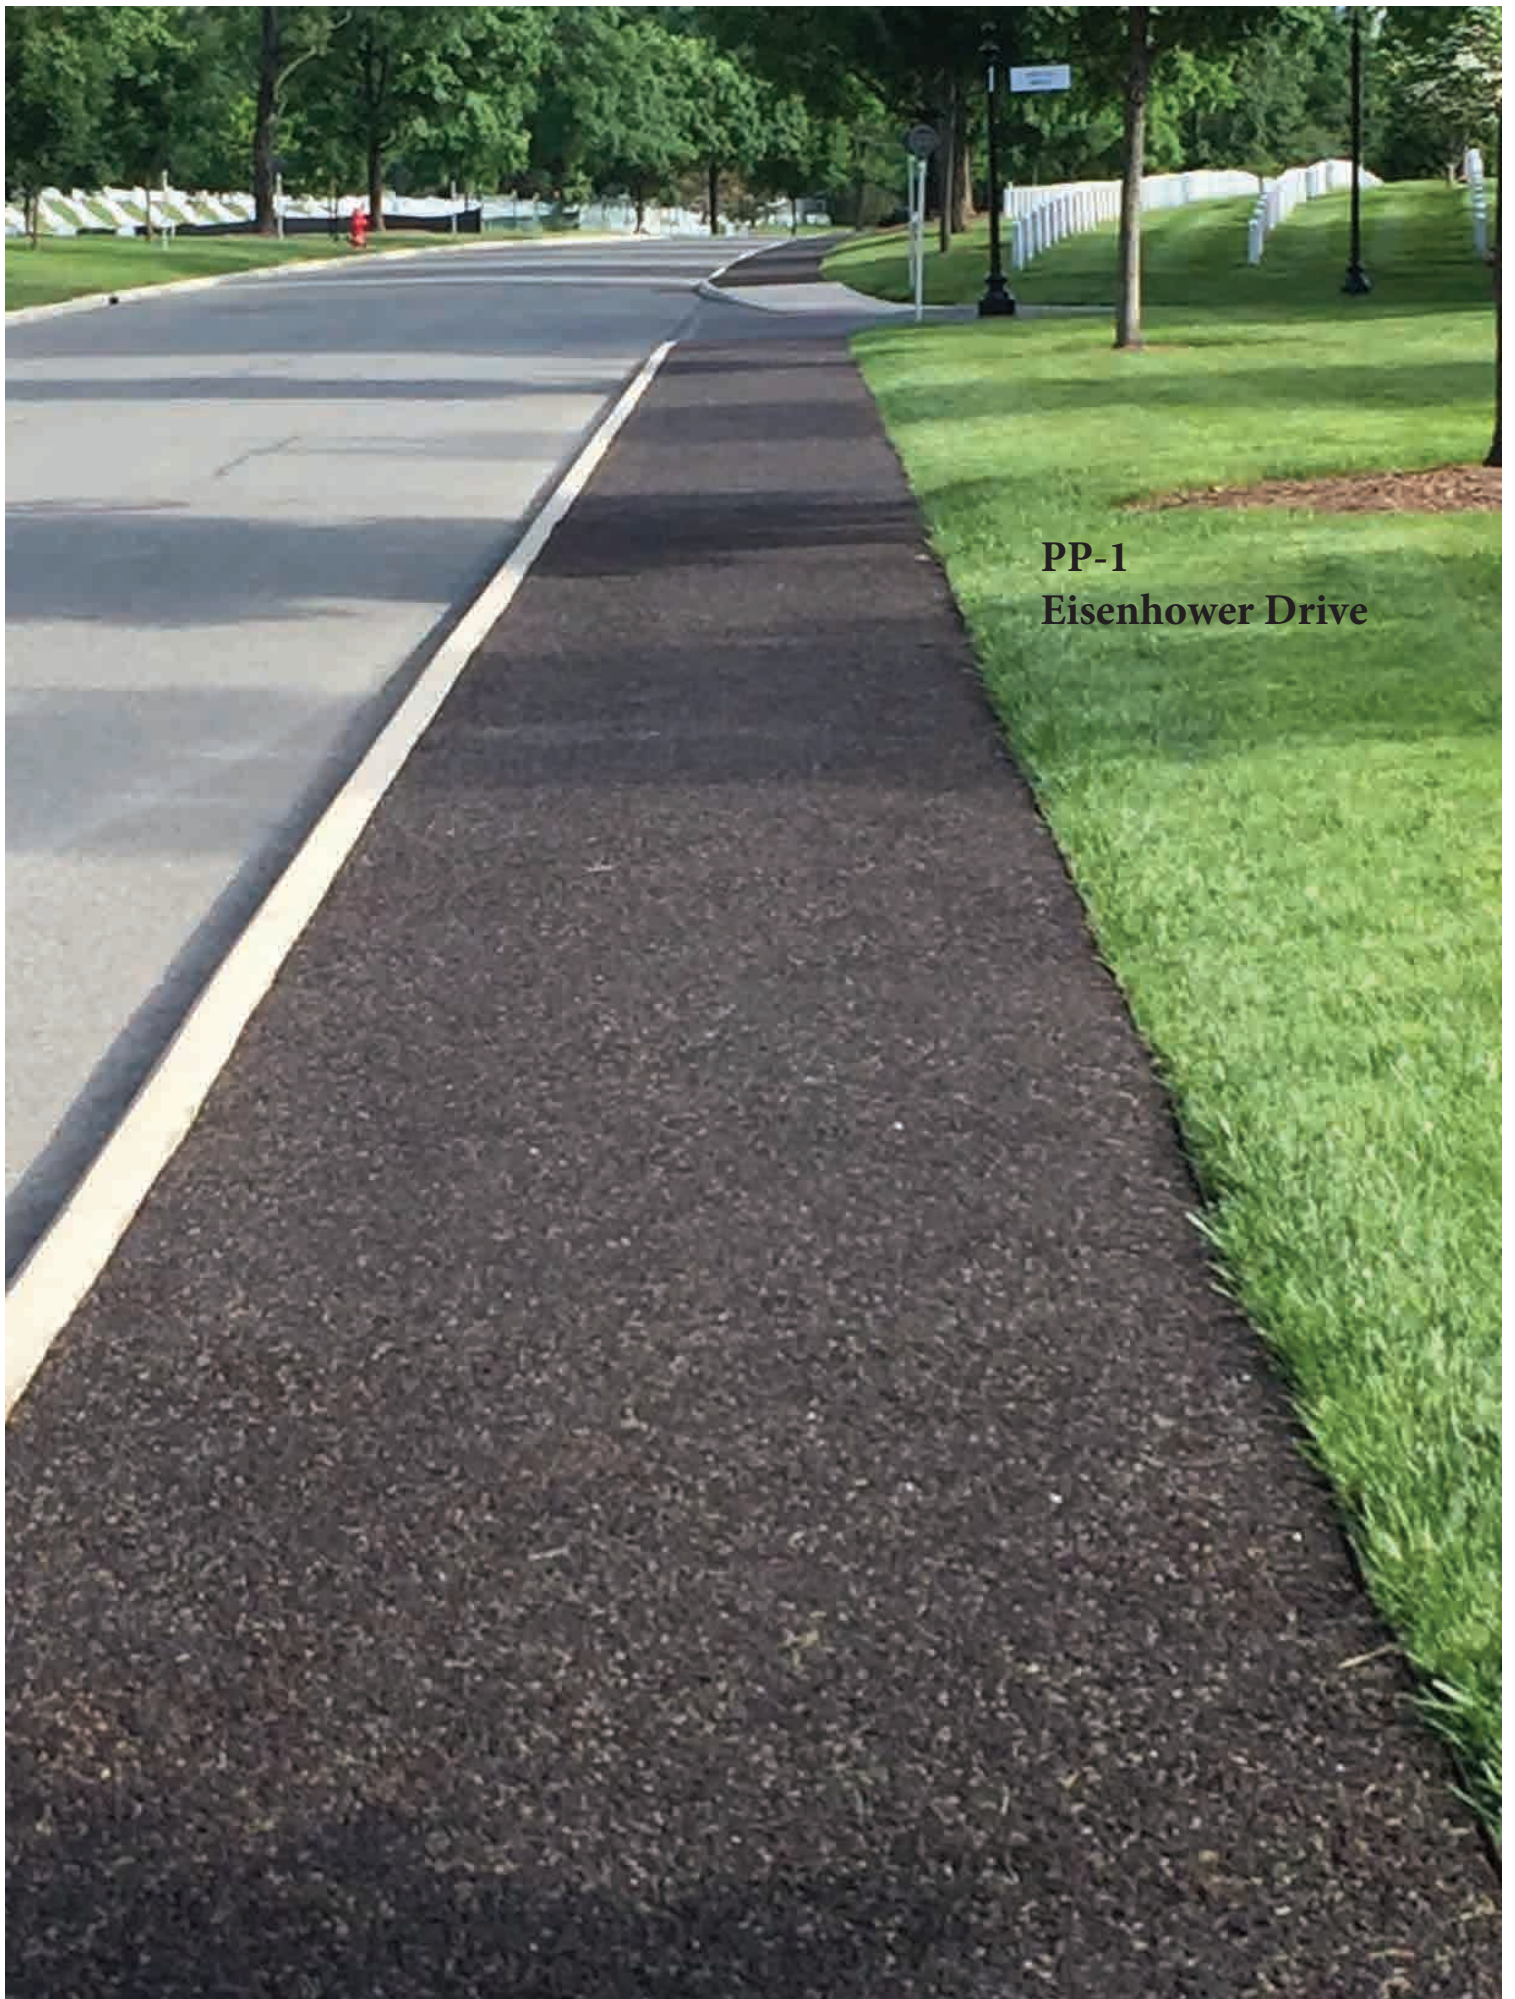
**PP-1**  
**Eisenhower Drive**

<b>Additional Observations or Comments:</b> KTR completed repairs (removal and replacement, vacuuming, sealant placement) of the permeable pavement systems in Fall 2018.				
ANNUAL REPORTING				
Are significant maintenance activities required for the stormwater management facility to perform as designed? (does not activities such as grass mowing or trash collection)				<input type="checkbox"/> Yes <input checked="" type="checkbox"/> No
