## **ANNUAL REPORT UPDATE**

**Reporting Period**  
**July 1, 2018 to June 30, 2019 (Due October 1, 2019)**

### **Arlington National Cemetery**

**VPDES Permit Number: VAR040139**  
**Permit Effective Date: November 1, 2018**  
**Permit Expiration Date: October 31, 2023**

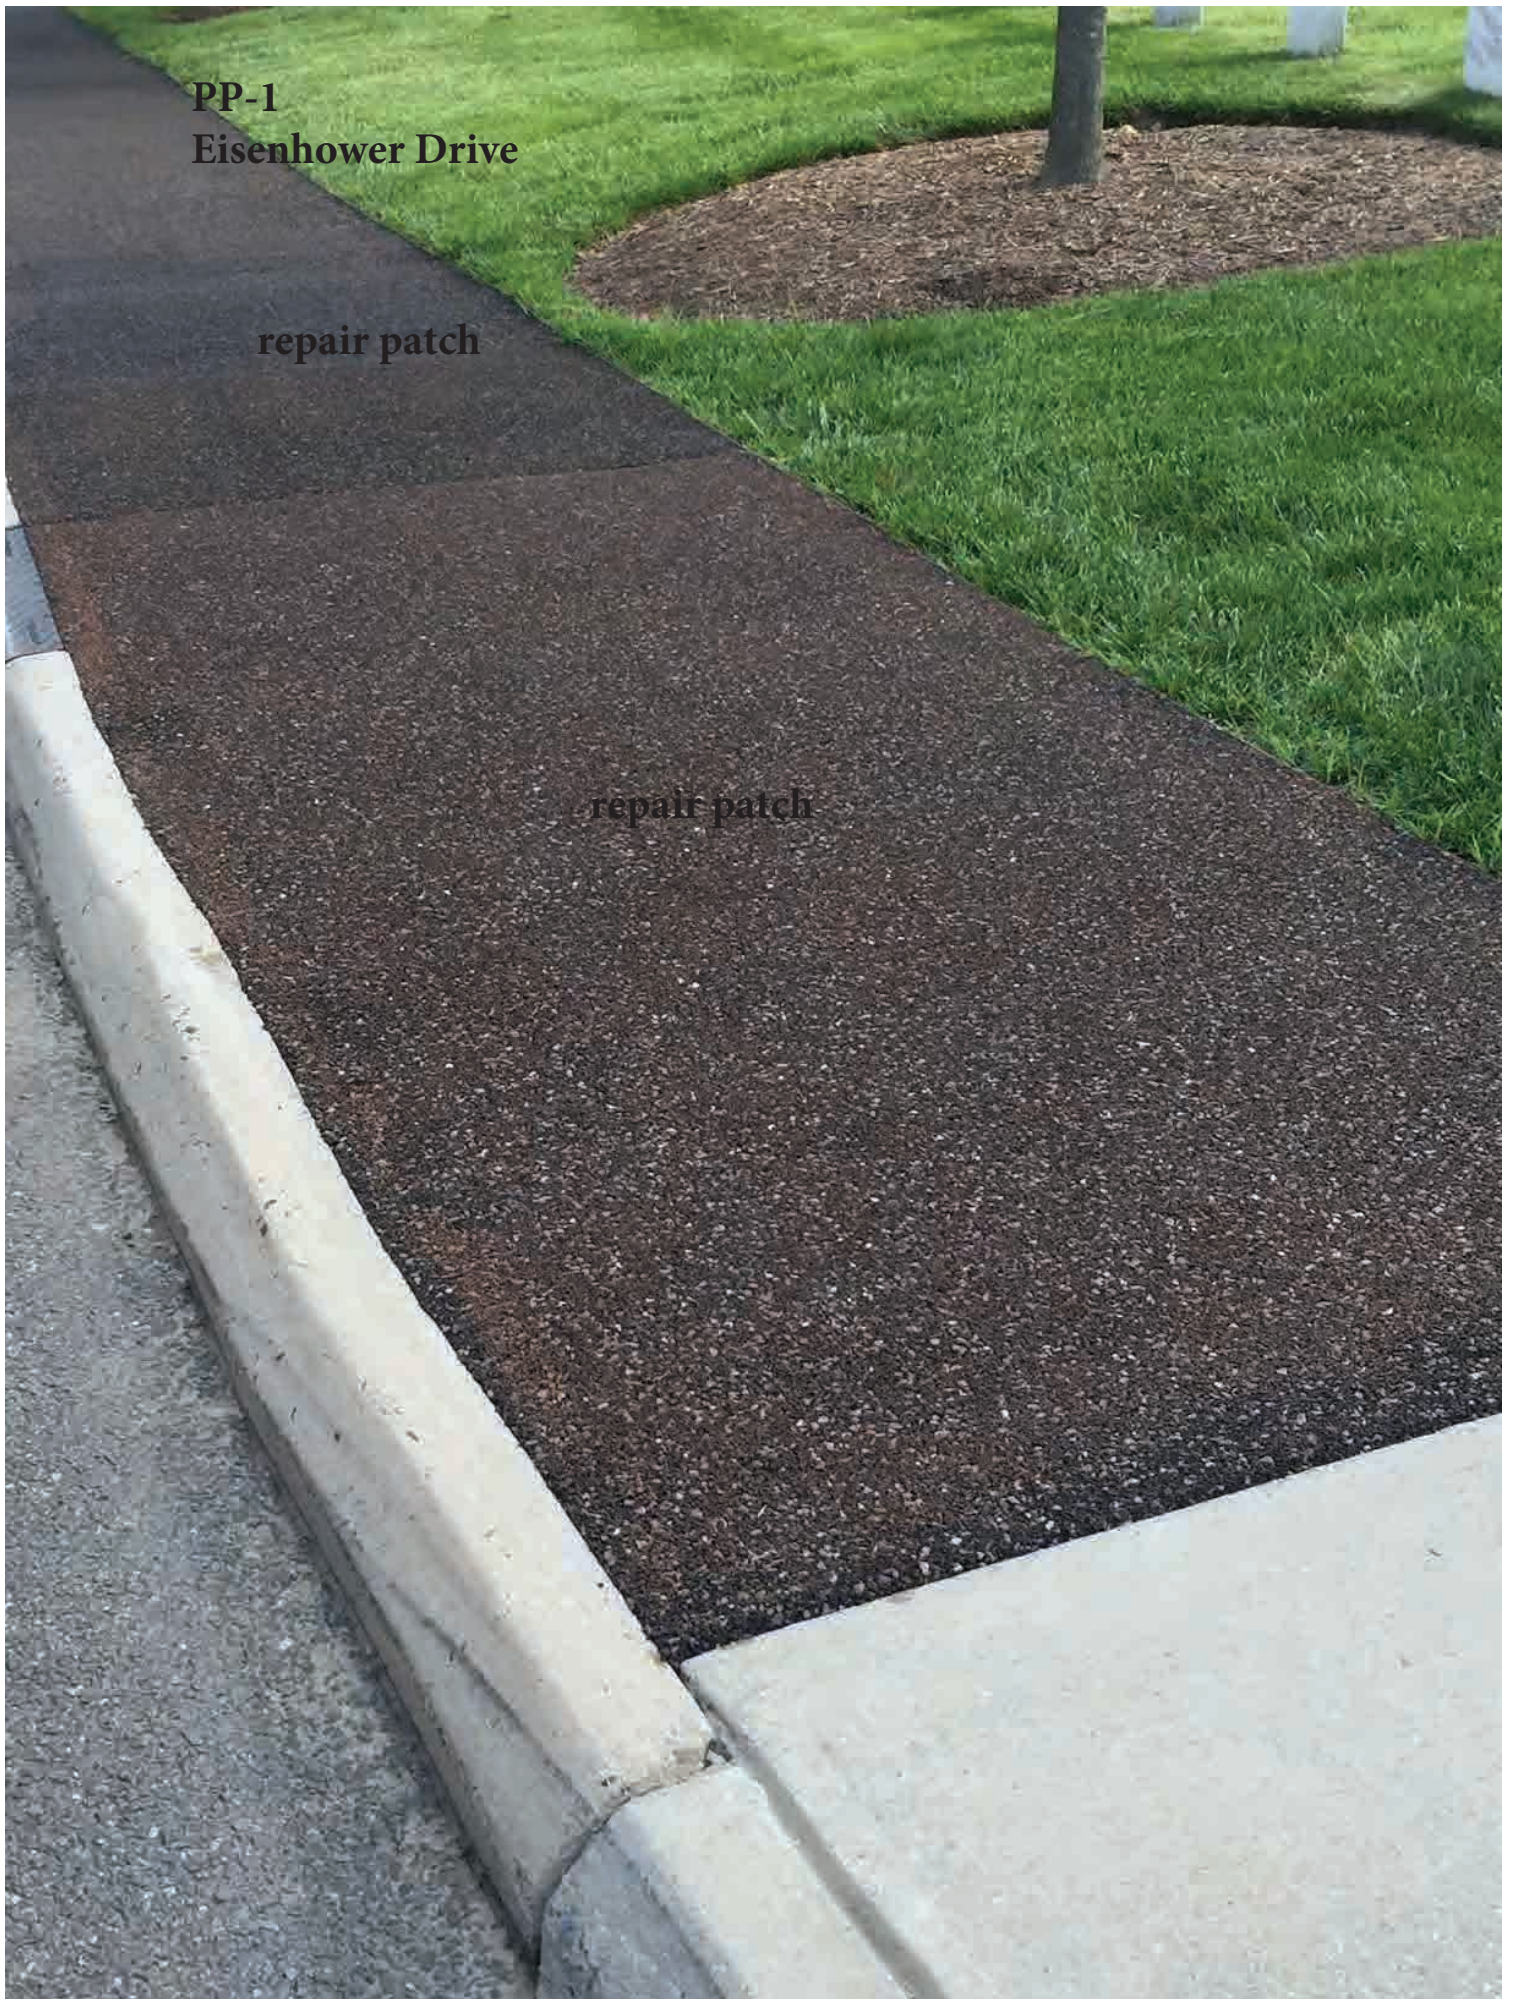
PP-1

repair patch

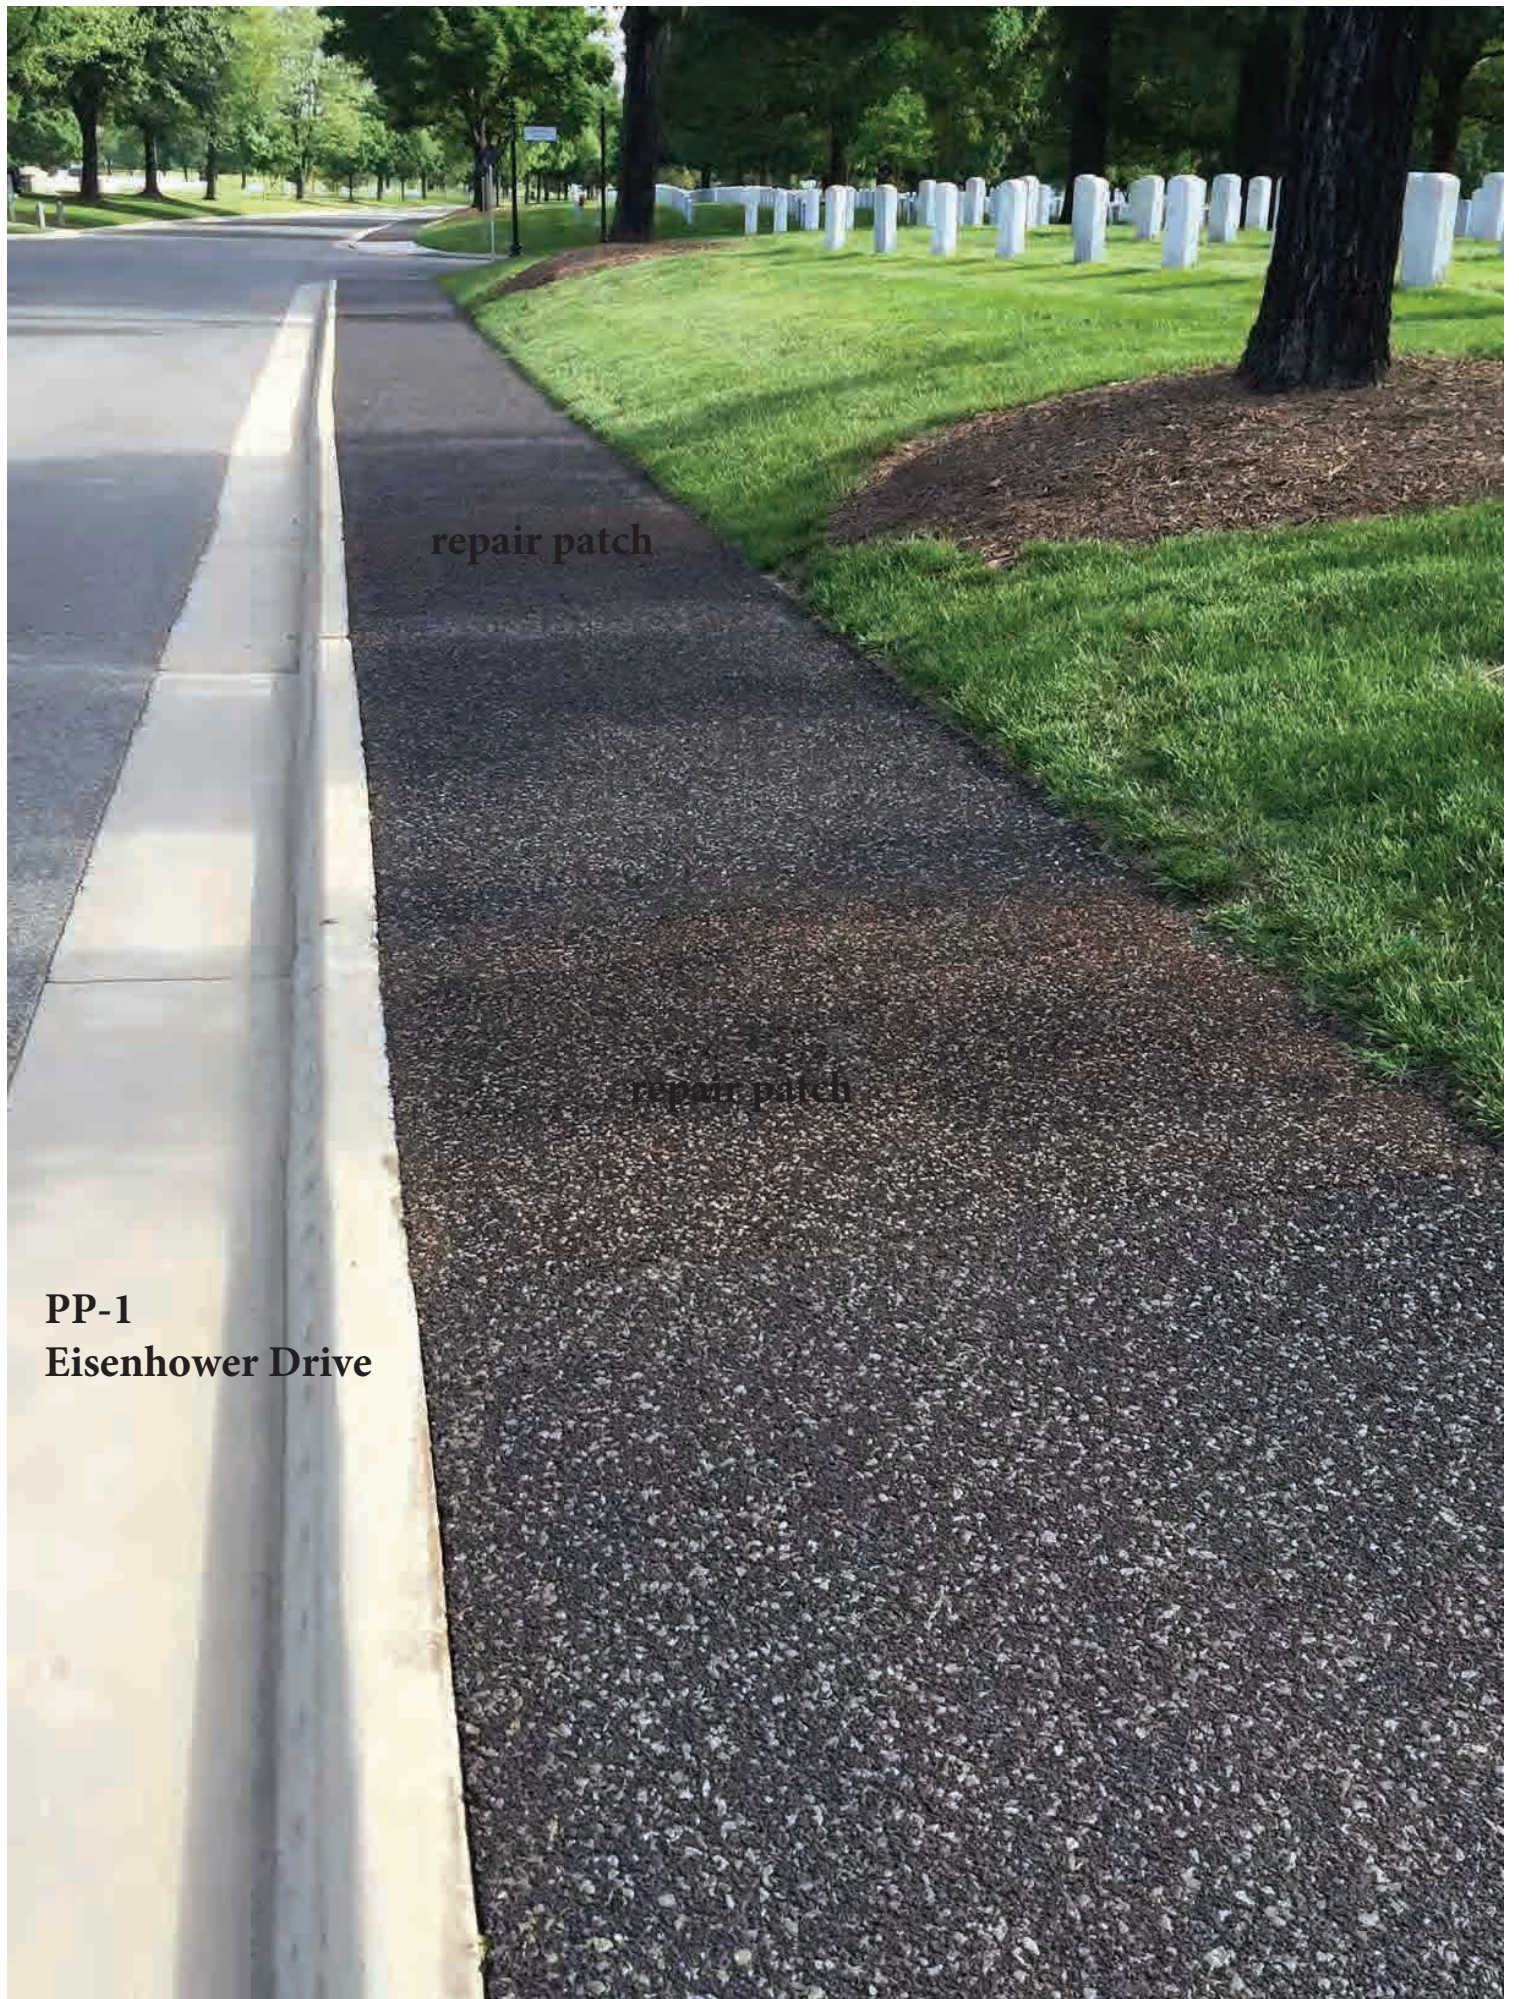
PP-1  
Eisenhower Drive

repair patch

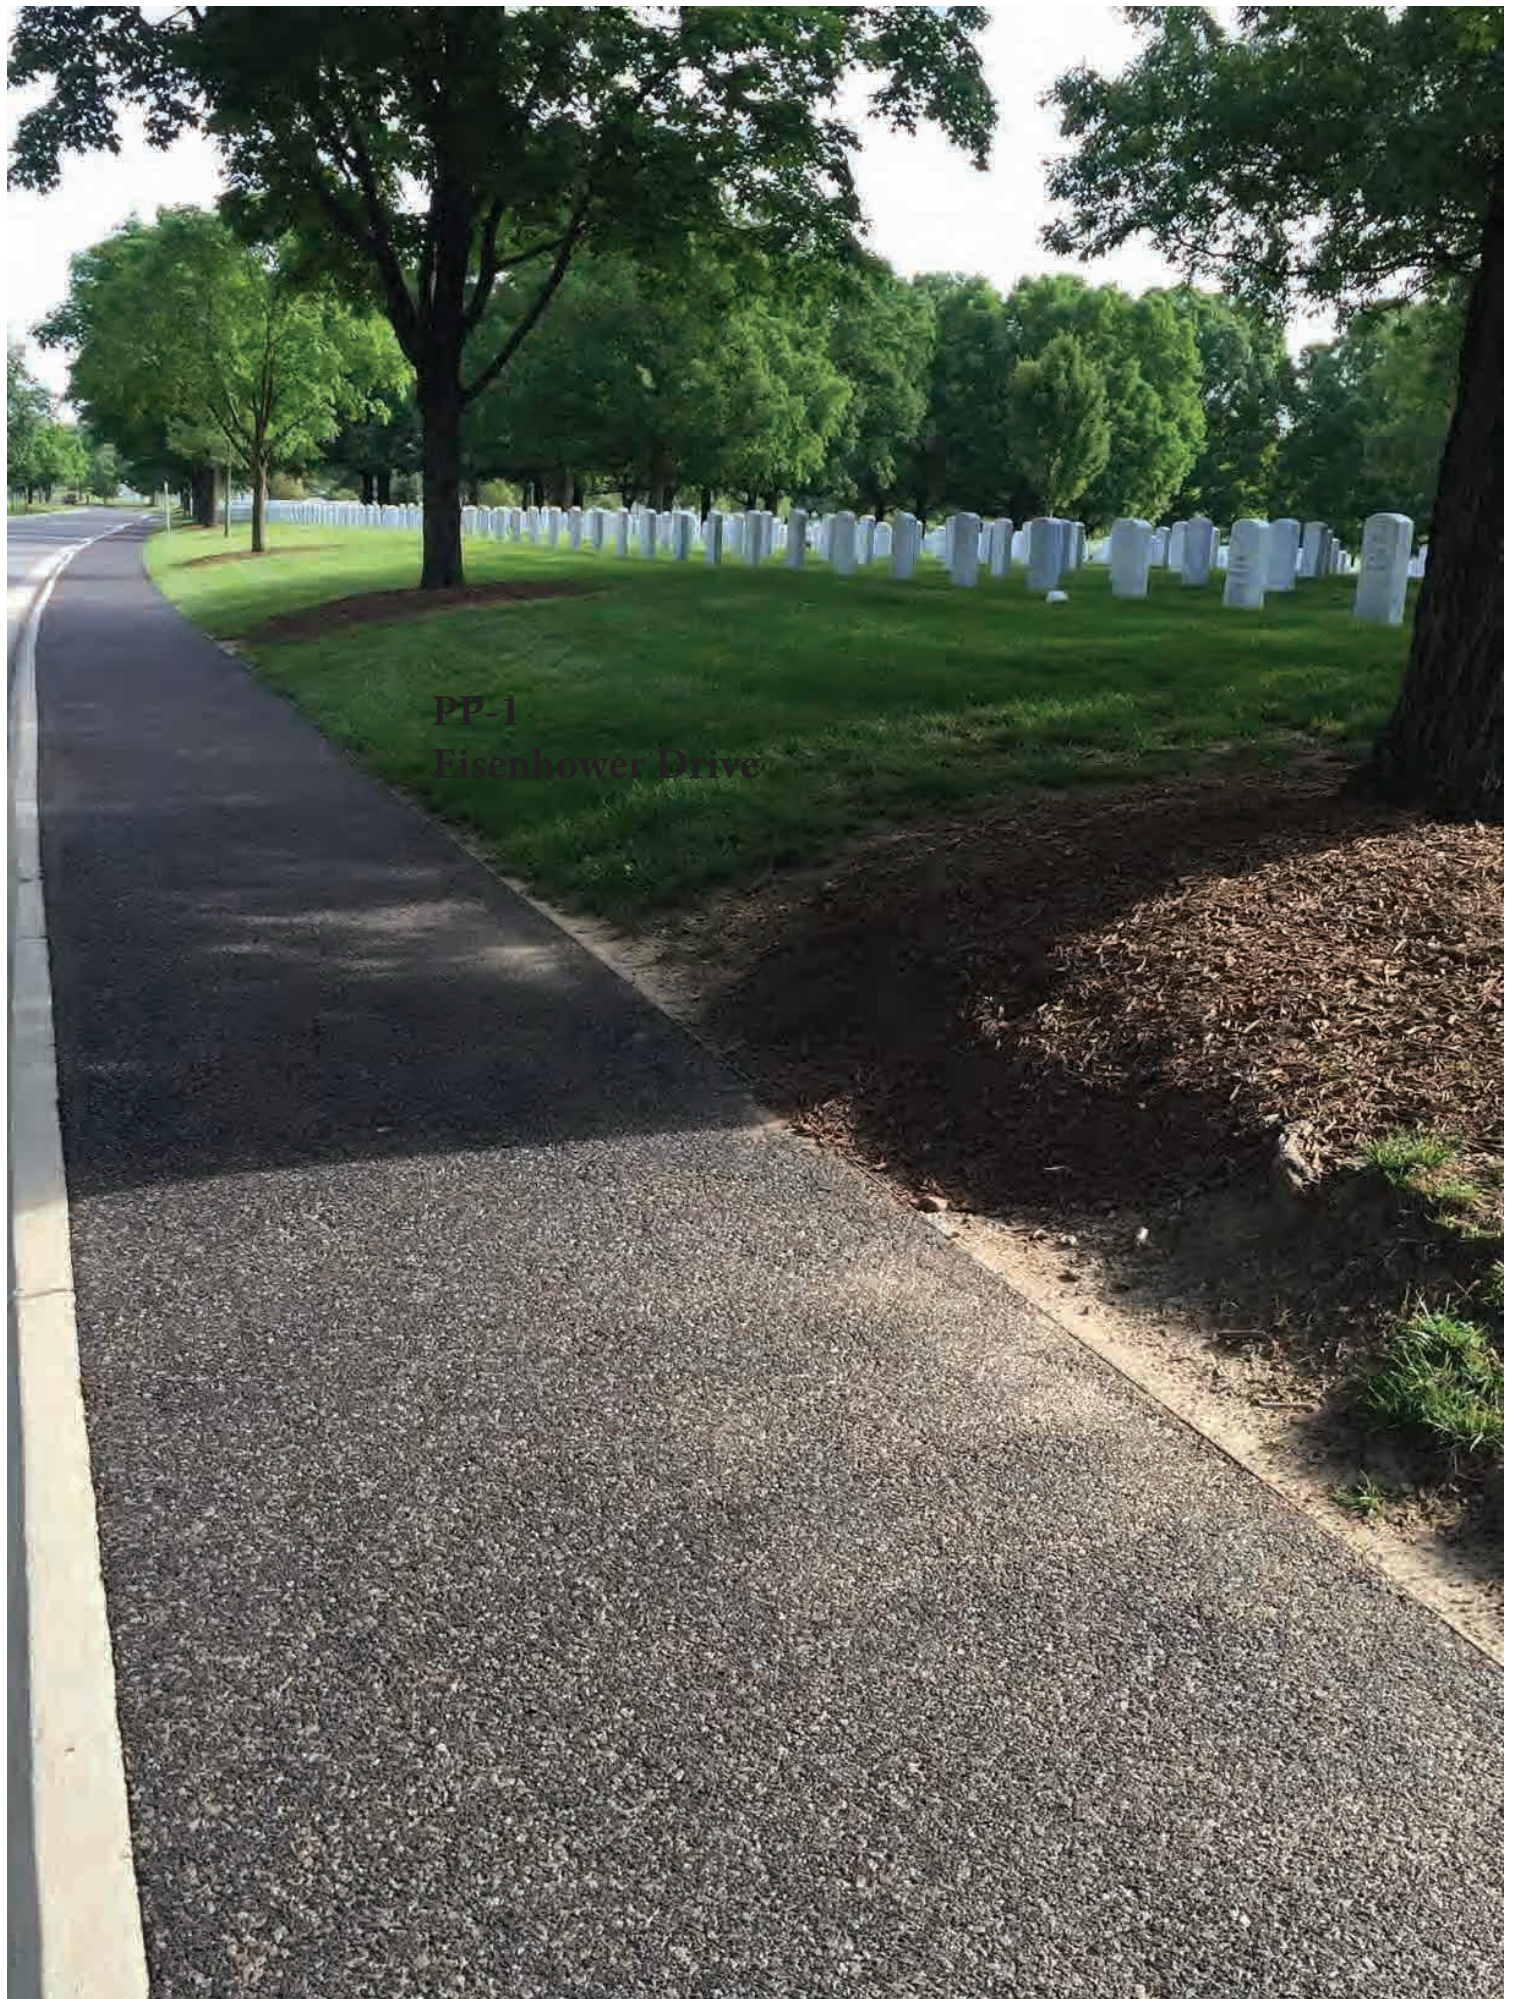
PP-1  
Eisenhower Drive

<b>Additional Observations or Comments:</b> KTR completed repairs (removal and replacement, vacuuming, sealant placement) of the permeable pavement systems in Fall 2018.				
ANNUAL REPORTING				
Are significant maintenance activities required for the stormwater management facility to perform as designed? (does not activities such as grass mowing or trash collection)				<input type="checkbox"/> Yes <input checked="" type="checkbox"/> No

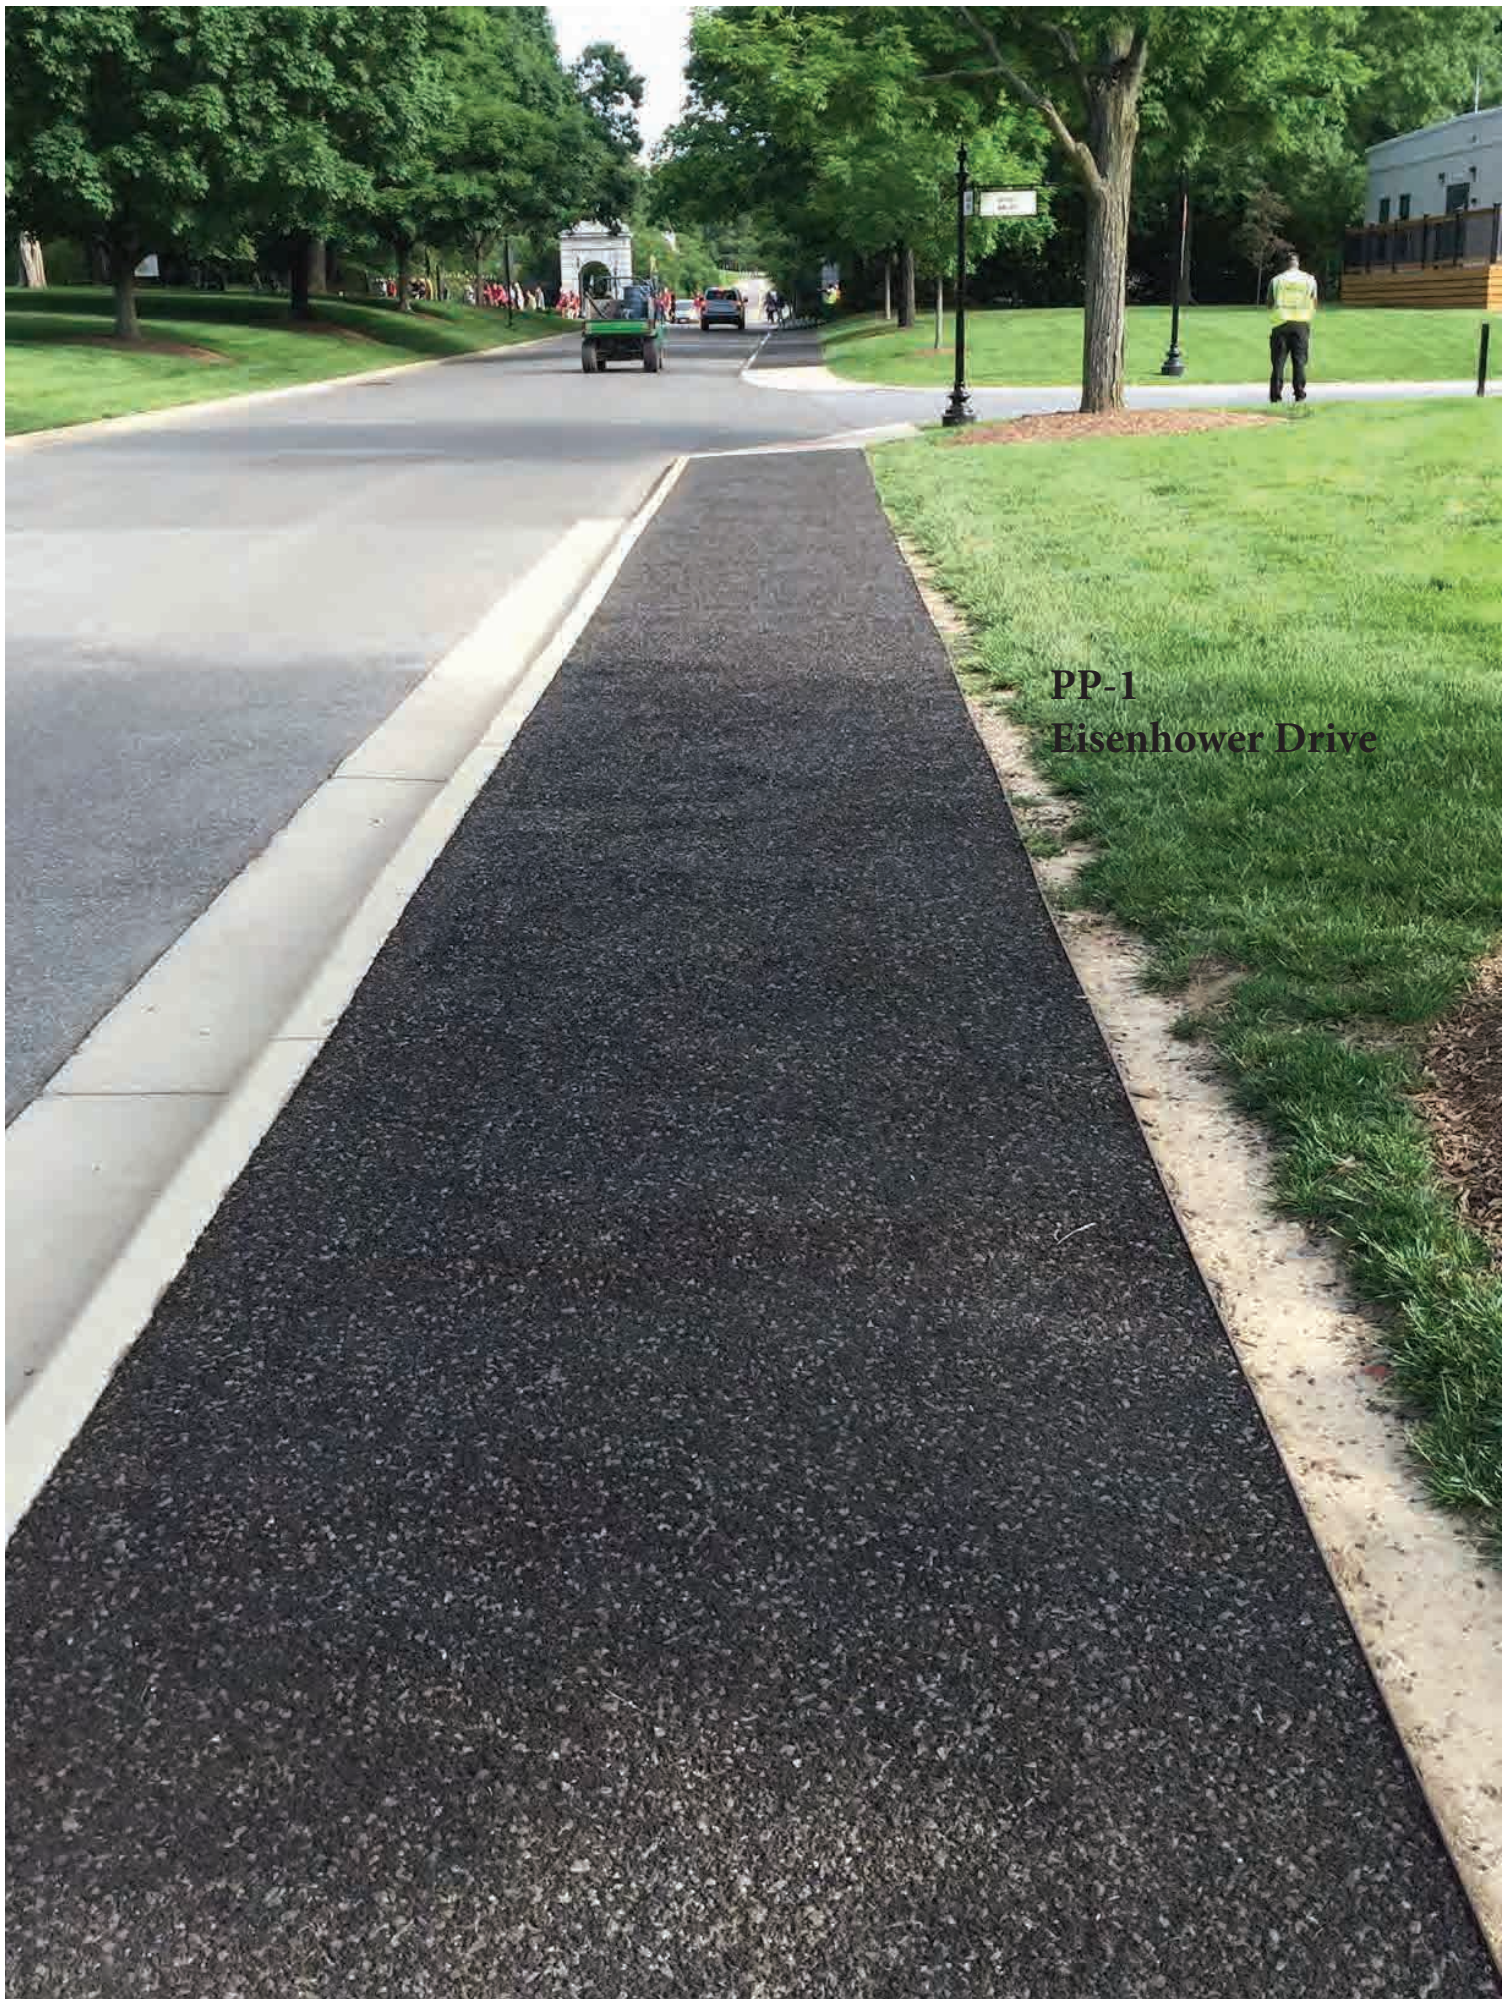
**PP-1**  
**Eisenhower Drive**

repair patch

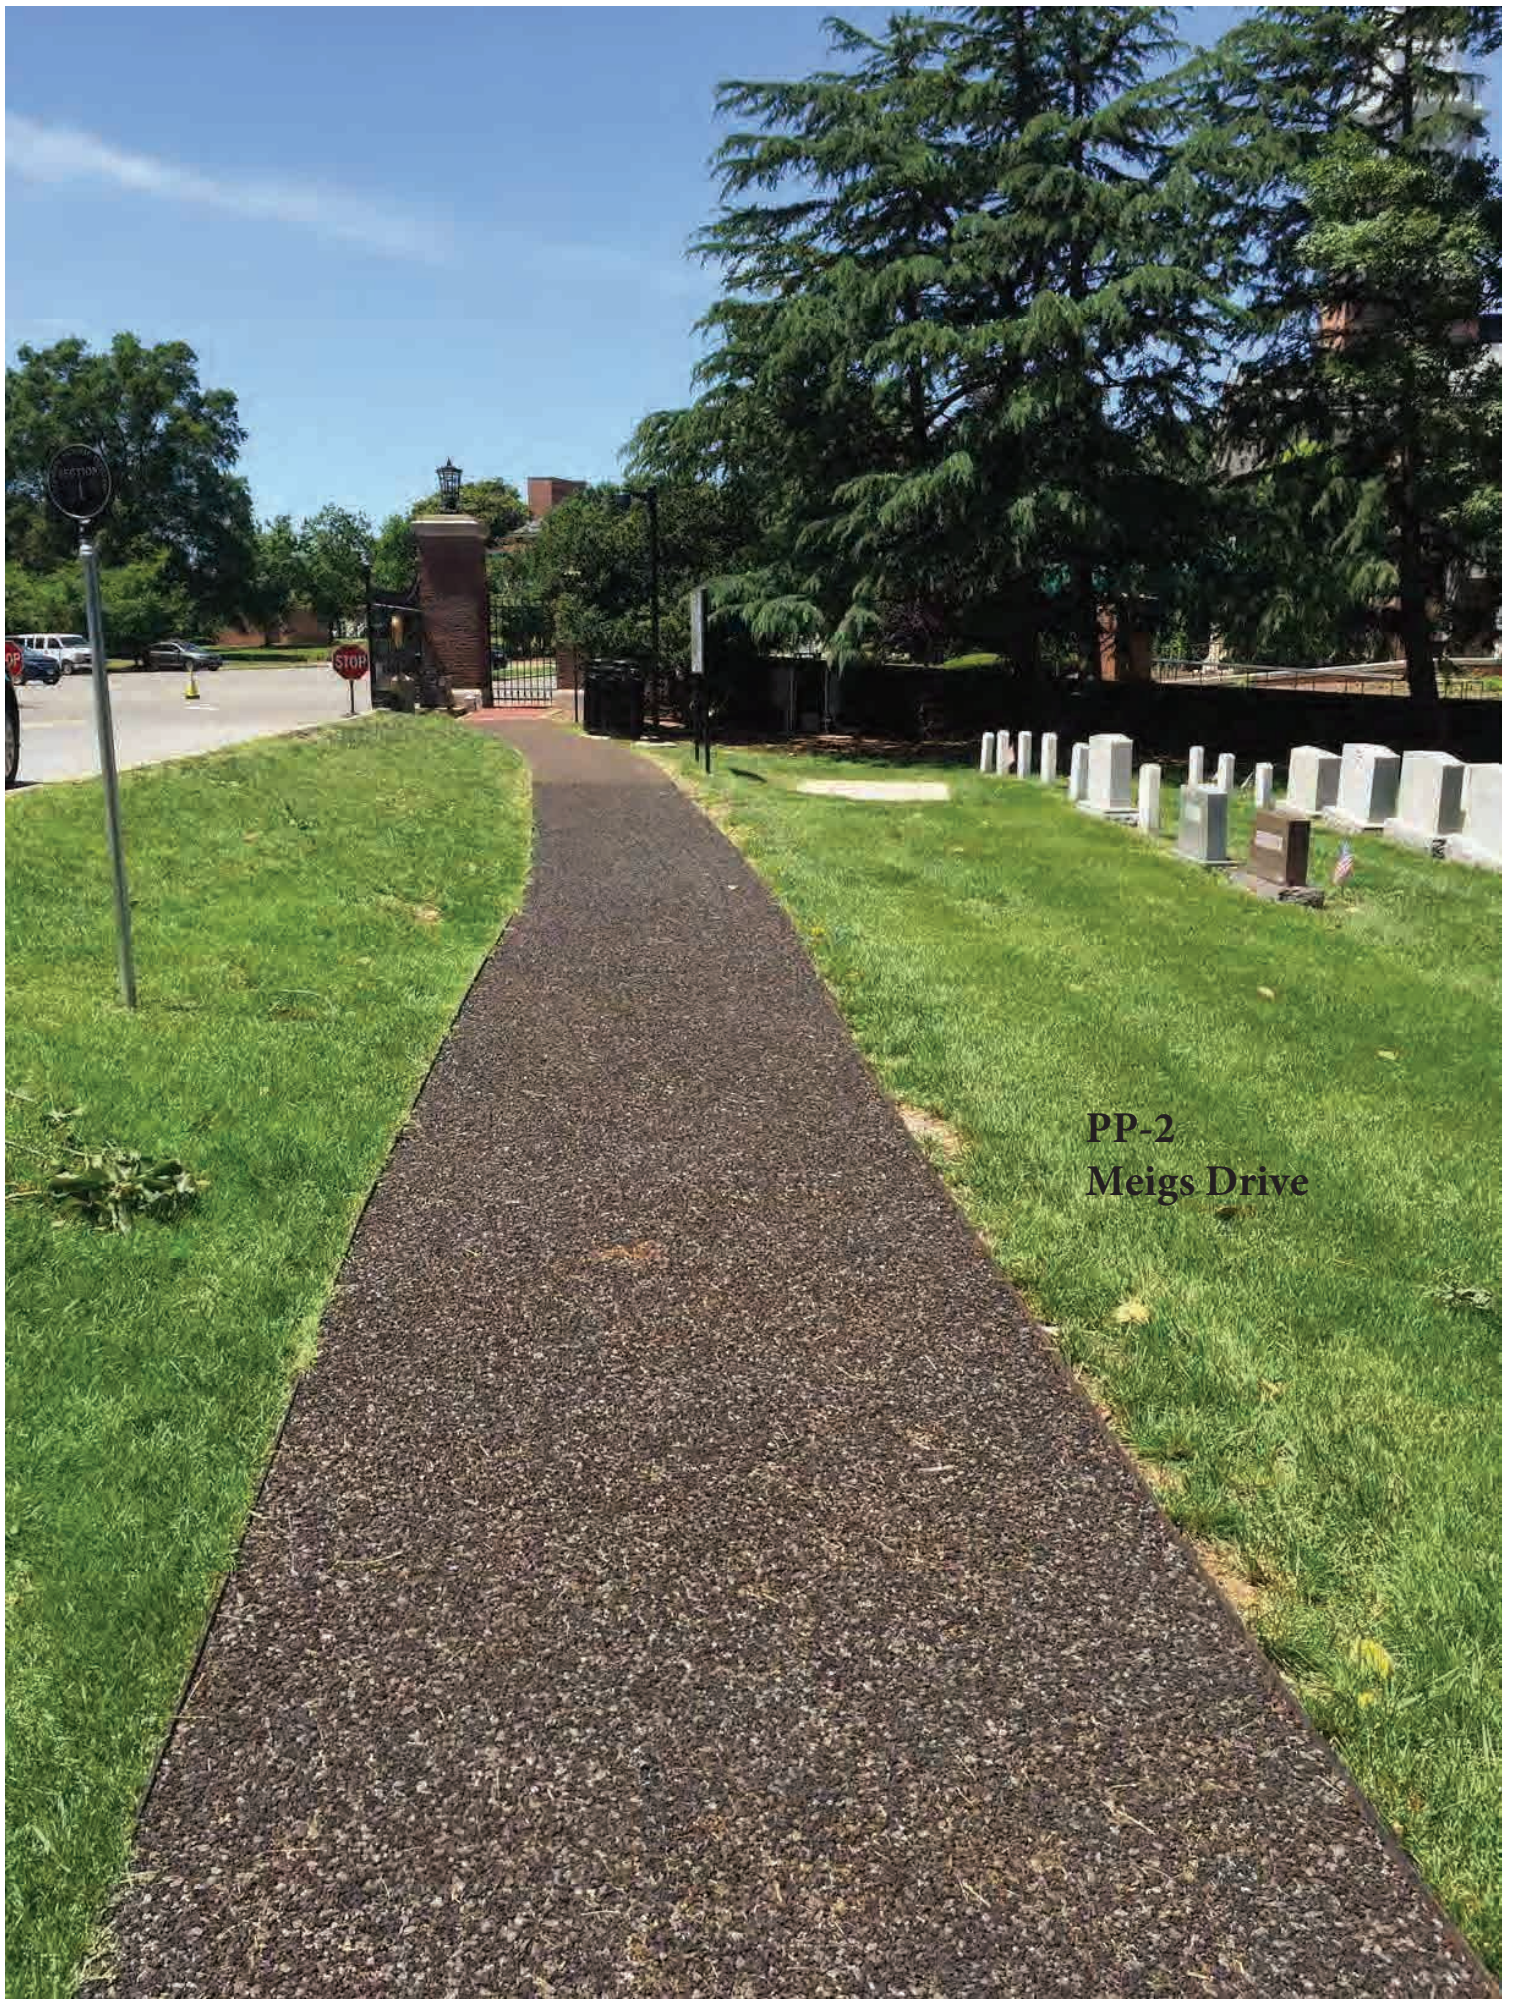
PP-2  
Meigs Drive

A photograph of a cemetery scene. In the background, a large, light-colored gravestone for Thomas Jefferson Gove is visible. The stone is inscribed with his name and dates. To the left of the main stone, there are other smaller, partially visible gravestones. The ground is covered in green grass, and several small American flags are planted in the grass near the graves. The foreground shows a dark, gravelly surface, likely a road or driveway, with some fallen leaves. The text 'PP-2' and 'Meigs Drive' is overlaid on the image.

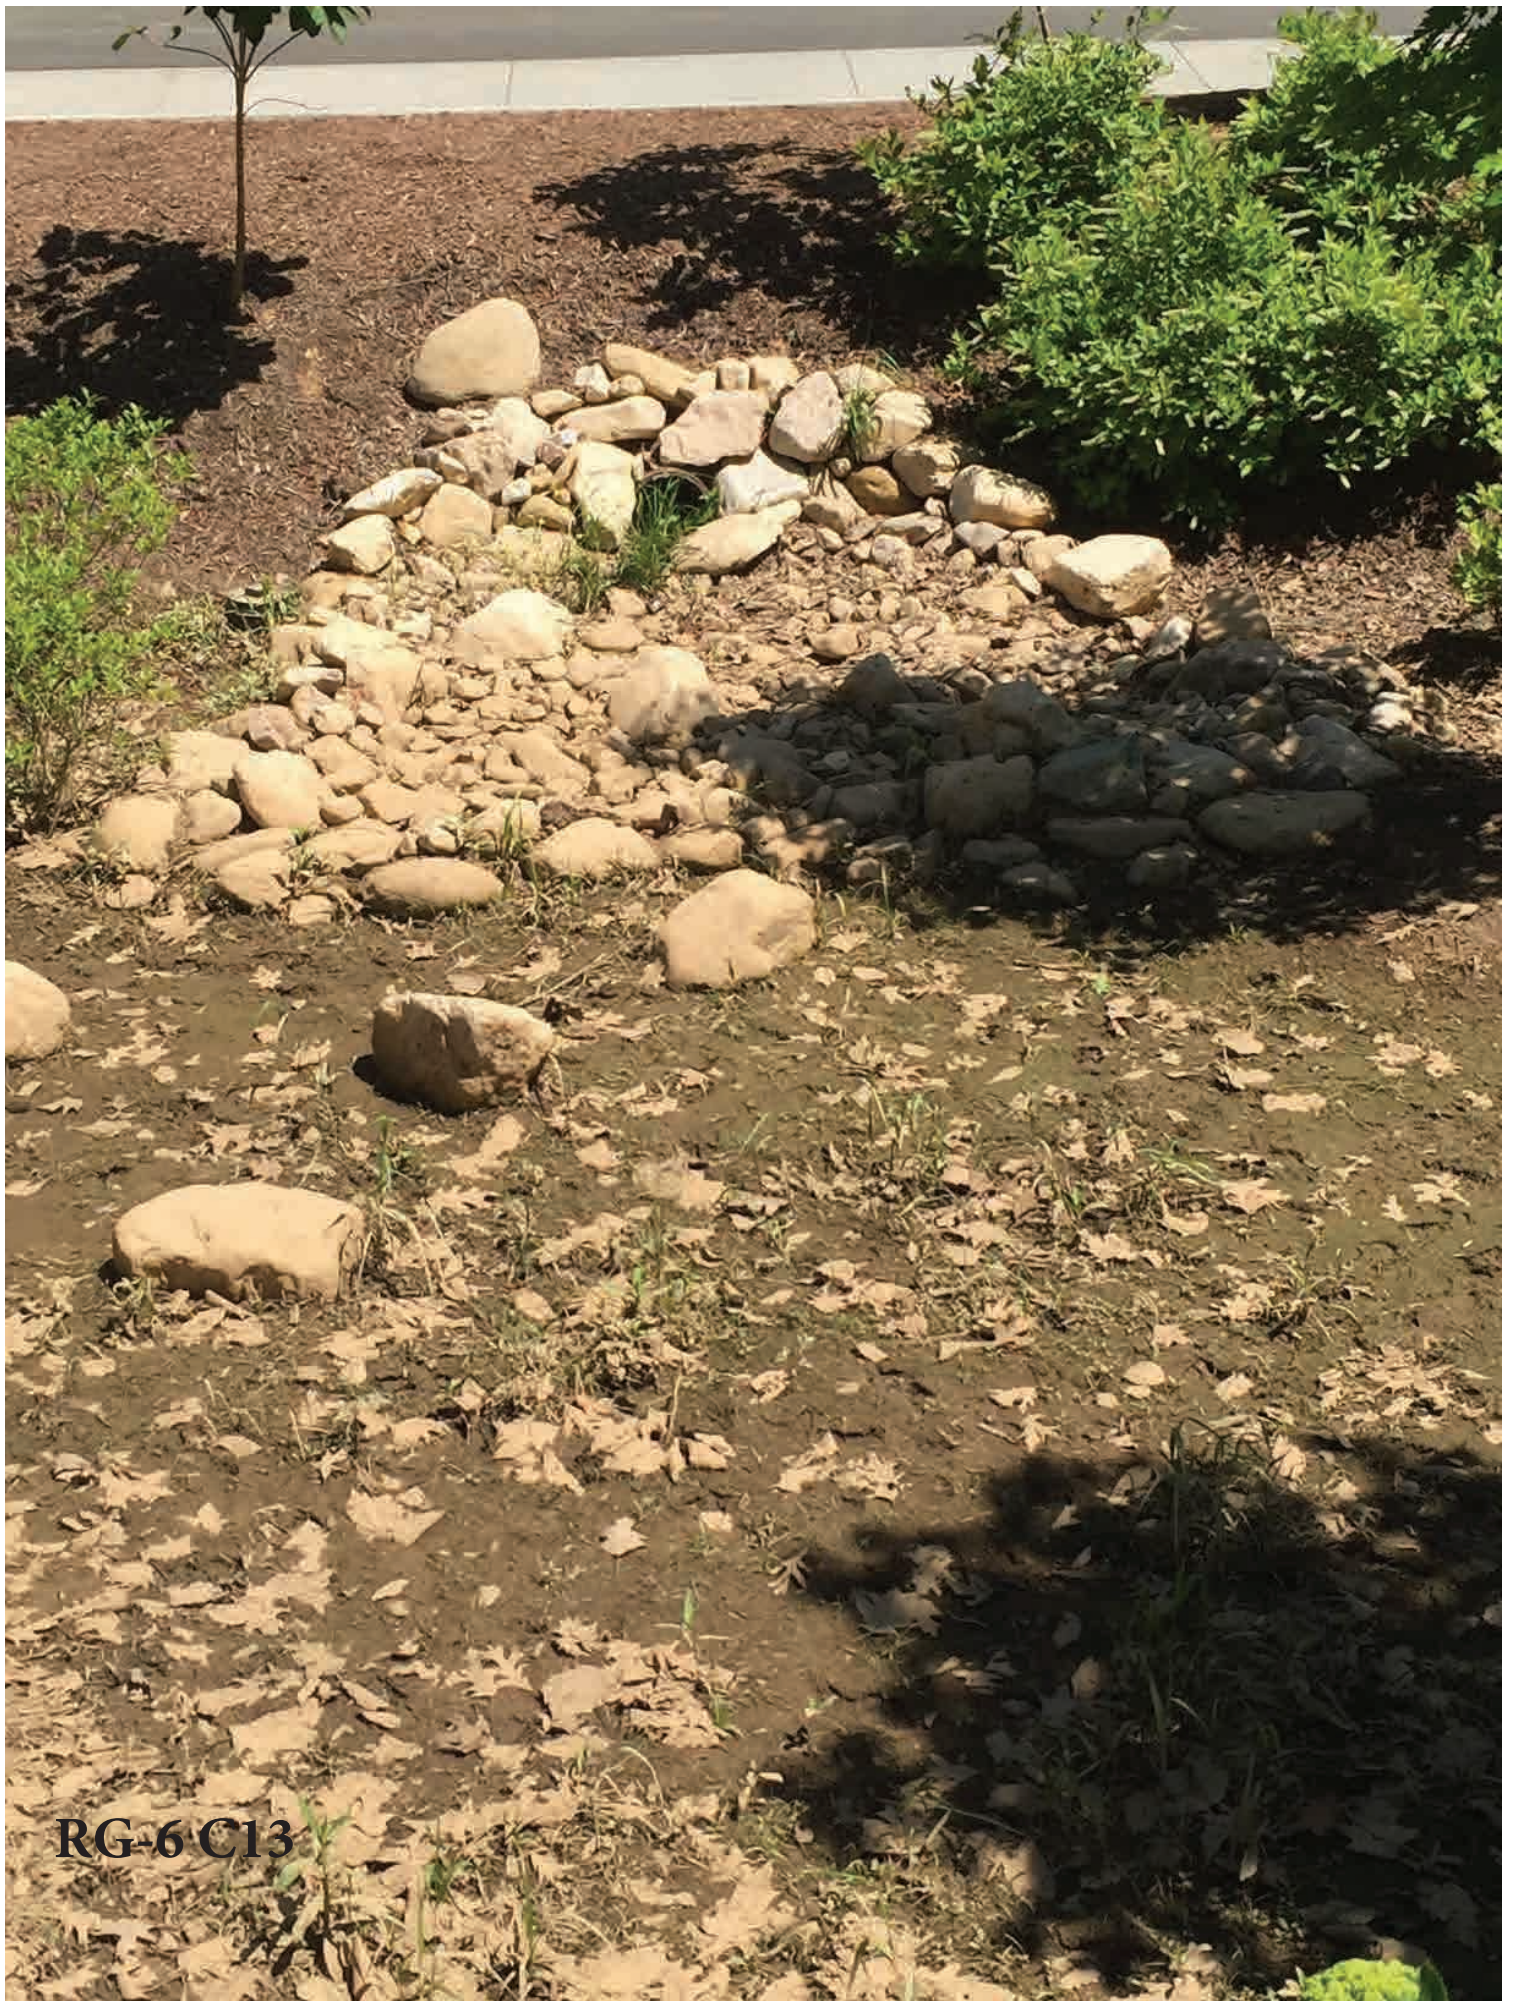
RG-6 C13

<ul style="list-style-type: none"> <li>Spring visual inspection and cleanup</li> <li>Supplement mulch to maintain a 3" layer</li> <li>Prune trees and shrubs</li> </ul>		Annually	<input checked="" type="checkbox"/> Yes <input type="checkbox"/> No	
Remove sediment in pre-treatment cells and inflow points		Once every 2 to 3 years	<input type="checkbox"/> Yes <input type="checkbox"/> No <input checked="" type="checkbox"/> Not due	
Replace the mulch layer		Every 3 years	<input type="checkbox"/> Yes <input type="checkbox"/> No <input checked="" type="checkbox"/> Not due	
FIELD INSPECTION CHECKLIST				
Criteria	Maintenance Required?	ANC or Professional fix	Comments	Date Repaired
<b>Surface</b>				
Vegetation <ul style="list-style-type: none"> <li>Vegetation species inconsistent with design specs</li> <li>Less than 75-90% cover (mulch plus vegetation)</li> <li>High grass</li> <li>Dying or dead vegetation</li> <li>Vegetation killed by salt or winter elements</li> </ul>	<input checked="" type="checkbox"/> Yes <input type="checkbox"/> No	ANC	vegetation died, <75% vegetation  KTR repaired BMP. ANC will add new vegetation.	June 2019

Filter Media/Mulch Layer <ul style="list-style-type: none"> <li>Too low, too compacted, and/or clogged</li> <li>Older than 3 years and/or in poor condition</li> <li>Ponding</li> <li>Chemicals, fertilizers, oil, grease, trash, debris, sediment, sand</li> <li>Erosion, exposed soil</li> <li>Topsoil in poor condition</li> </ul>	<input checked="" type="checkbox"/> Yes <input type="checkbox"/> No	Professional	Filter media appears clogged. BMP holds water longer than 48 hours.  KTR removed filter media and mulch to improve BMP functionality.	June 2019
