## **ANNUAL REPORT UPDATE**

**Reporting Period**  
**July 1, 2018 to June 30, 2019 (Due October 1, 2019)**

### **Arlington National Cemetery**

**VPDES Permit Number: VAR040139**  
**Permit Effective Date: November 1, 2018**  
**Permit Expiration Date: October 31, 2023**

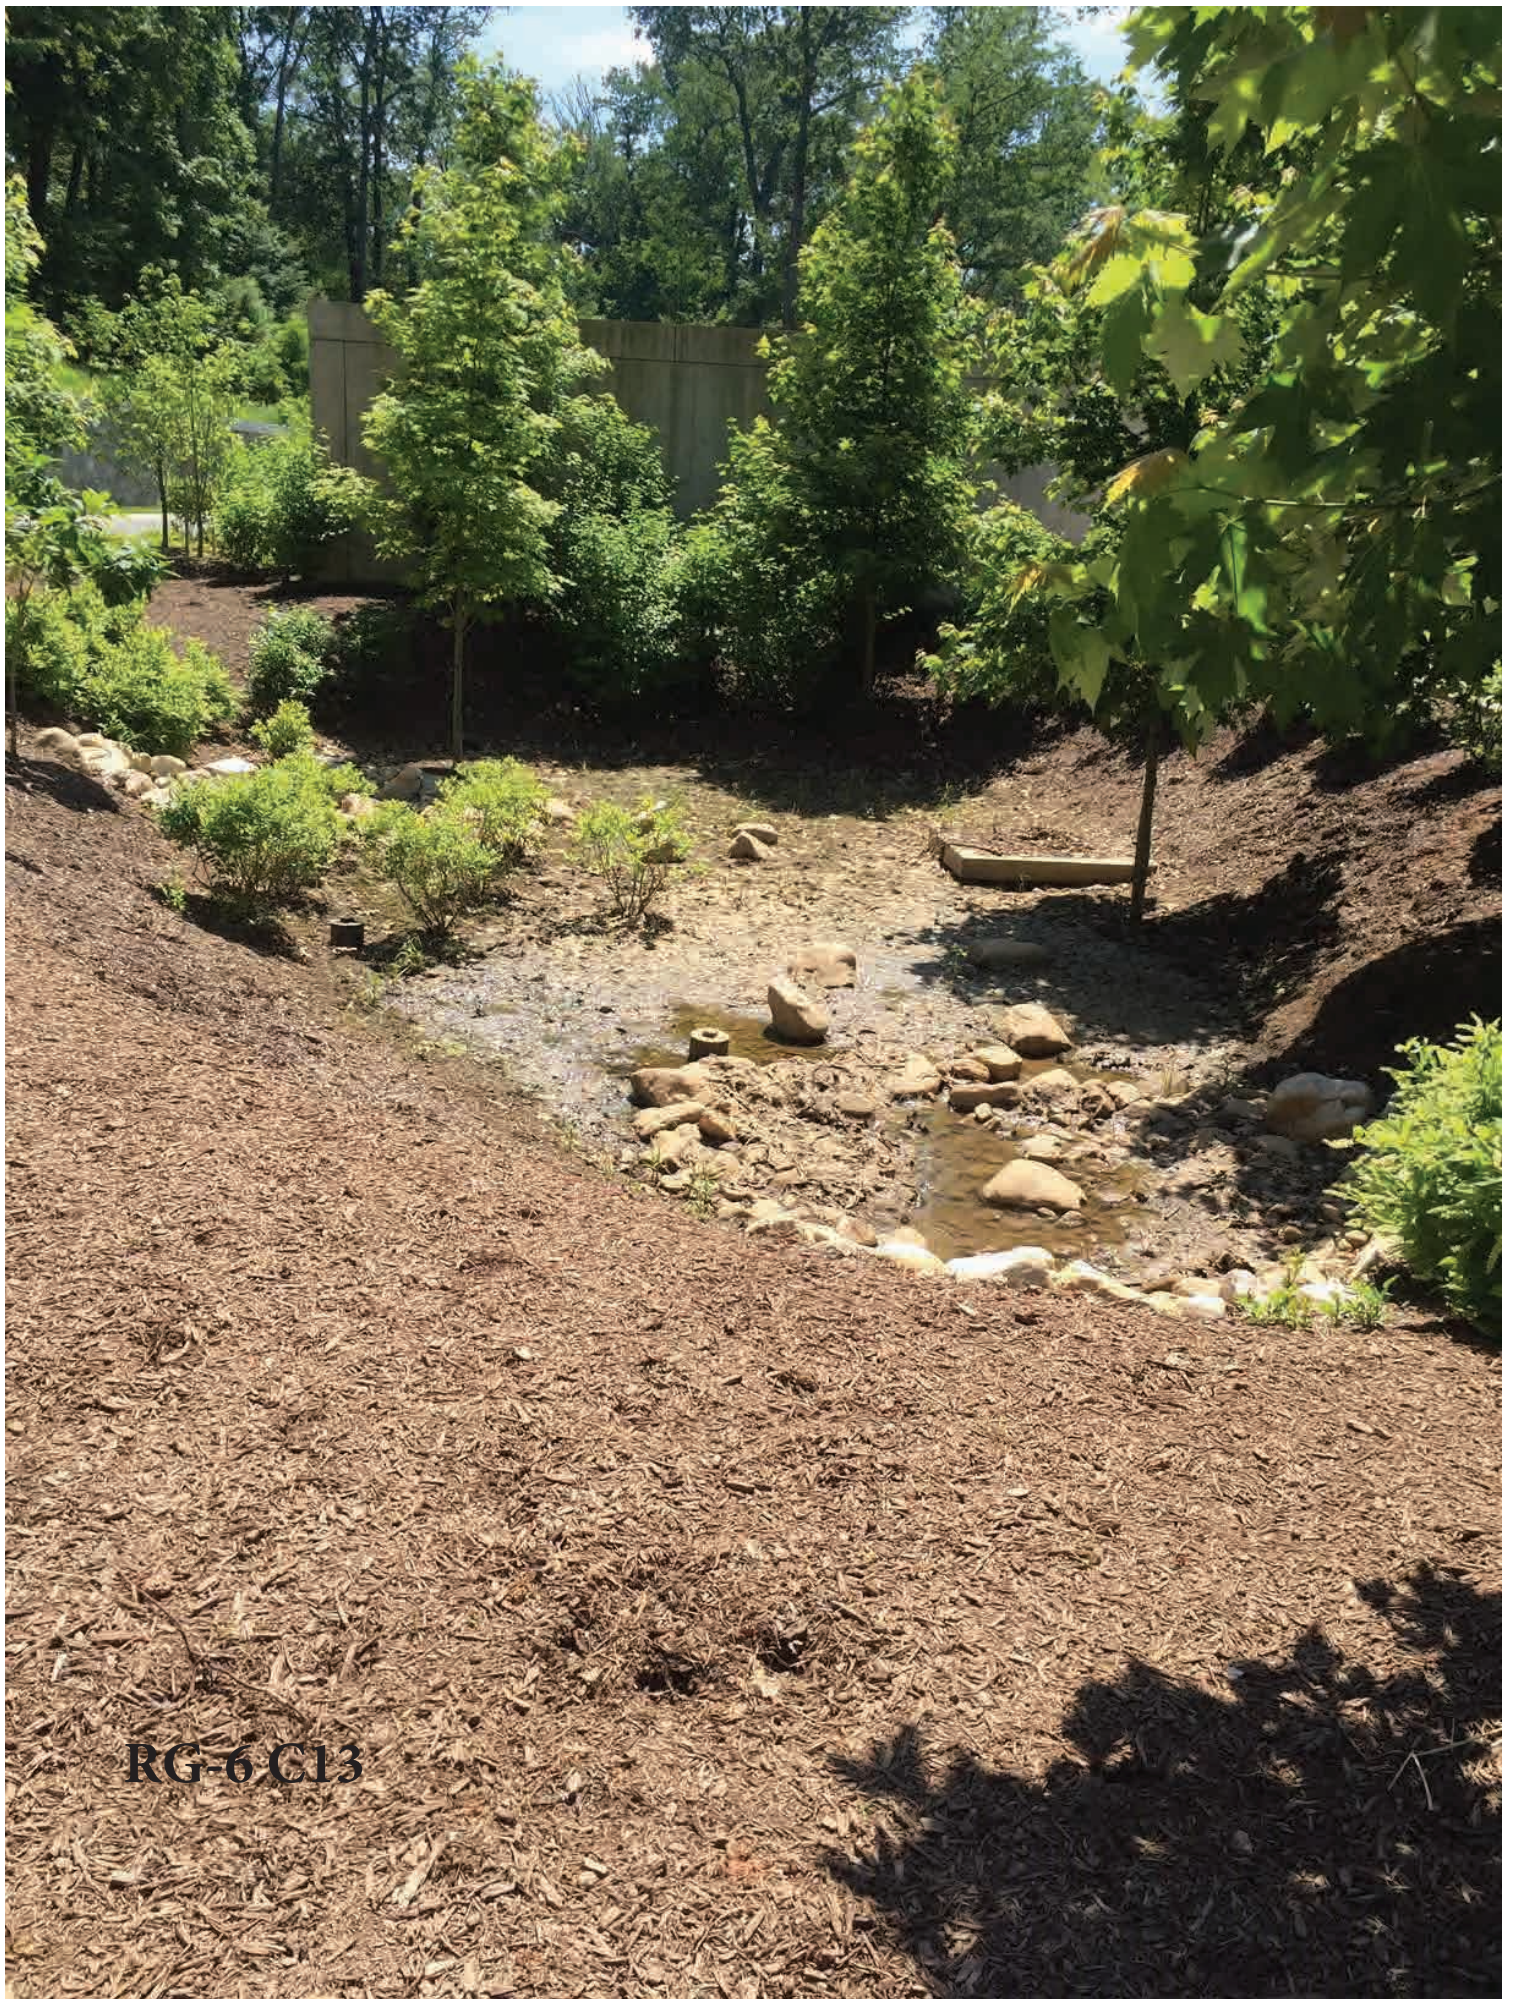
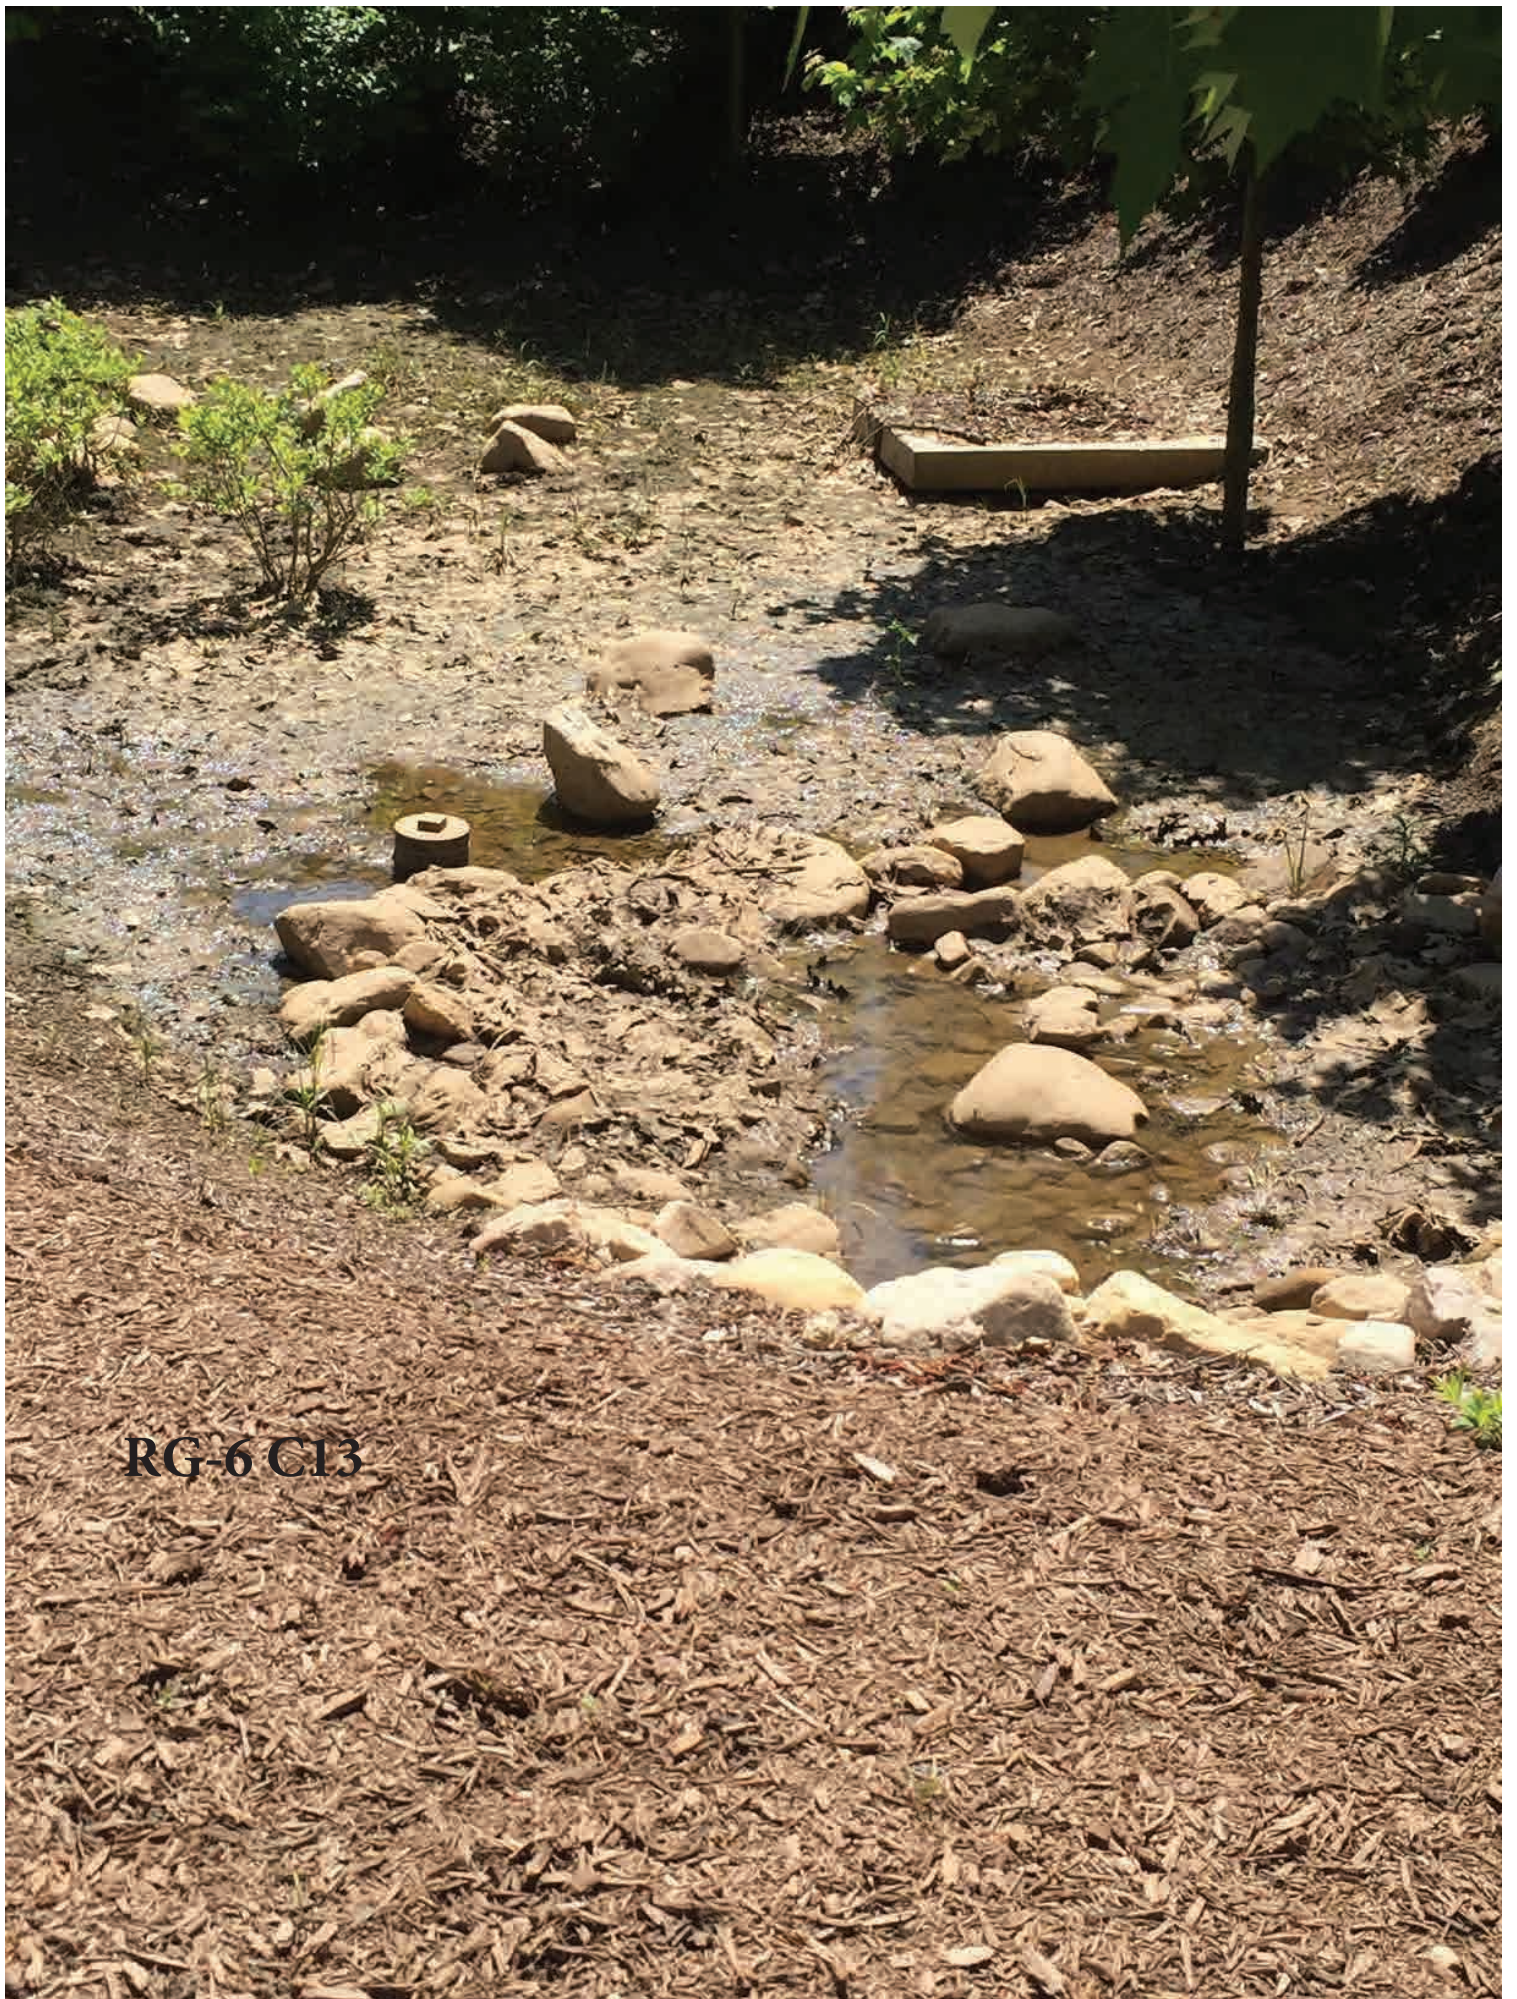
RG-6 C13

Filter Media/Mulch Layer <ul style="list-style-type: none"> <li>Too low, too compacted, and/or clogged</li> <li>Older than 3 years and/or in poor condition</li> <li>Ponding</li> <li>Chemicals, fertilizers, oil, grease, trash, debris, sediment, sand</li> <li>Erosion, exposed soil</li> <li>Topsoil in poor condition</li> </ul>	<input checked="" type="checkbox"/> Yes <input type="checkbox"/> No	Professional	Filter media appears clogged. BMP holds water longer than 48 hours.  KTR removed filter media and mulch to improve BMP functionality.	June 2019

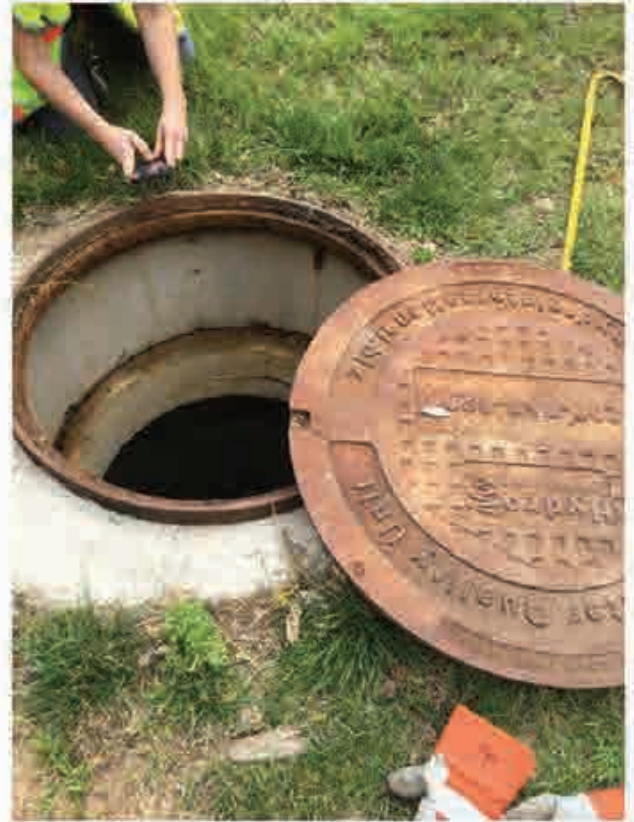
Chamber 1

Criteria	Maintenance Required?	ANC or Professional fix	Comments	Date Repaired
<b>Inlet/Outlet/Access</b>				
Pipe blockages	<input type="checkbox"/> Yes <input checked="" type="checkbox"/> No			
Pipe or joint breaks or cracks	<input type="checkbox"/> Yes <input checked="" type="checkbox"/> No			
Access cover missing, cracked, damaged, or unable to open	<input type="checkbox"/> Yes <input checked="" type="checkbox"/> No			
<b>Sediment Level</b>				
Sediment accumulation in forebay	<input type="checkbox"/> Yes <input checked="" type="checkbox"/> No <input type="checkbox"/> N/A			
Sediment depth on vault floor greater than 15% of diameter or interior depth of vault	<input type="checkbox"/> Yes <input checked="" type="checkbox"/> No			
Standing water inside chamber for more than 24 hours after storm	<input checked="" type="checkbox"/> Yes <input type="checkbox"/> No			
Scum line present	<input checked="" type="checkbox"/> Yes <input type="checkbox"/> No	Professional	Trash visible within chamber 1

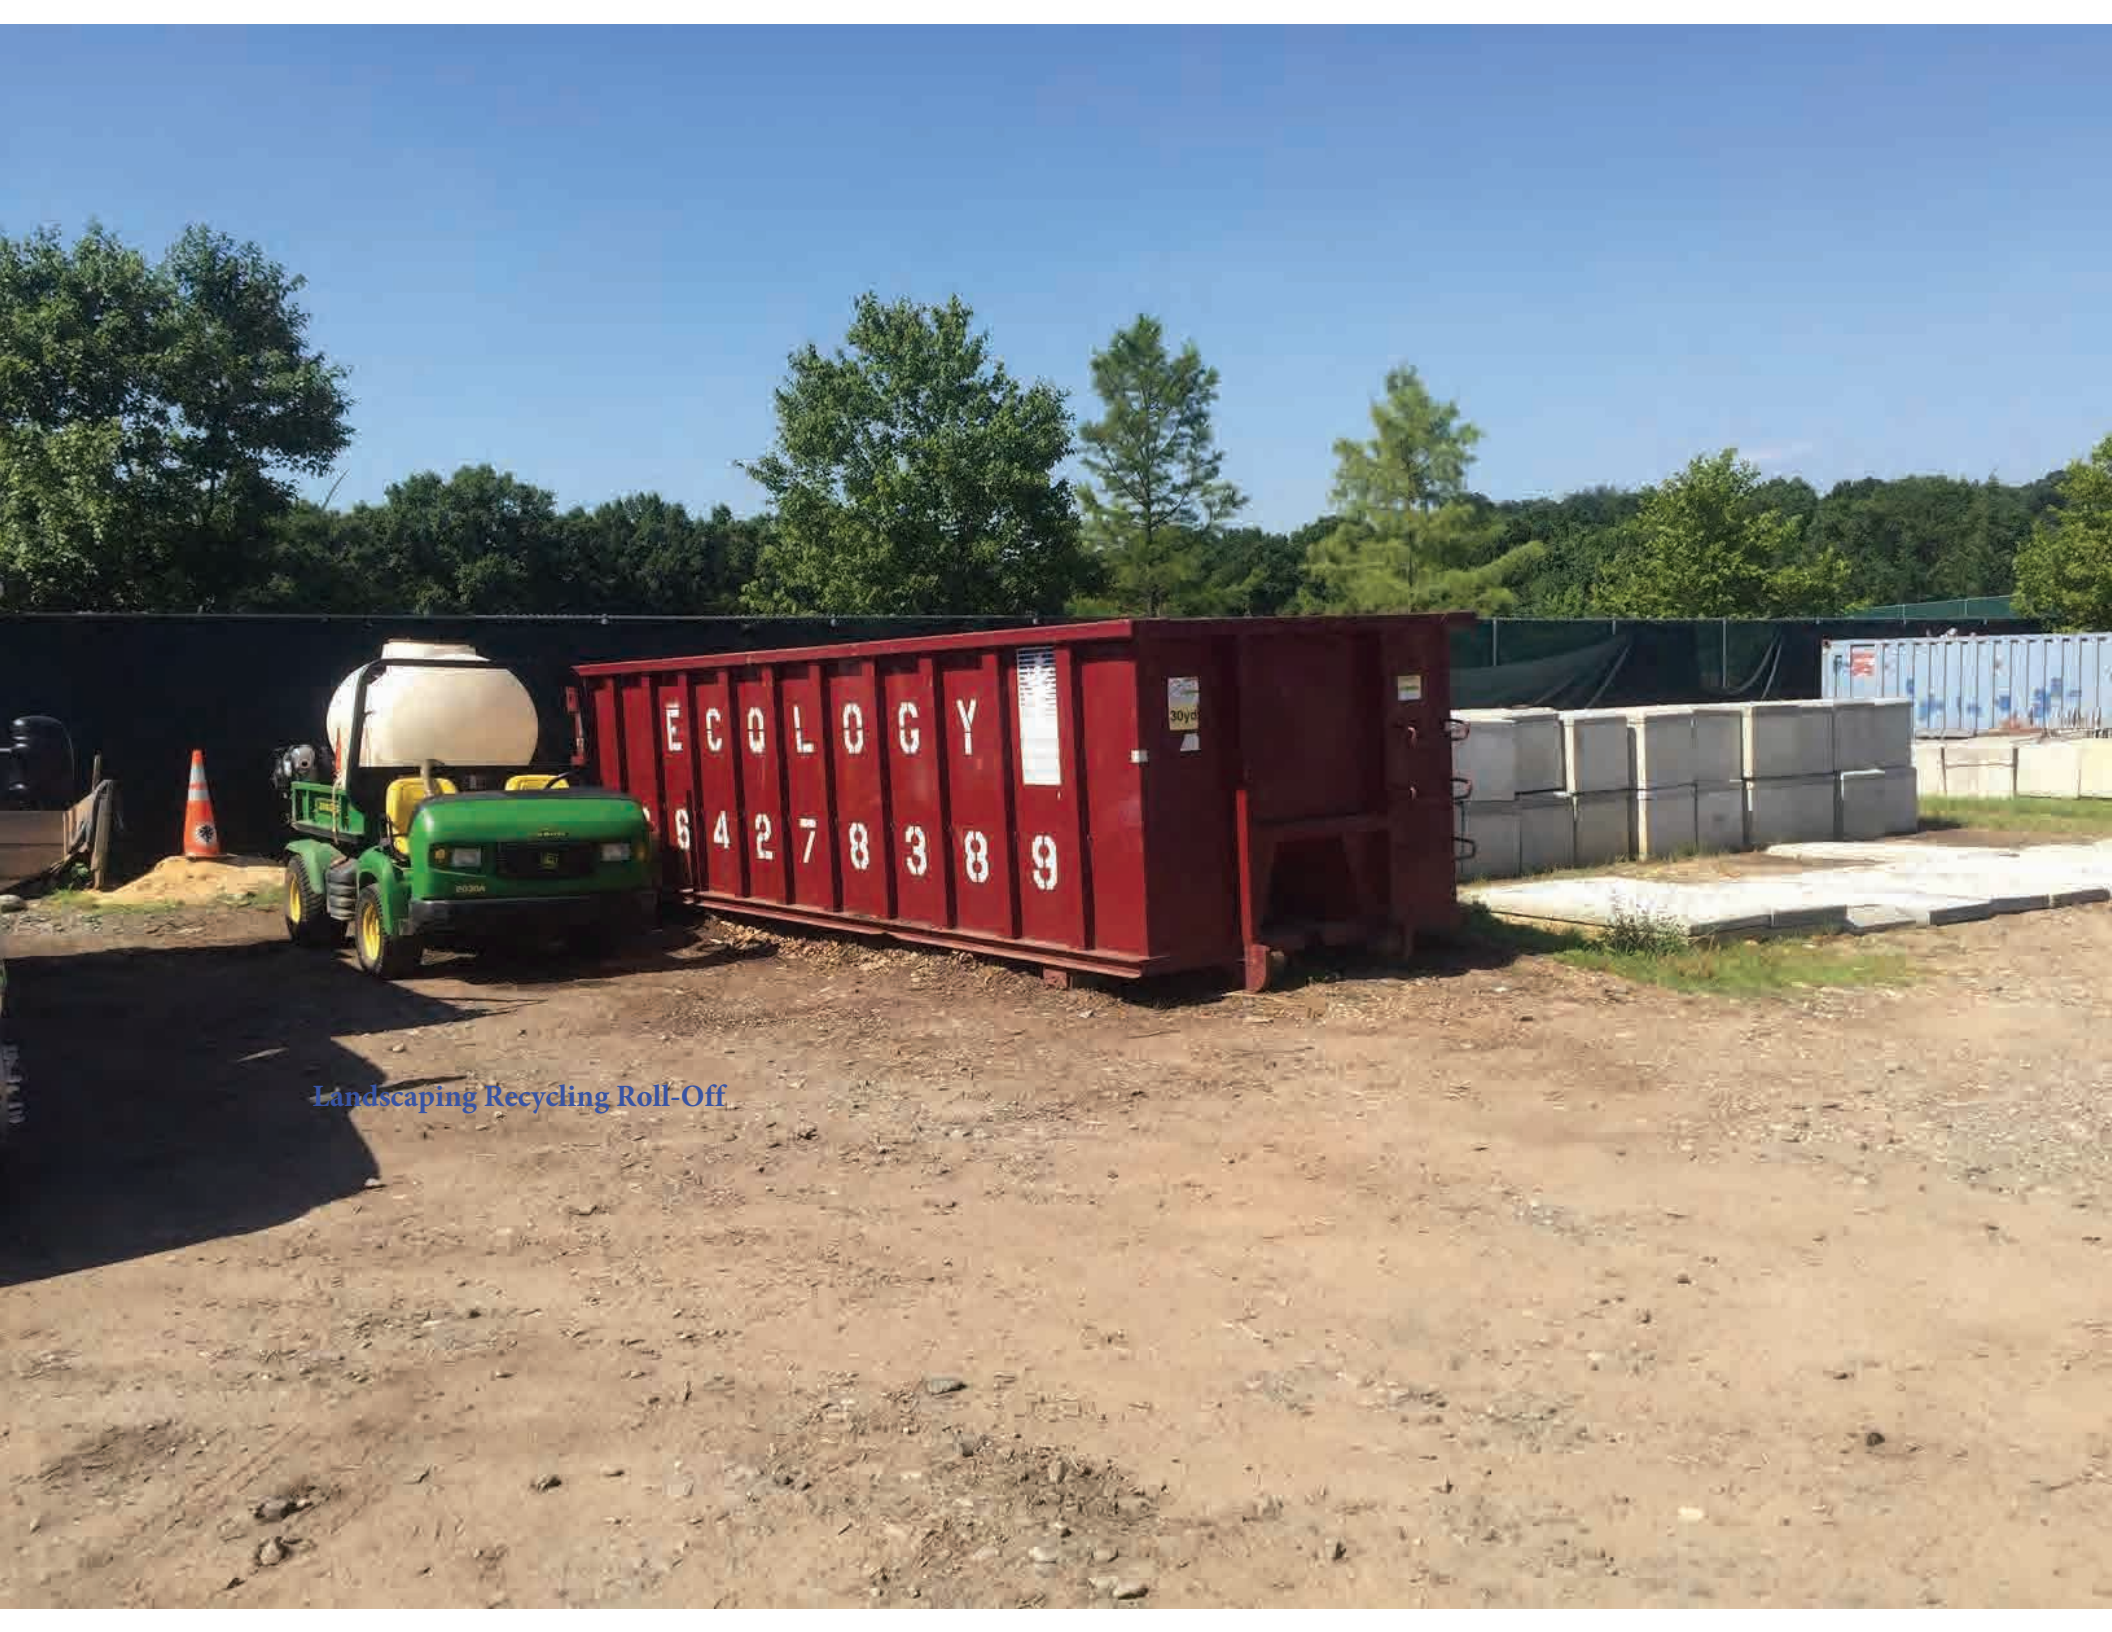
Landscaping Material Storage Area

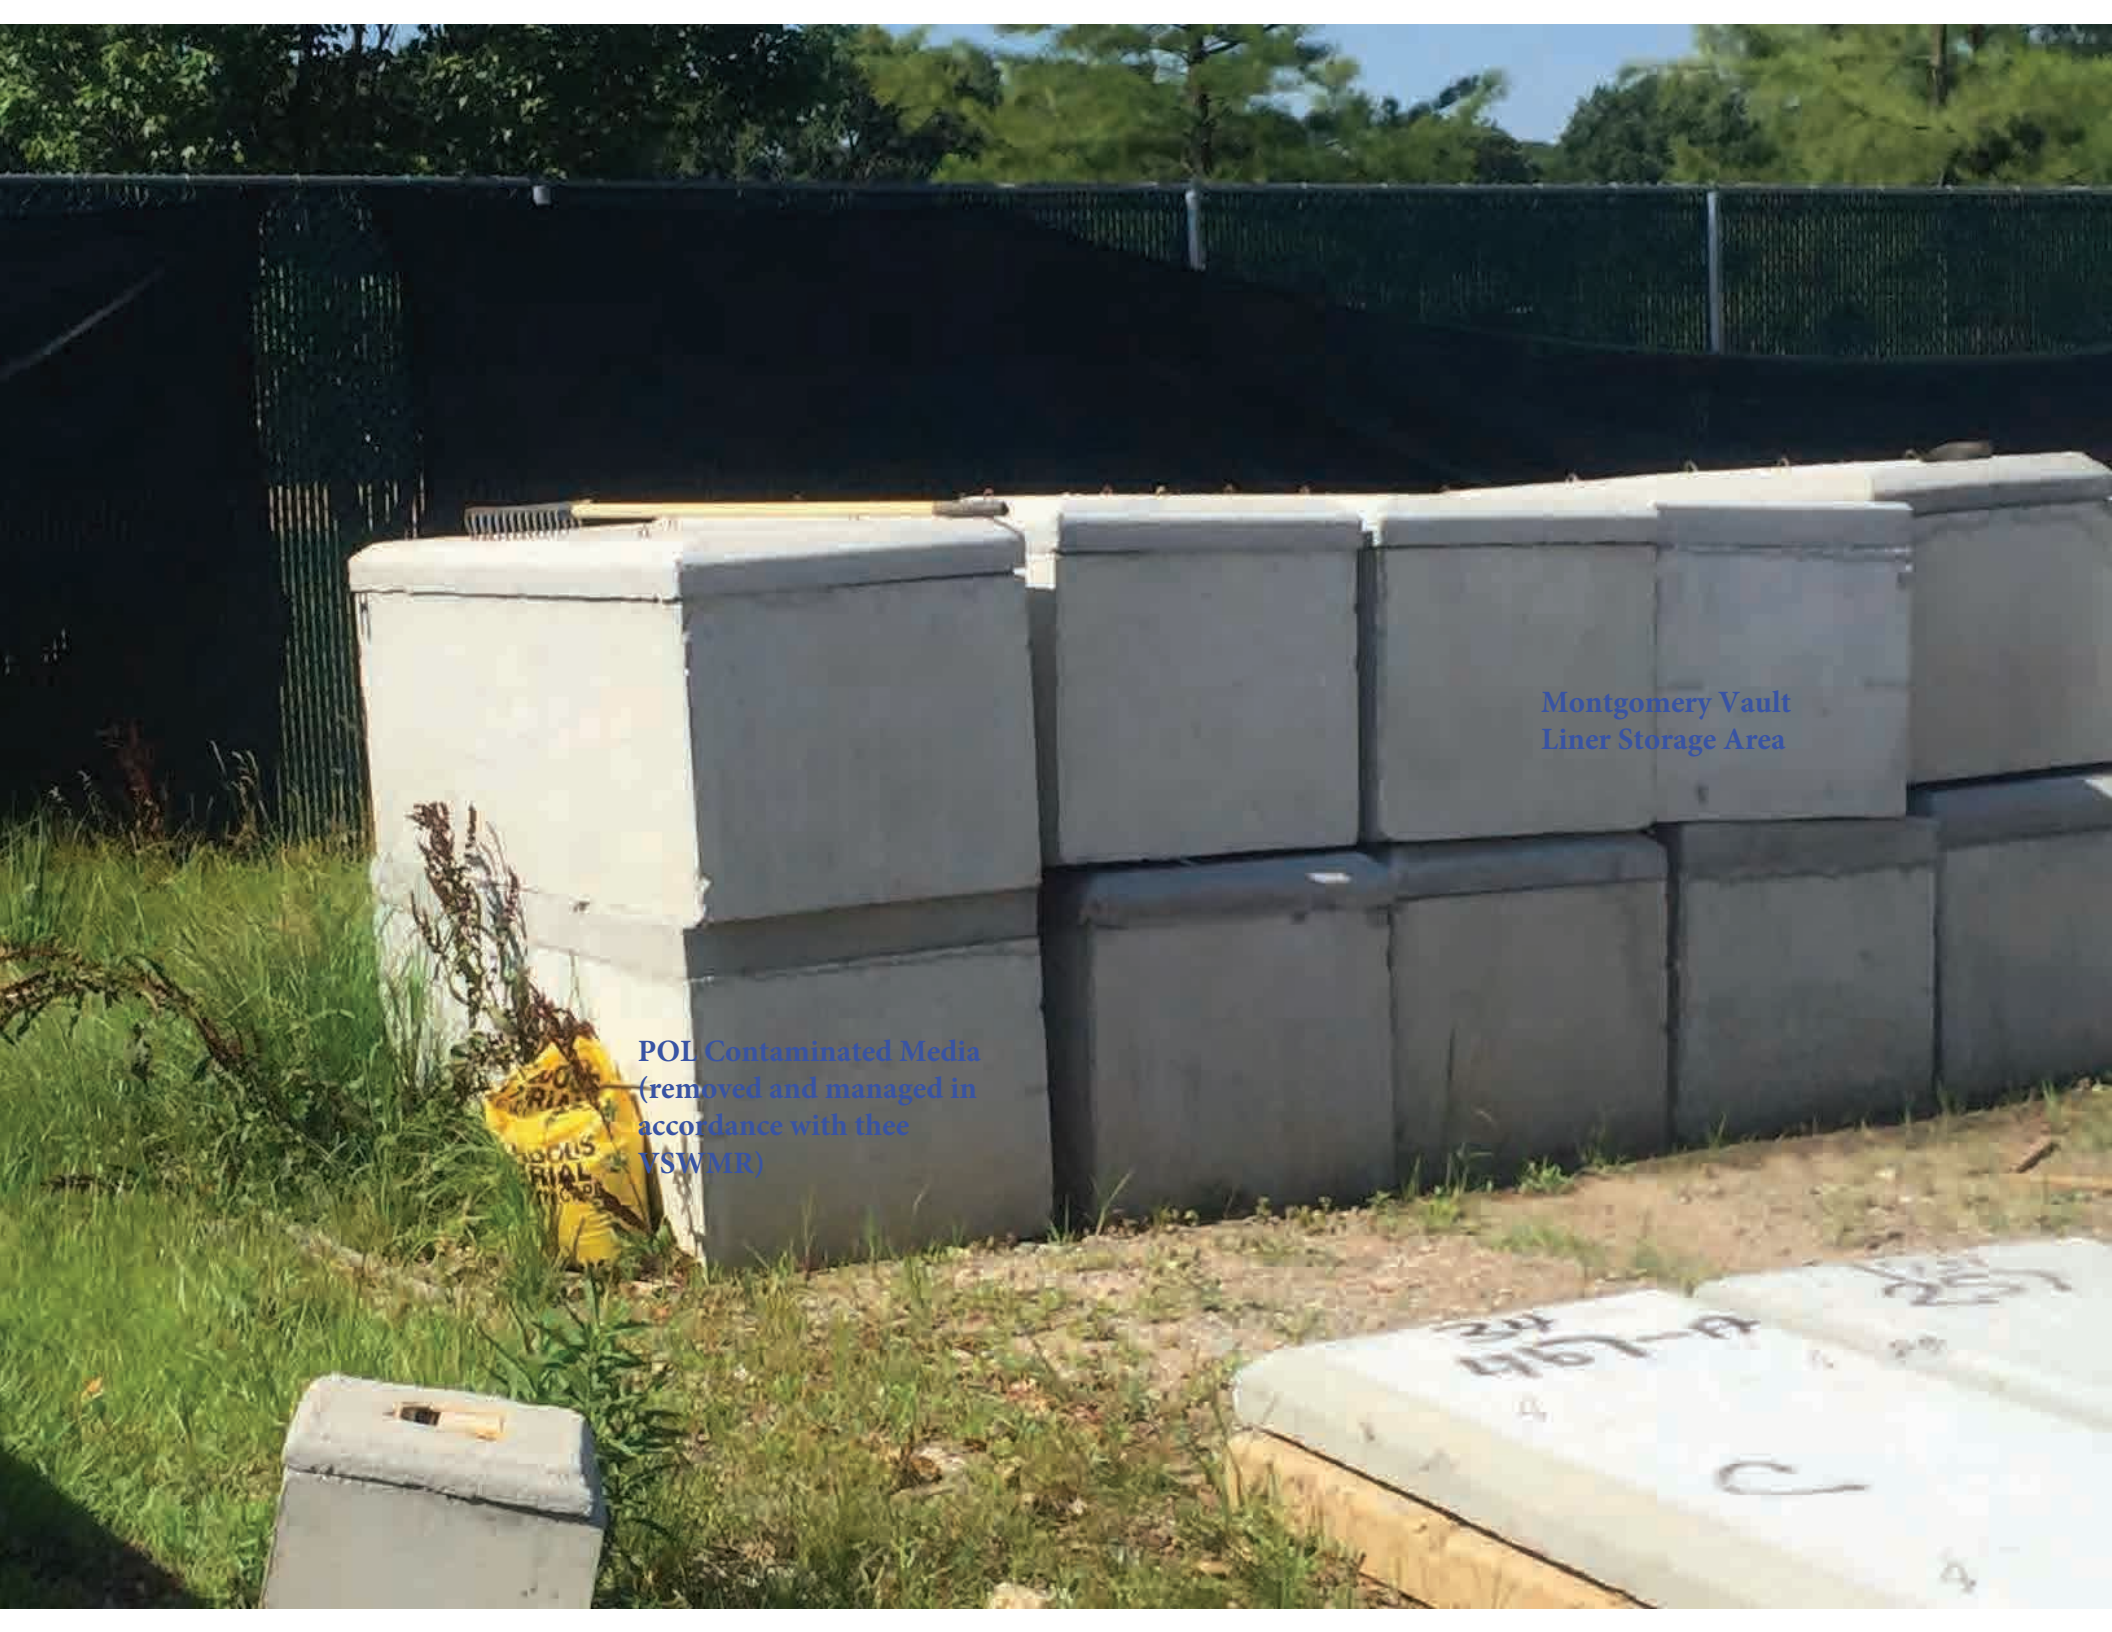
Montgomery Vault  
Liner Storage Area

POL Contaminated Media  
(removed and managed in  
accordance with the  
VSWMR)

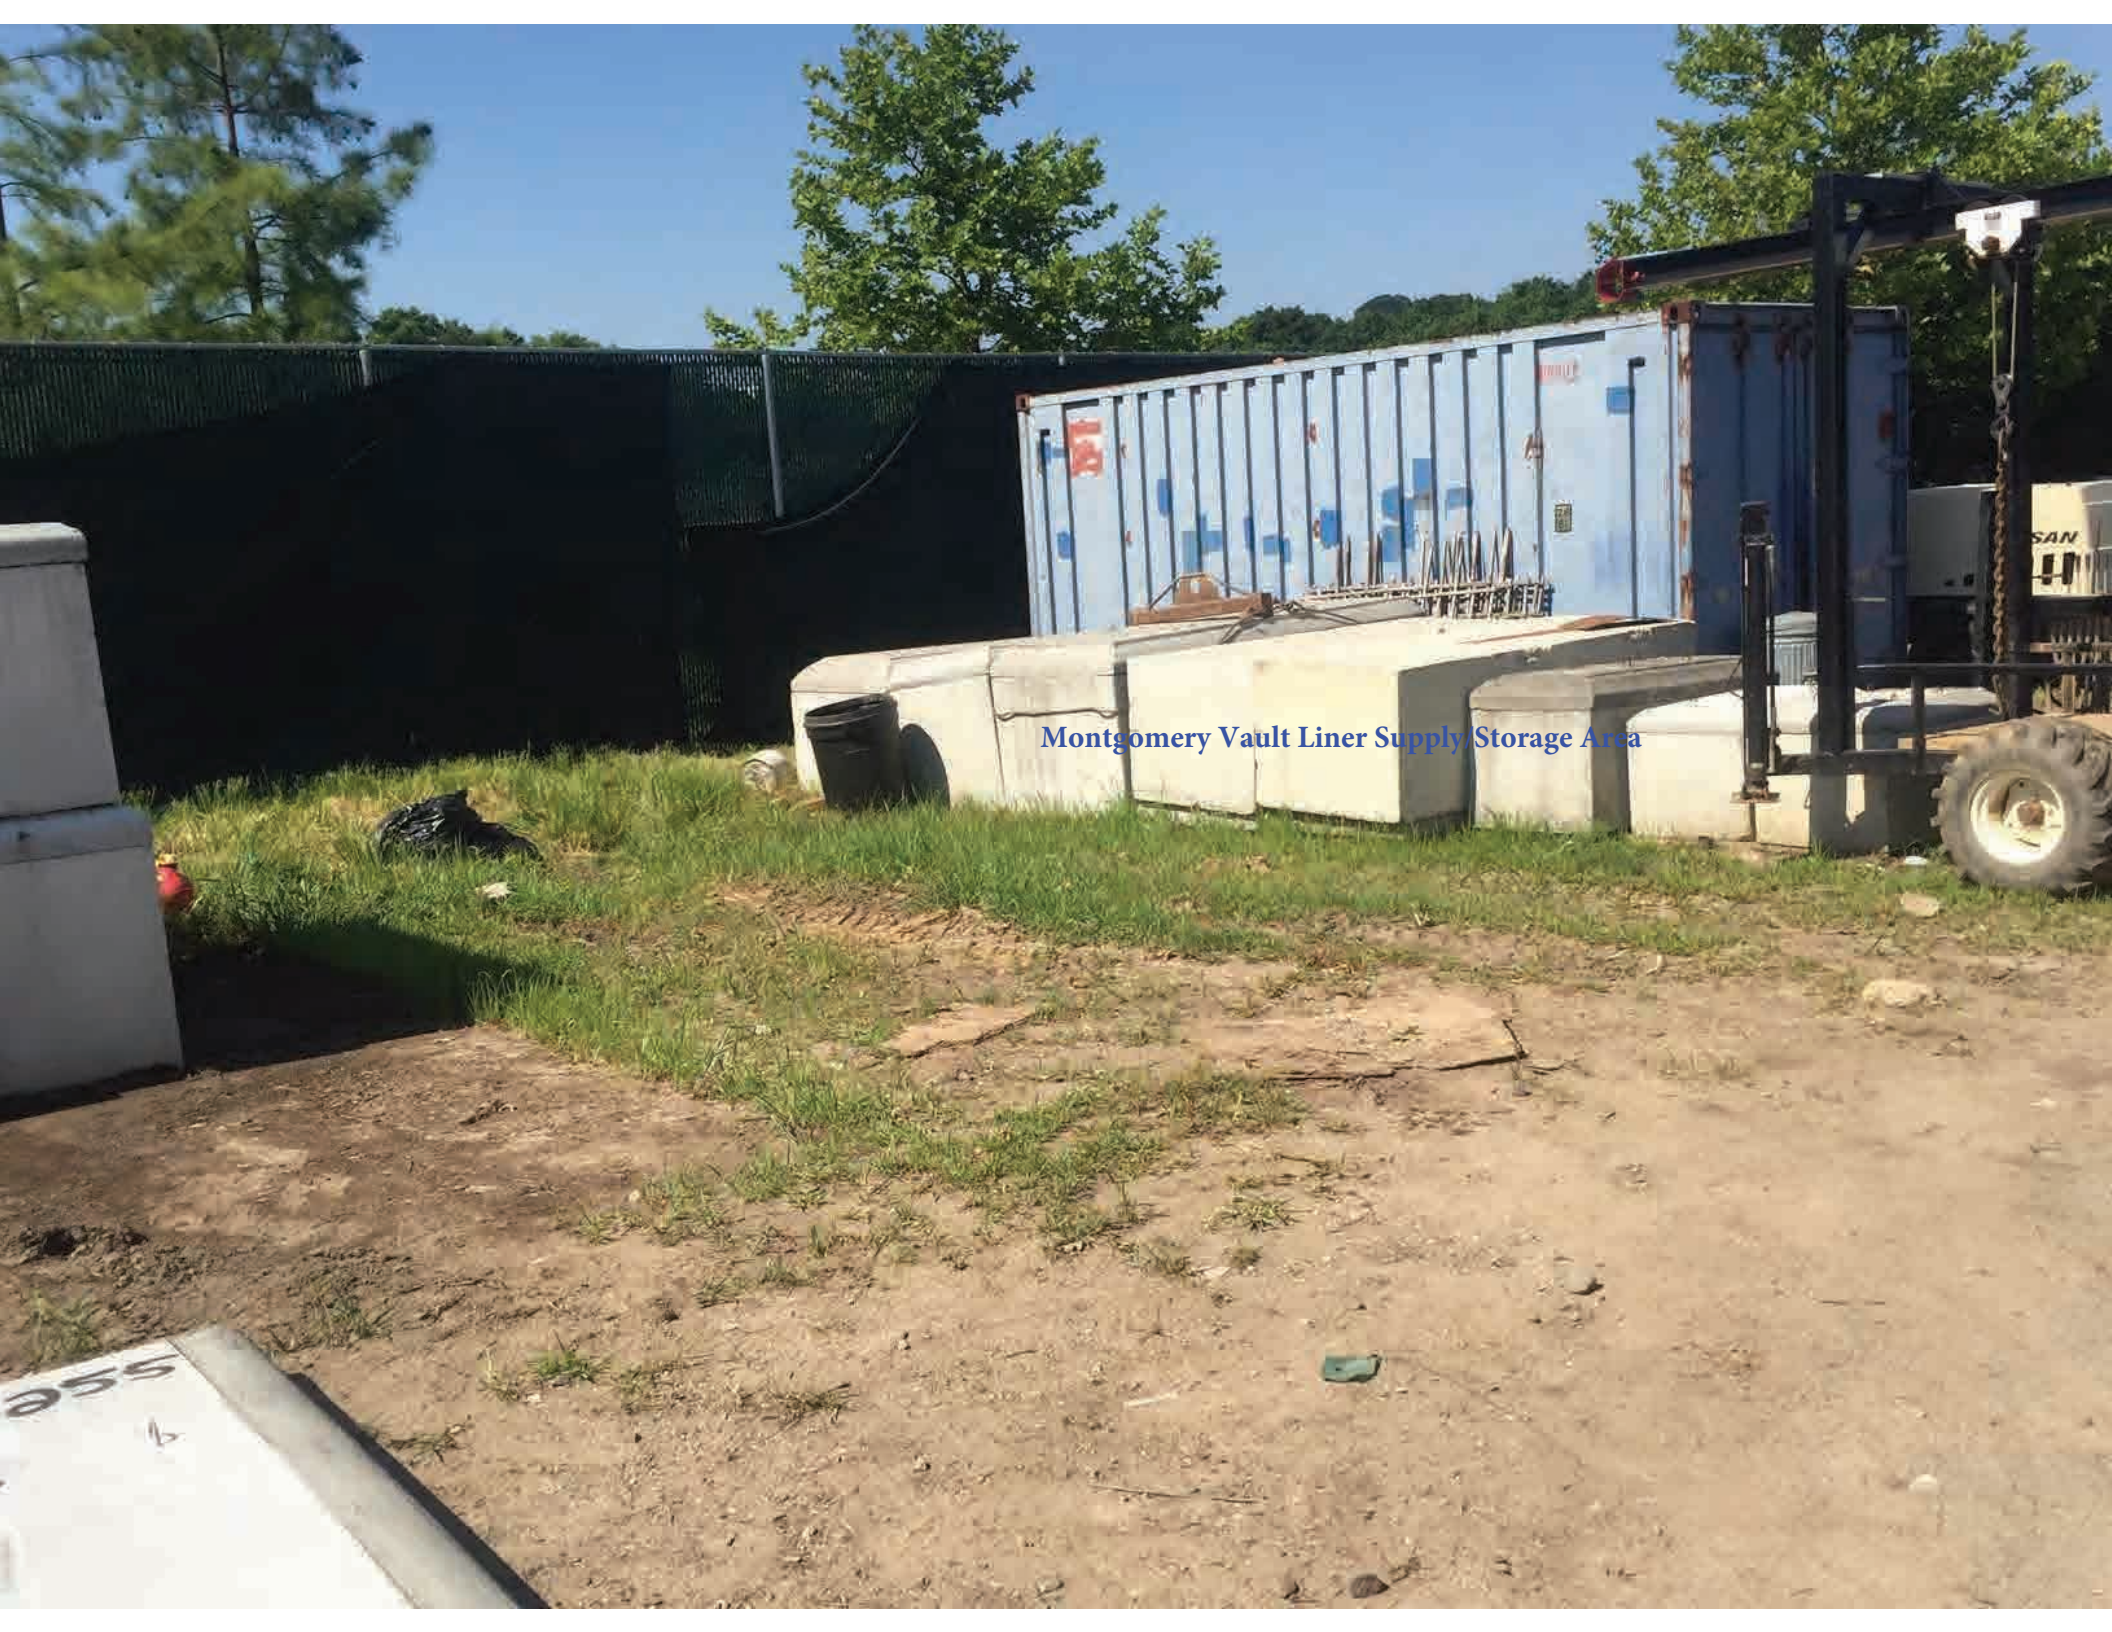
Montgomery Vault Liner Supply/Storage Area

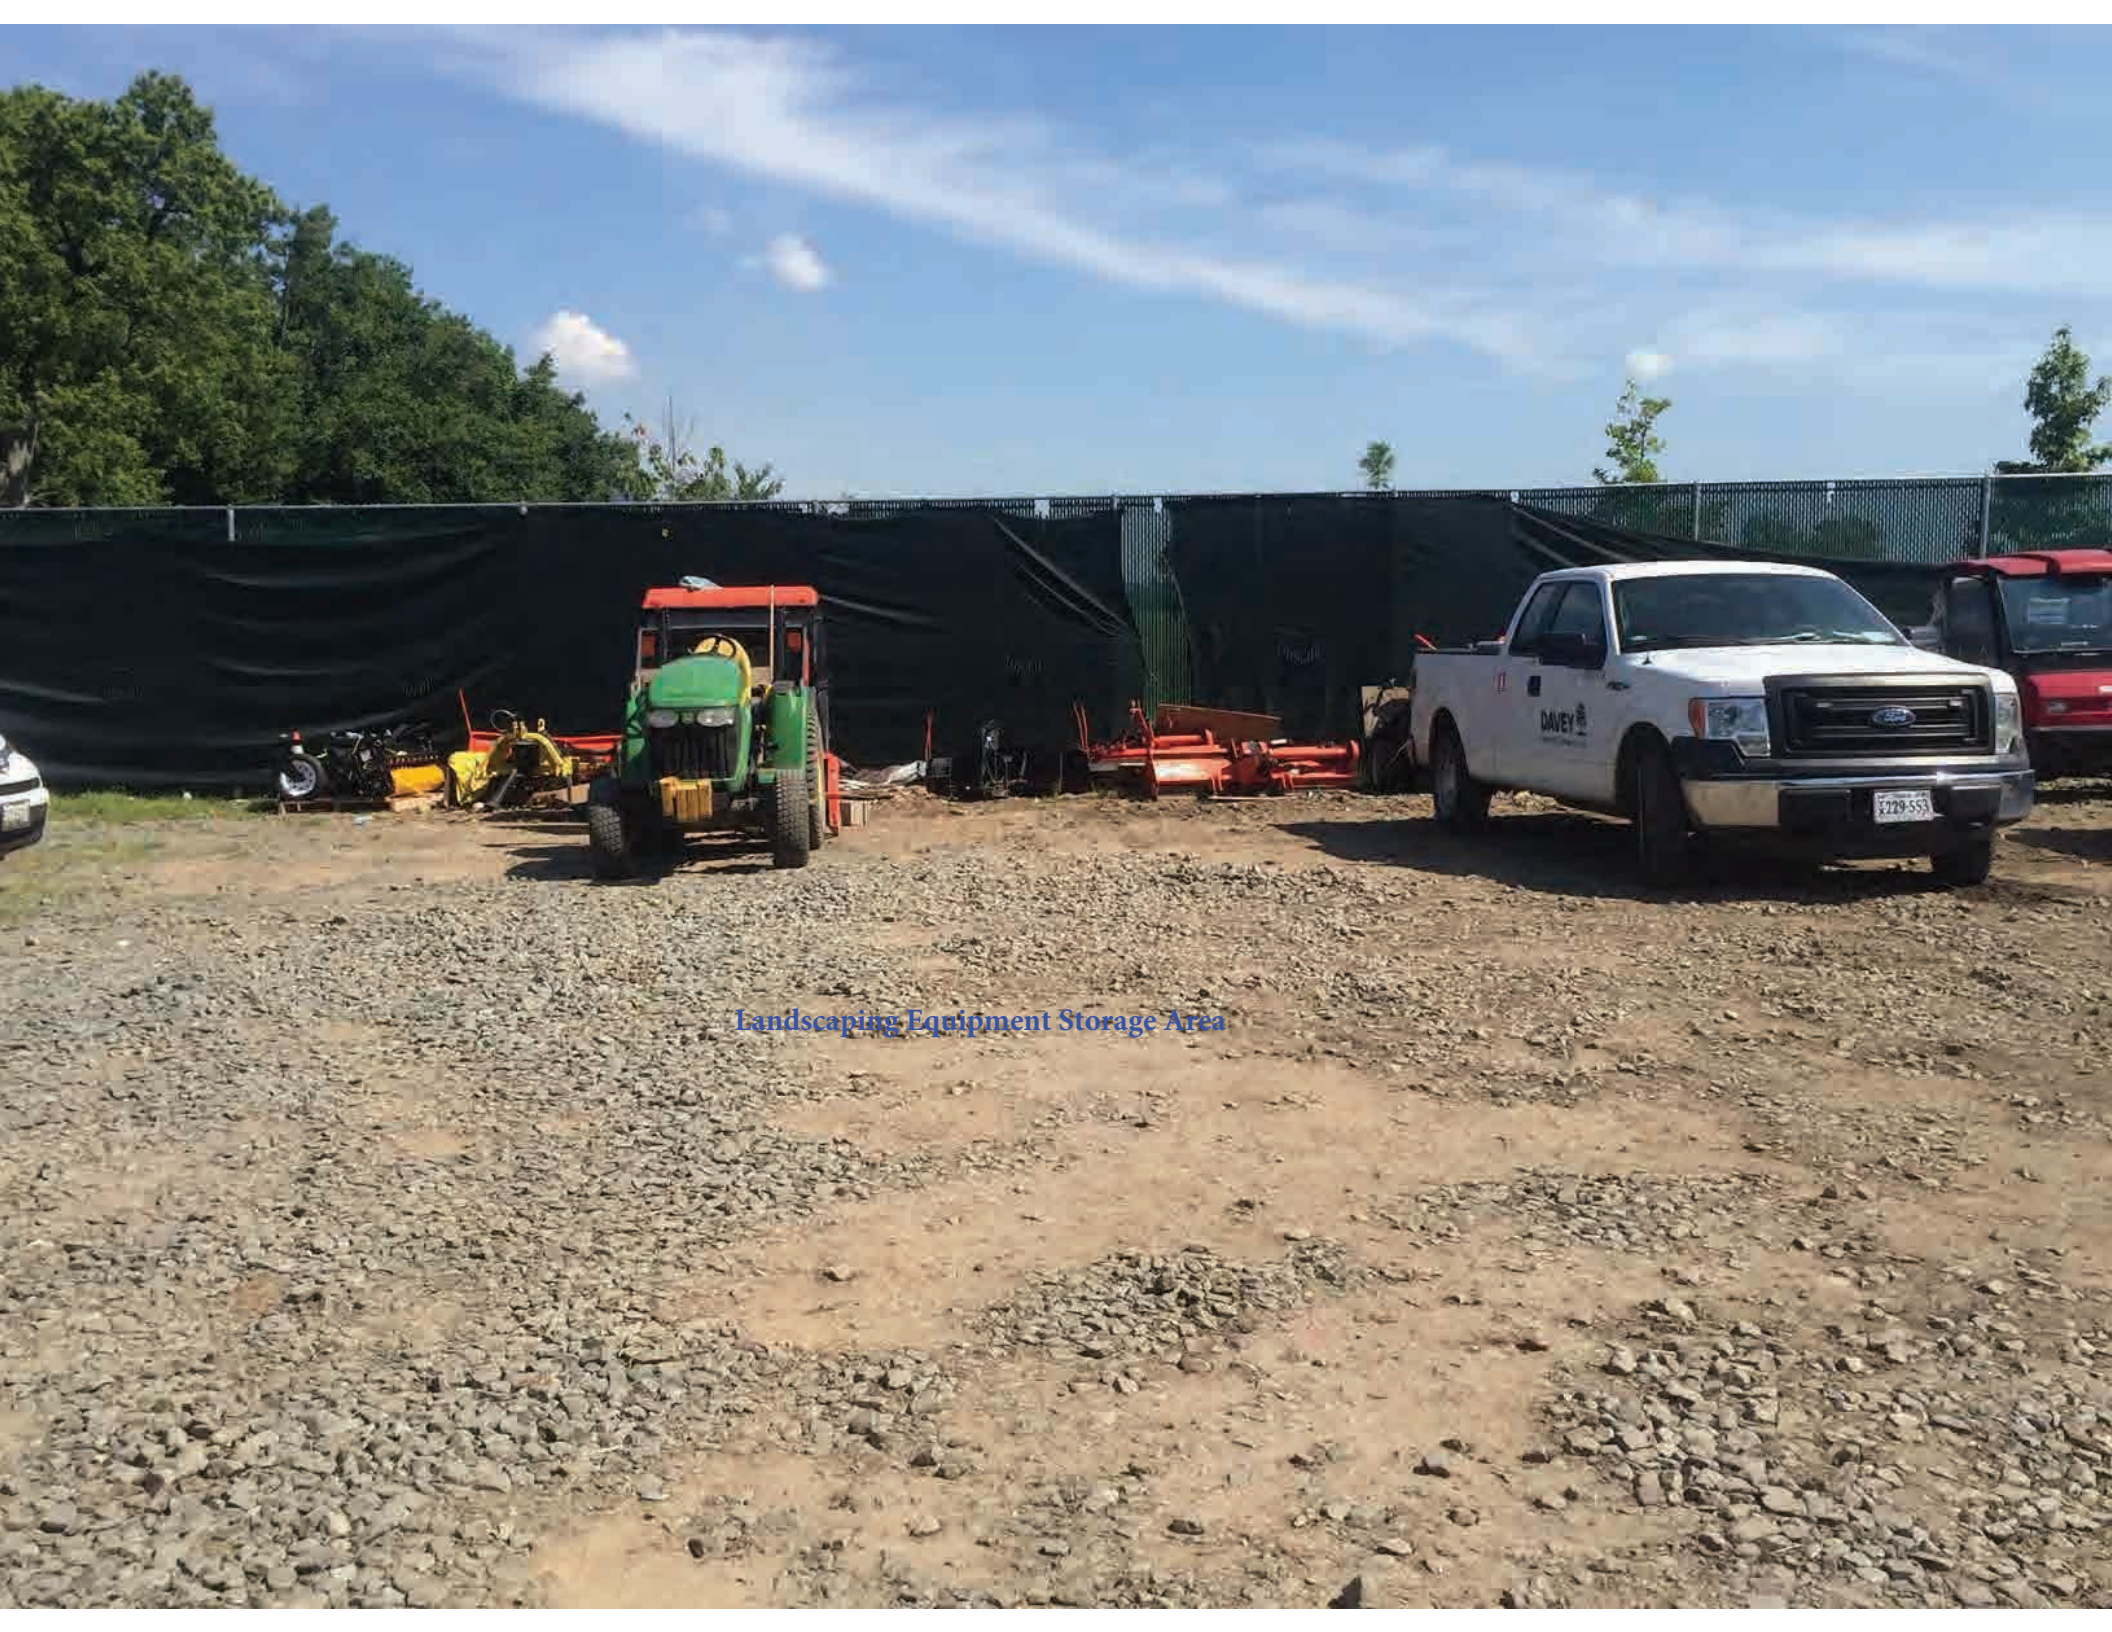
Landscaping Equipment Storage Area
