## **ANNUAL REPORT UPDATE**

**Reporting Period**  
**July 1, 2018 to June 30, 2019 (Due October 1, 2019)**

### **Arlington National Cemetery**

**VPDES Permit Number: VAR040139**  
**Permit Effective Date: November 1, 2018**  
**Permit Expiration Date: October 31, 2023**

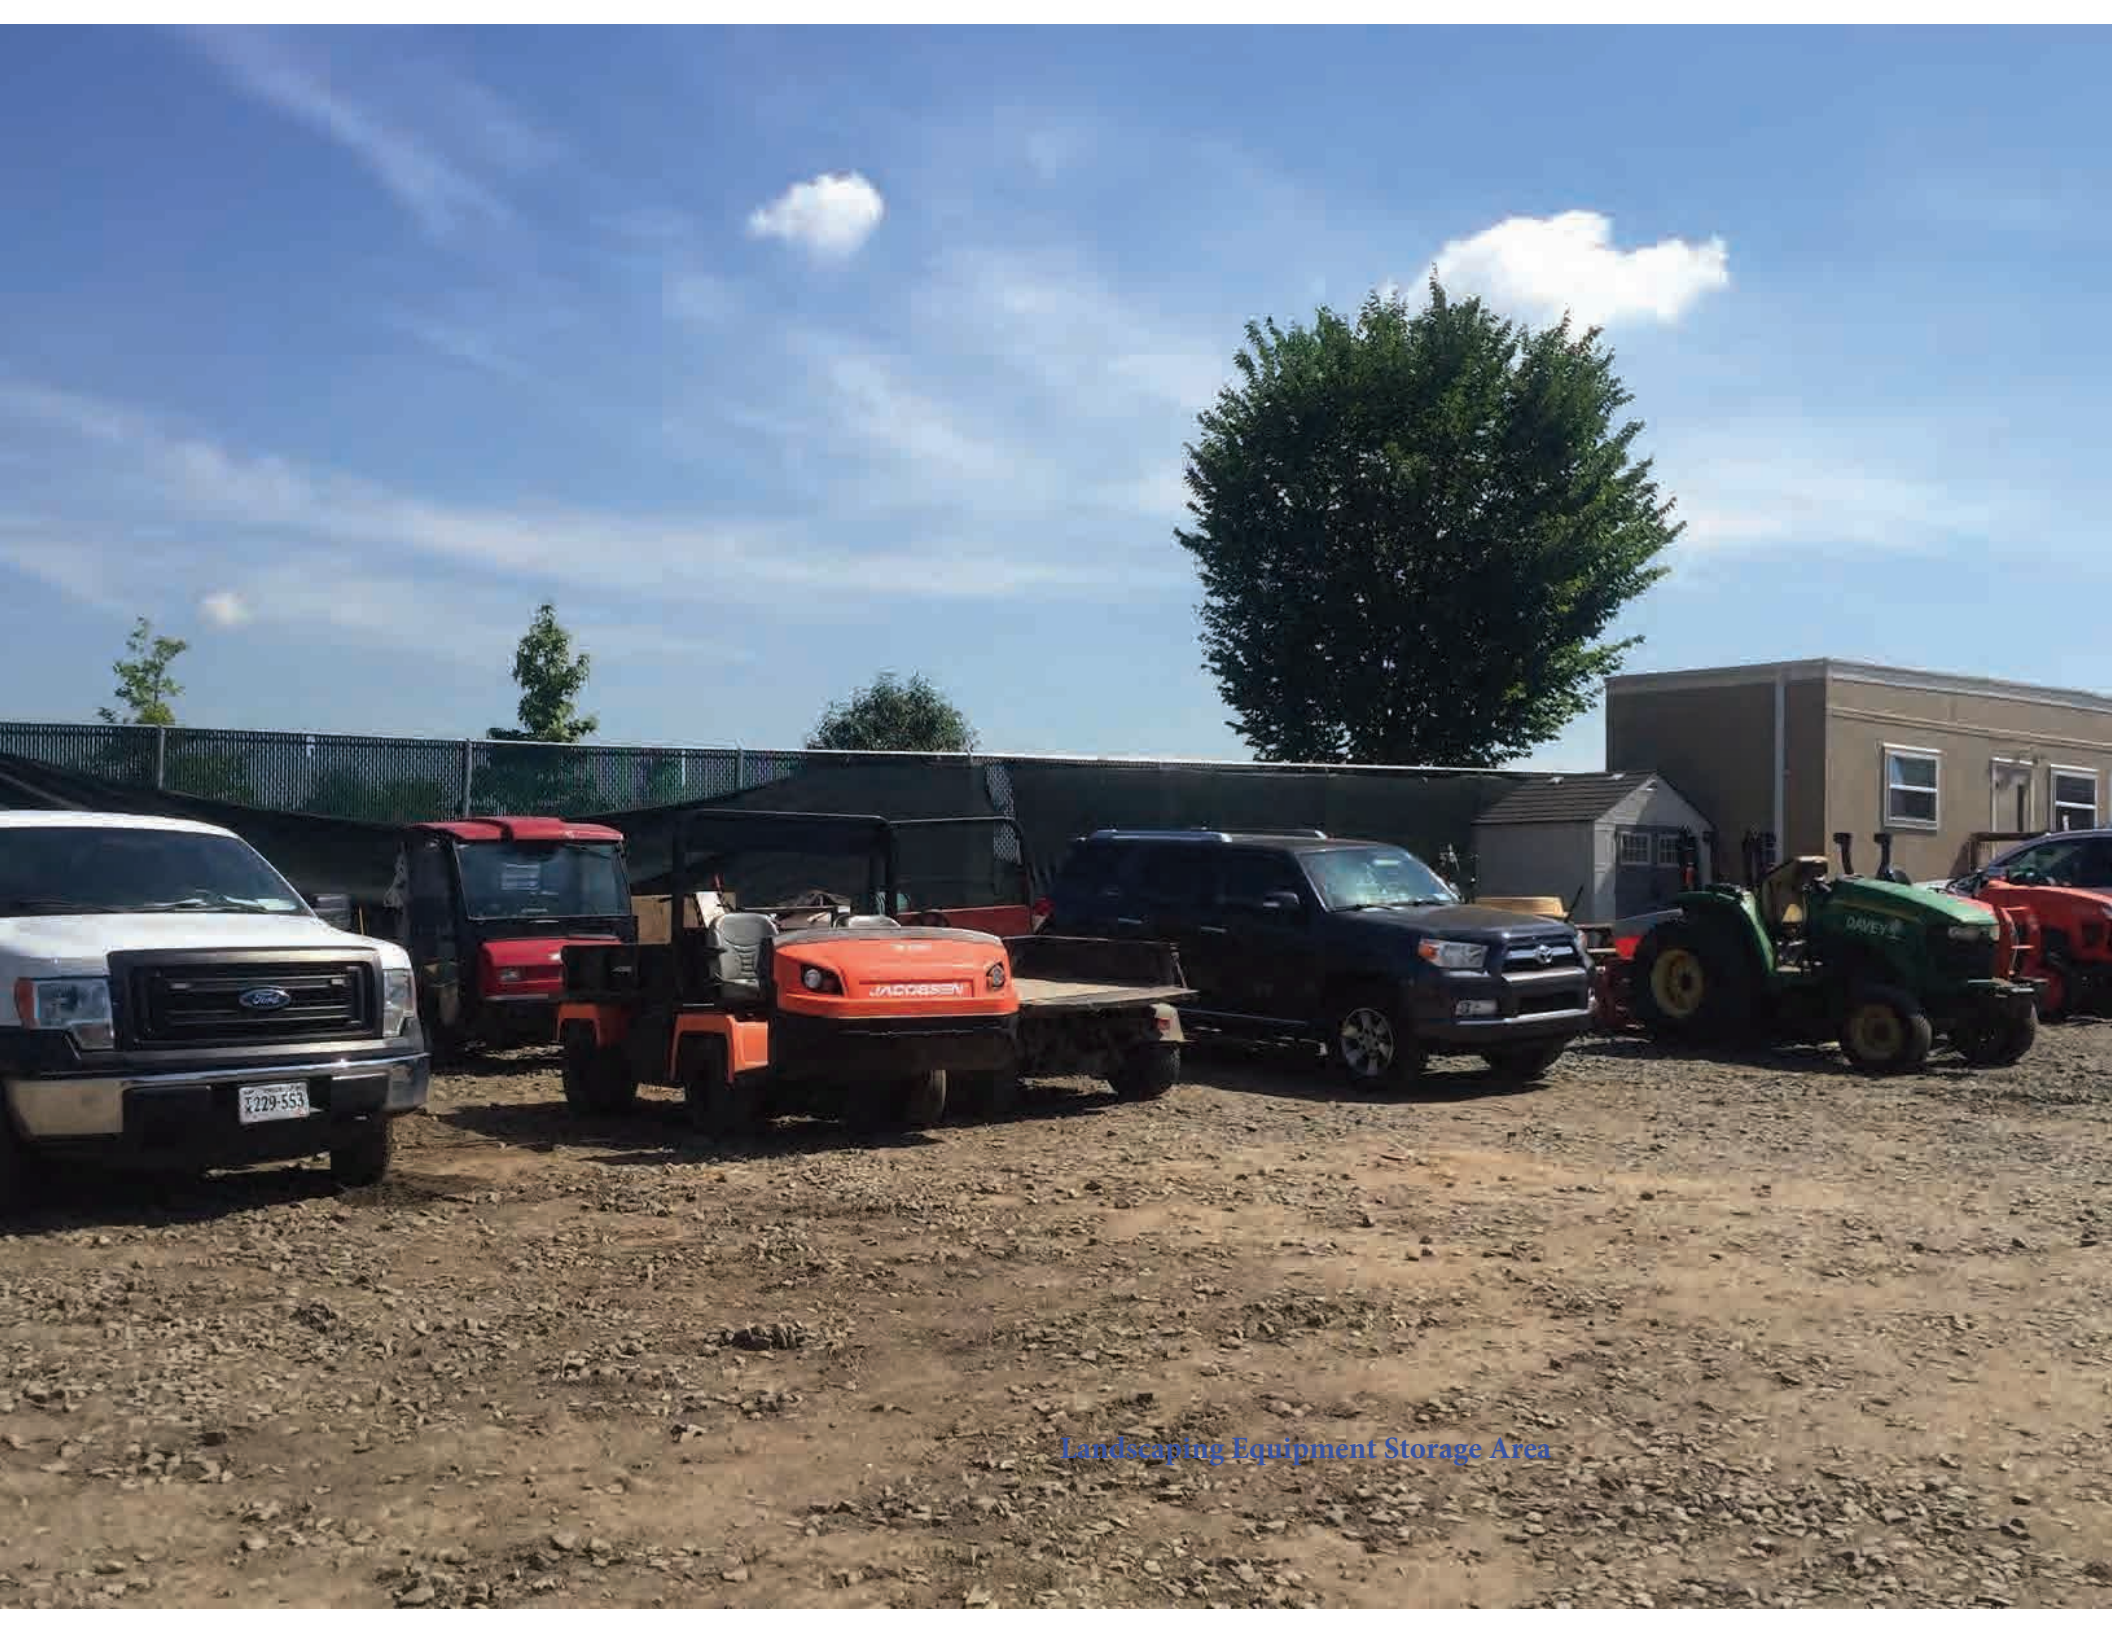
Landscaping Equipment Storage Area
