ARLINGTON NATIONAL CEMETERY

MS4 Permit Year 2016/2017

Annual Report and Program Plan Update

Reporting Period
July 1, 2016 through June 30, 2017
(Due: October 1, 2017)

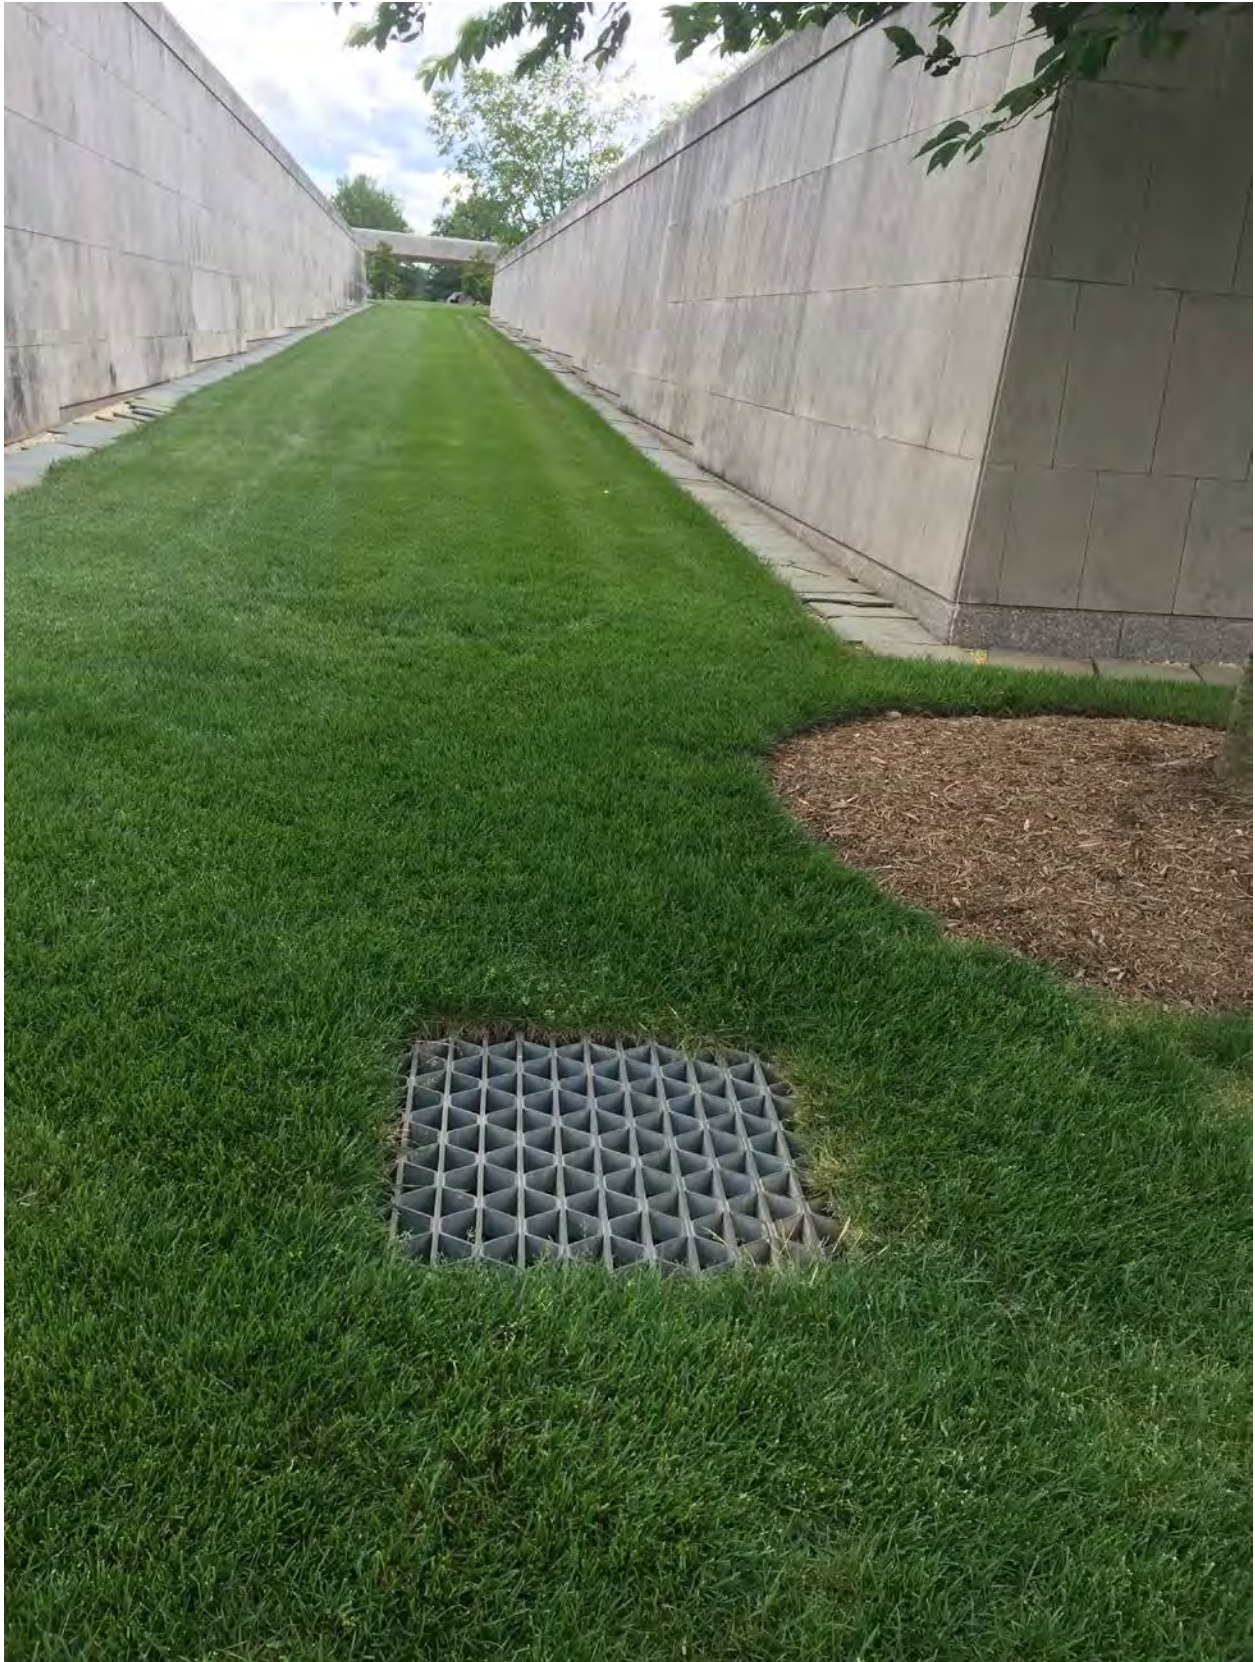
Sample Maintenance Inspection Checklist: Filtering Practices

Inspection Date May 24, 2017
 Project _____ Site Plan/Permit Number ANC/VAR040139
 Location Underground Stormwater Chamber (B123) Date BMP Placed in Service 1996
 Date of Last Inspection April 2016 Inspector S. Rosenquist
 Owner/Owner's Representative _____
 As-Built Plans available: Y / N X

07/10/17: Operations has replaced trash cans.

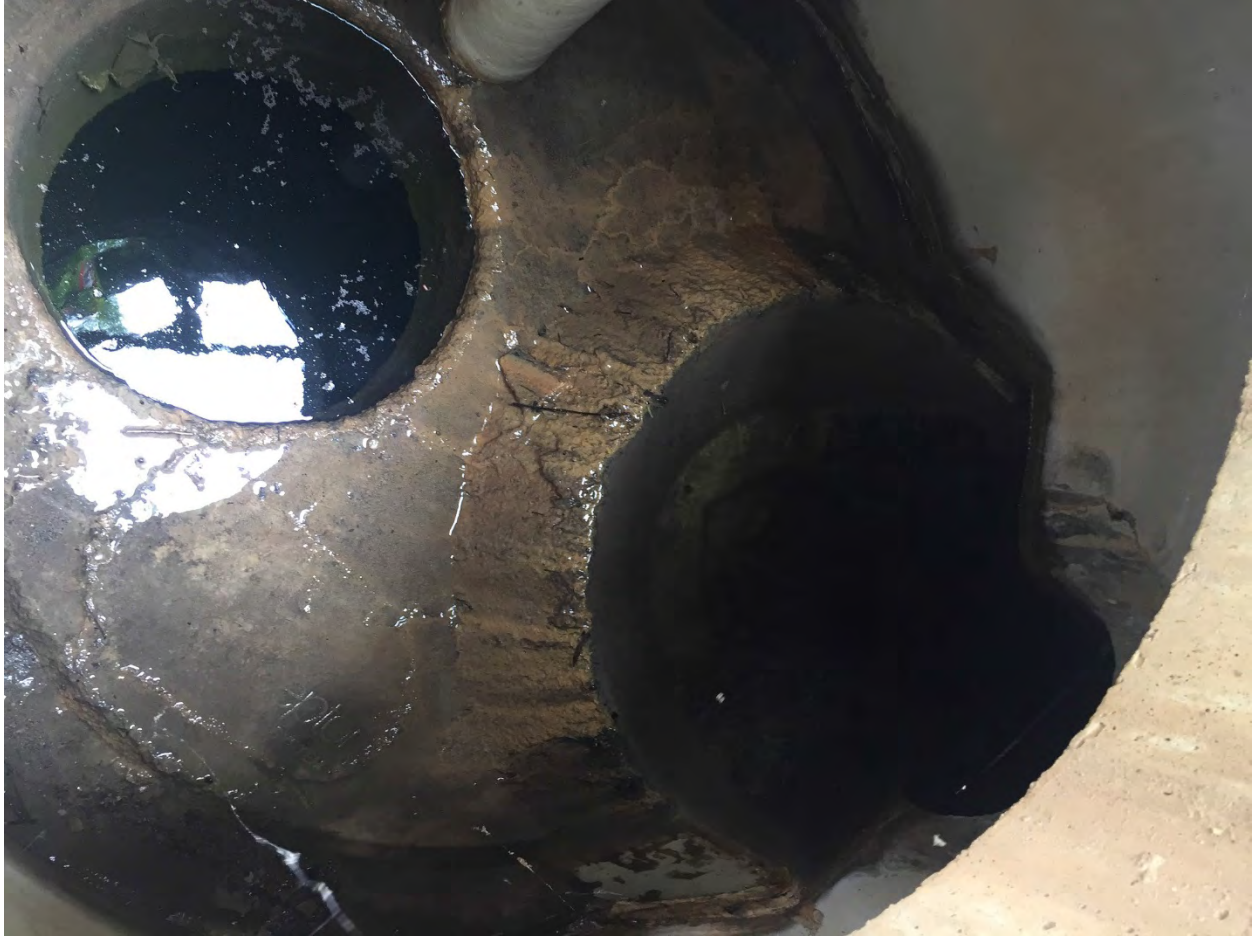
Inspection Date May 22, 2017 and June 6, 2017
 Project _____ Site Plan/Permit Number ANC/VAR040139
 Location Stormceptor 2 COL8 Date BMP Placed in Service 2002-2003
 Date of Last Inspection April 2016 Inspector S. Rosenquist
 Owner/Owner's Representative _____
 As-Built Plans available: Y / N X

Element of BMP	Potential Problem	Problem? Y / N	Investigate? Y / N	Repaired? Y / N	How to Fix Problem	Who Will Address Problem	Comments
Storage	Sediment and debris accumulation depth > 15% of total storage	Y			Correct the source of sediment and debris; remove and dispose according to environmental regulations	Owner or Professional	Maintenance required.
	Oil and fuel accumulation	unknown			Remove and dispose of accumulated oil/fuel waste according to environmental regulations	Owner or professional	
Inflow and outflow pipes	Blockage at inflow & outflow pipes	N			Remove blockage debris	Owner or professional	
	Breaks & cracks at pipe joint connections	unknown			Repair joints according to type of joint connections in-place	Professional	
Structural components	Concrete spalling or deterioration	unknown			Replace and repair damaged components in accordance with approved specifications	Professional	
	Cracks wider than ½ inch and any evidence of soil particles entering the structure through the cracks	unknown				Professional

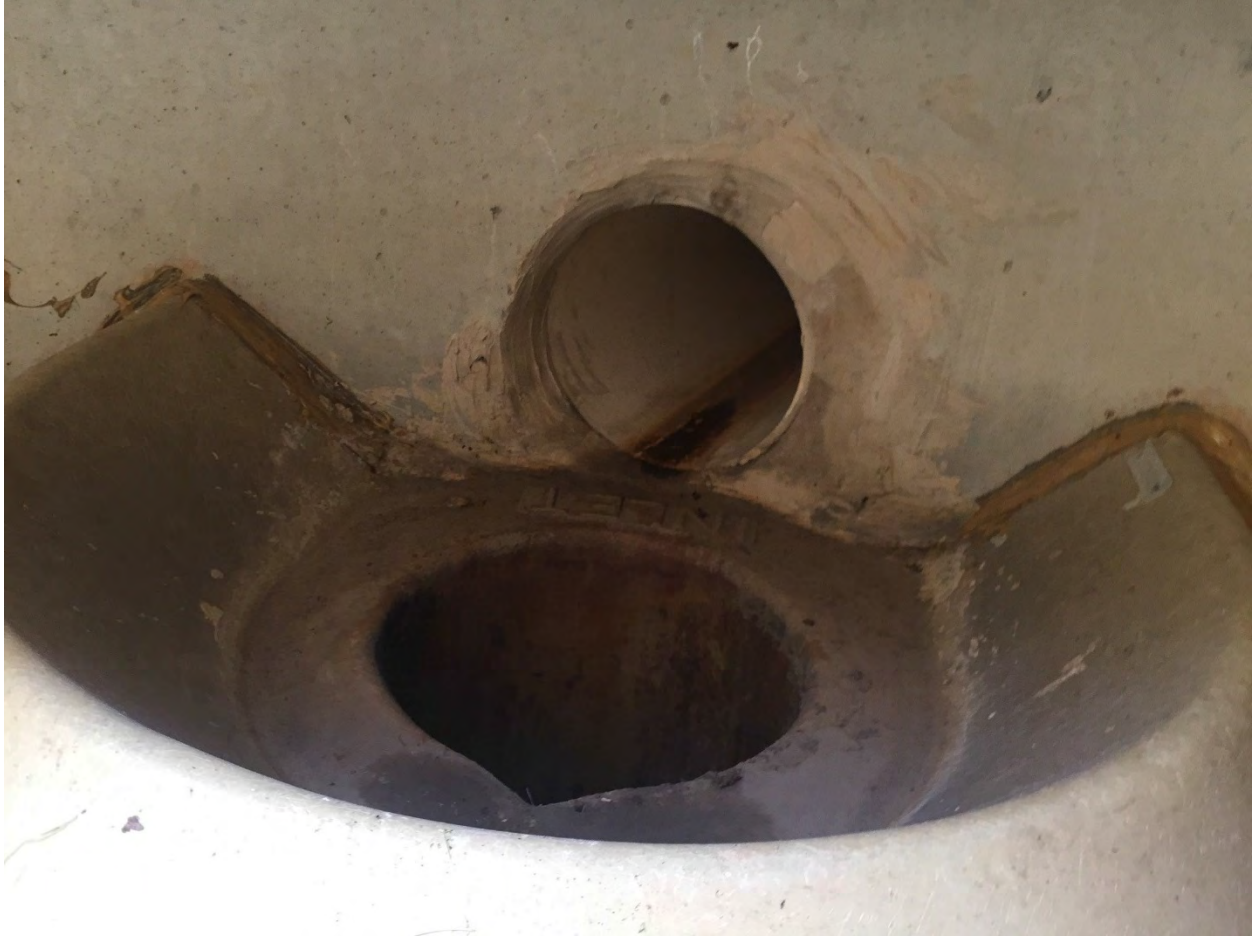
Inspection Date May 22, 2017 and June 6, 2017
 Project _____ Site Plan/Permit Number ANC / VAR040139
 Location Stormceptor 4 COL9 South Date BMP Placed in Service 2013
 Date of Last Inspection April 2016 Inspector S. Rosenquist
 Owner/Owner's Representative _____
 As-Built Plans available: Y / N X

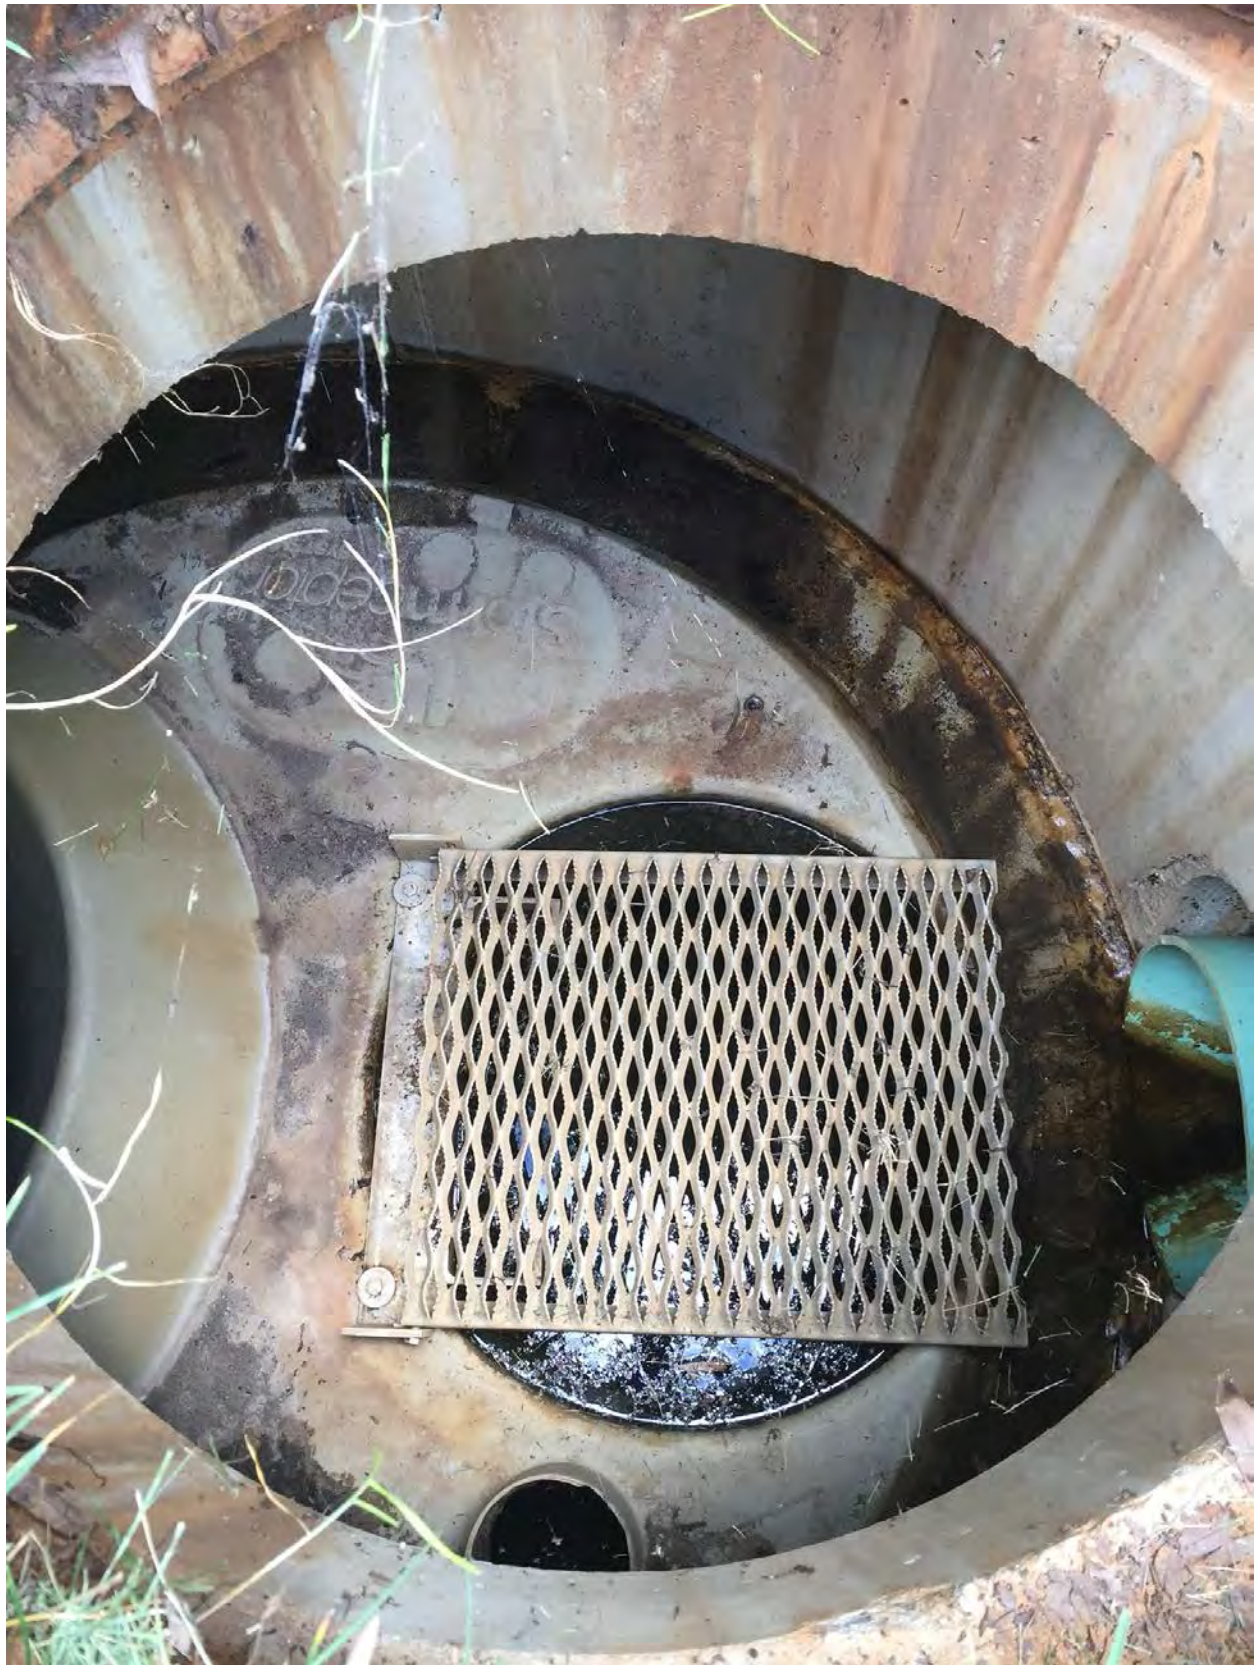
Inspection Date May 22, 2017 and June 6, 2017
 Project _____ Site Plan/Permit Number ANC/VAR040139
 Location Stormceptor 5 SEC76 Date BMP Placed in Service 2006
 Date of Last Inspection April 2016 Inspector S. Rosenquist
 Owner/Owner's Representative _____
 As-Built Plans available: Y / N X

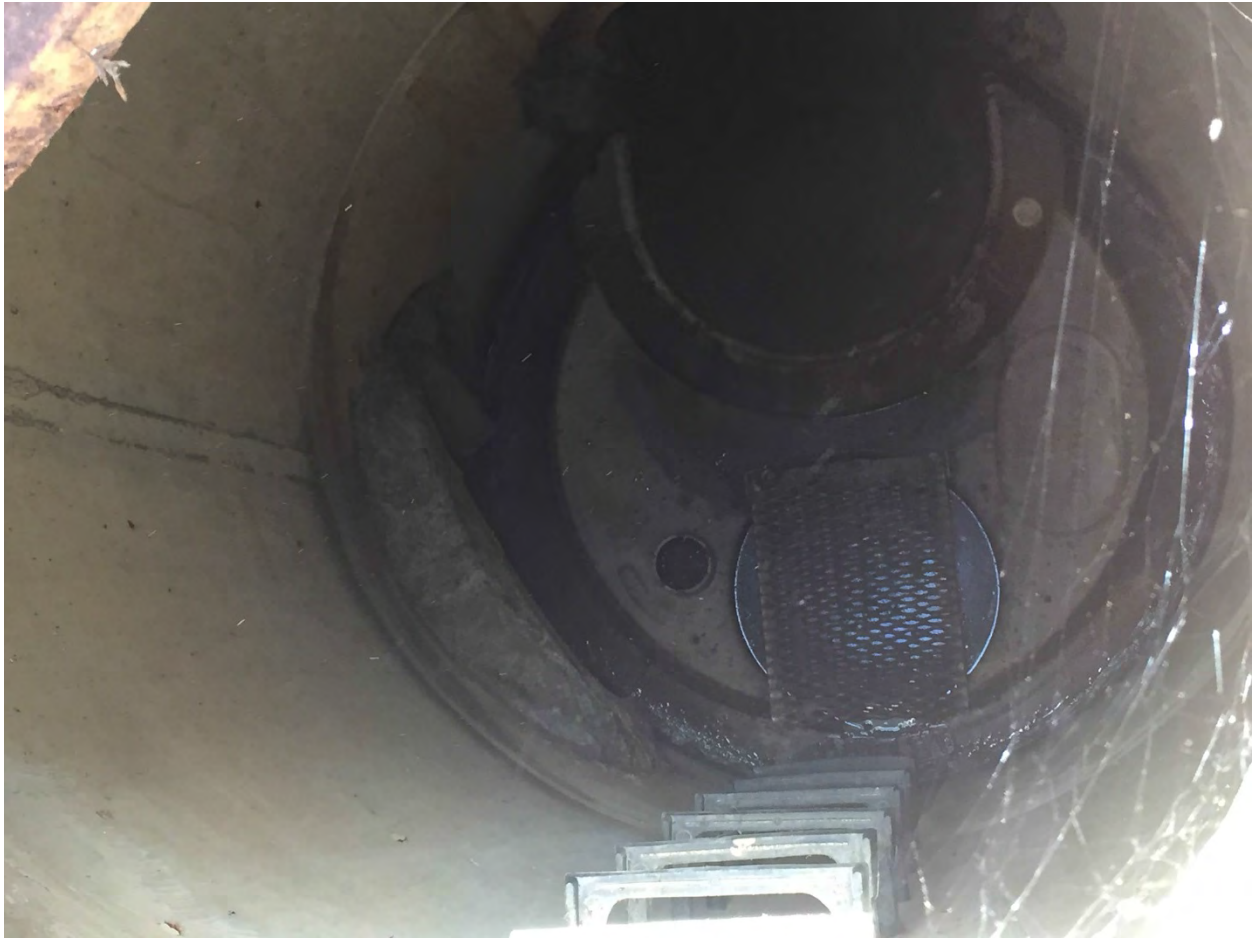
Inspection Date May 22, 2017 and June 6, 2017
 Project _____ Site Plan/Permit Number ANC/VAR040139
 Location Stormceptor 6 SEC78 Date BMP Placed in Service 2006
 Date of Last Inspection April 2016 Inspector S. Rosenquist
 Owner/Owner's Representative _____
 As-Built Plans available: Y / N X
